# Sewer System Evaluation Survey (SSES) Infiltration Study

227950.01  
City of Portsmouth, NH  
July 2020

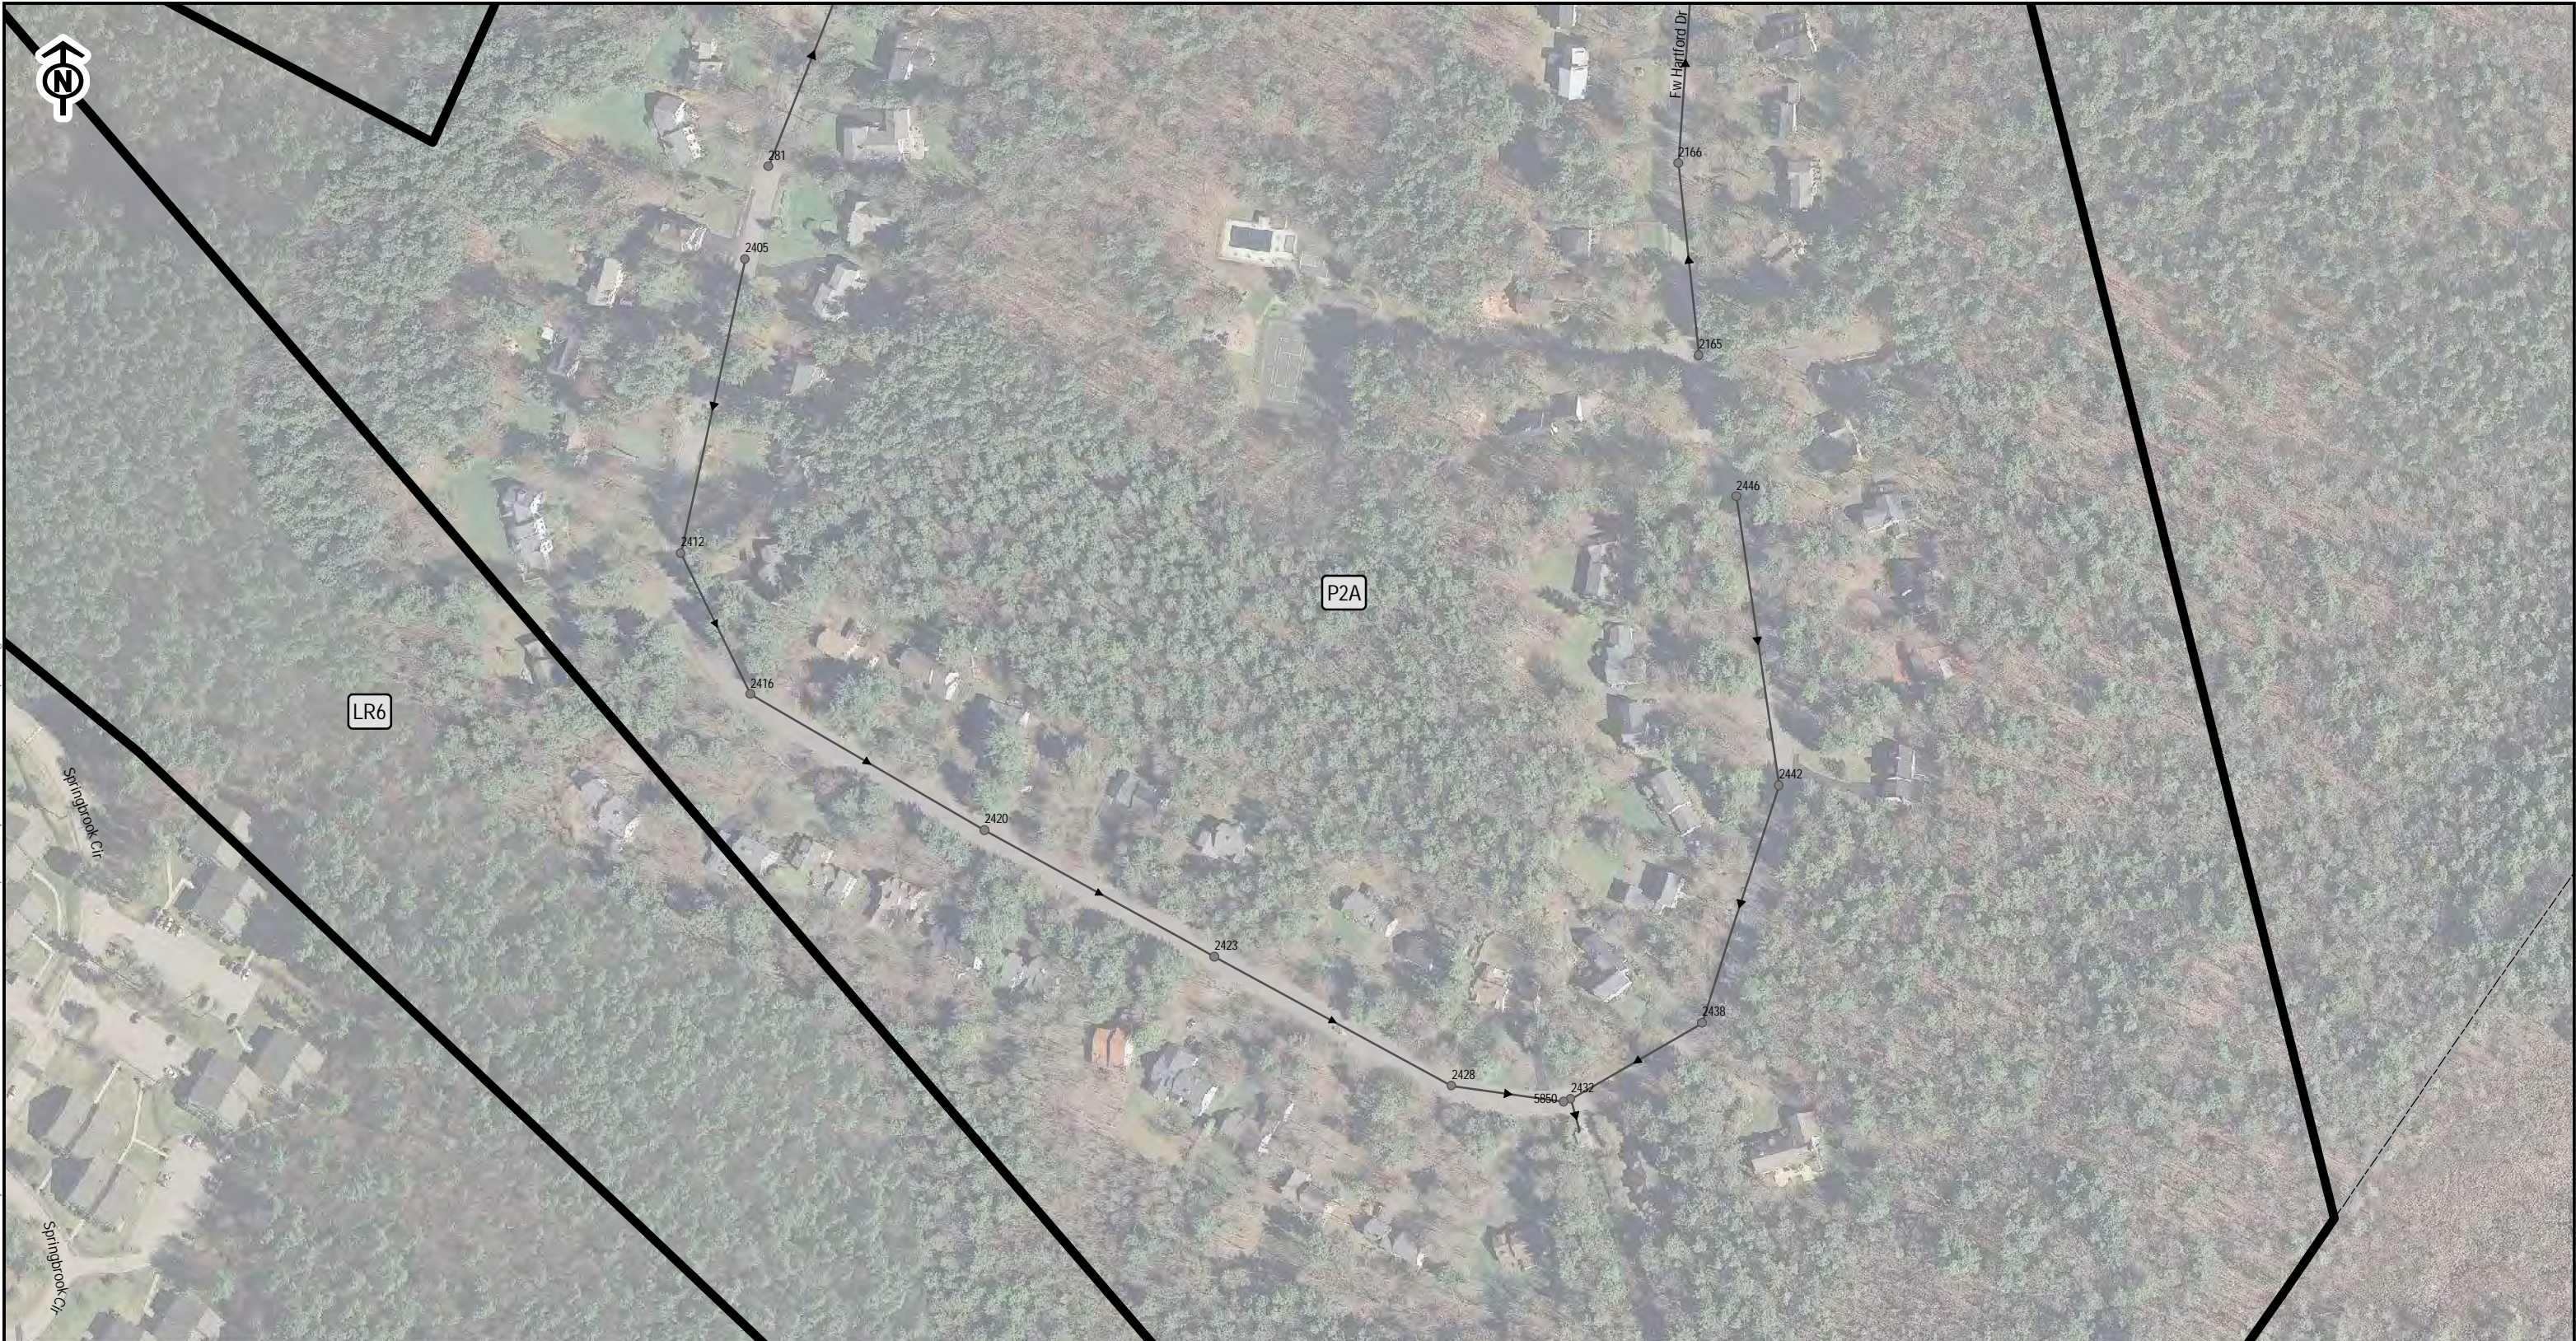
Figure 4-1: Recommended Pipeline Rehabilitation

- Assets labeled in italic text reflect those with higher rehabilitation priority
- Symbology does not reflect actual position of defect and/or recommended repair.
- Refer to recommended rehabilitation tables for detailed quantities and location(s) of defects.
- Not for construction.

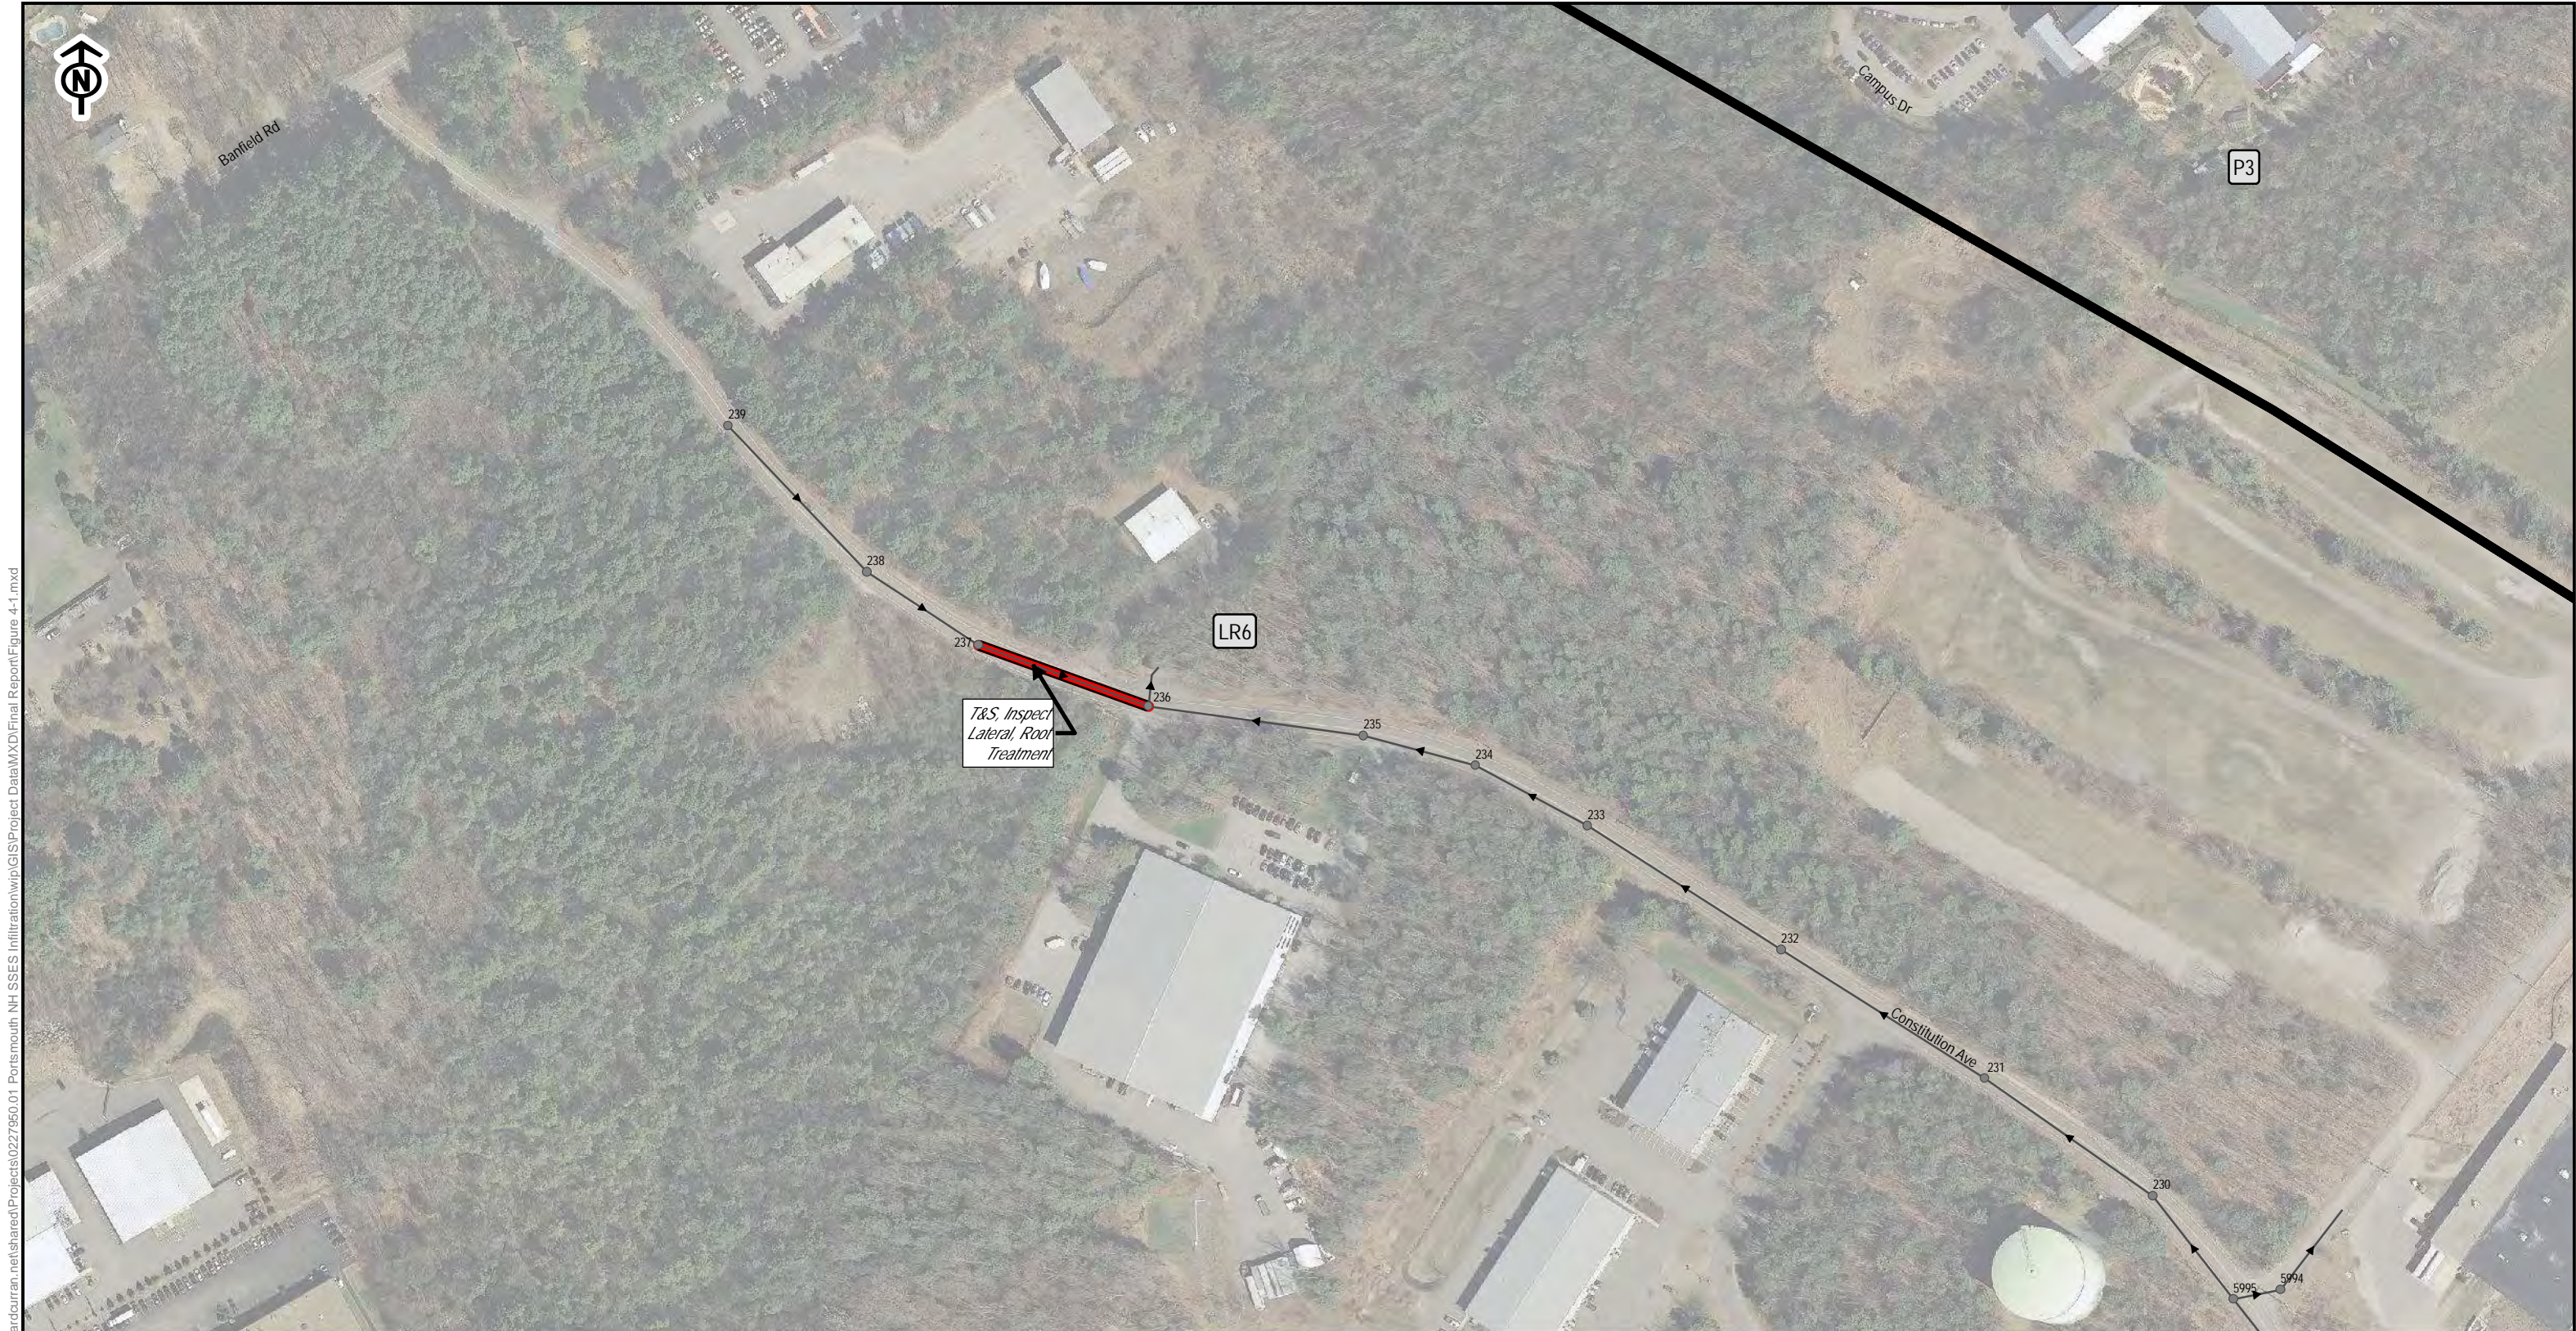
Figure 4-1: Recommended Pipeline Rehabilitation  
MAP 19 of 24

- Assets labeled in italic text reflect those with higher rehabilitation priority
- Symbology does not reflect actual position of defect and/or recommended repair.
- Refer to recommended rehabilitation tables for detailed quantities and location(s) of defects.
- Not for construction.

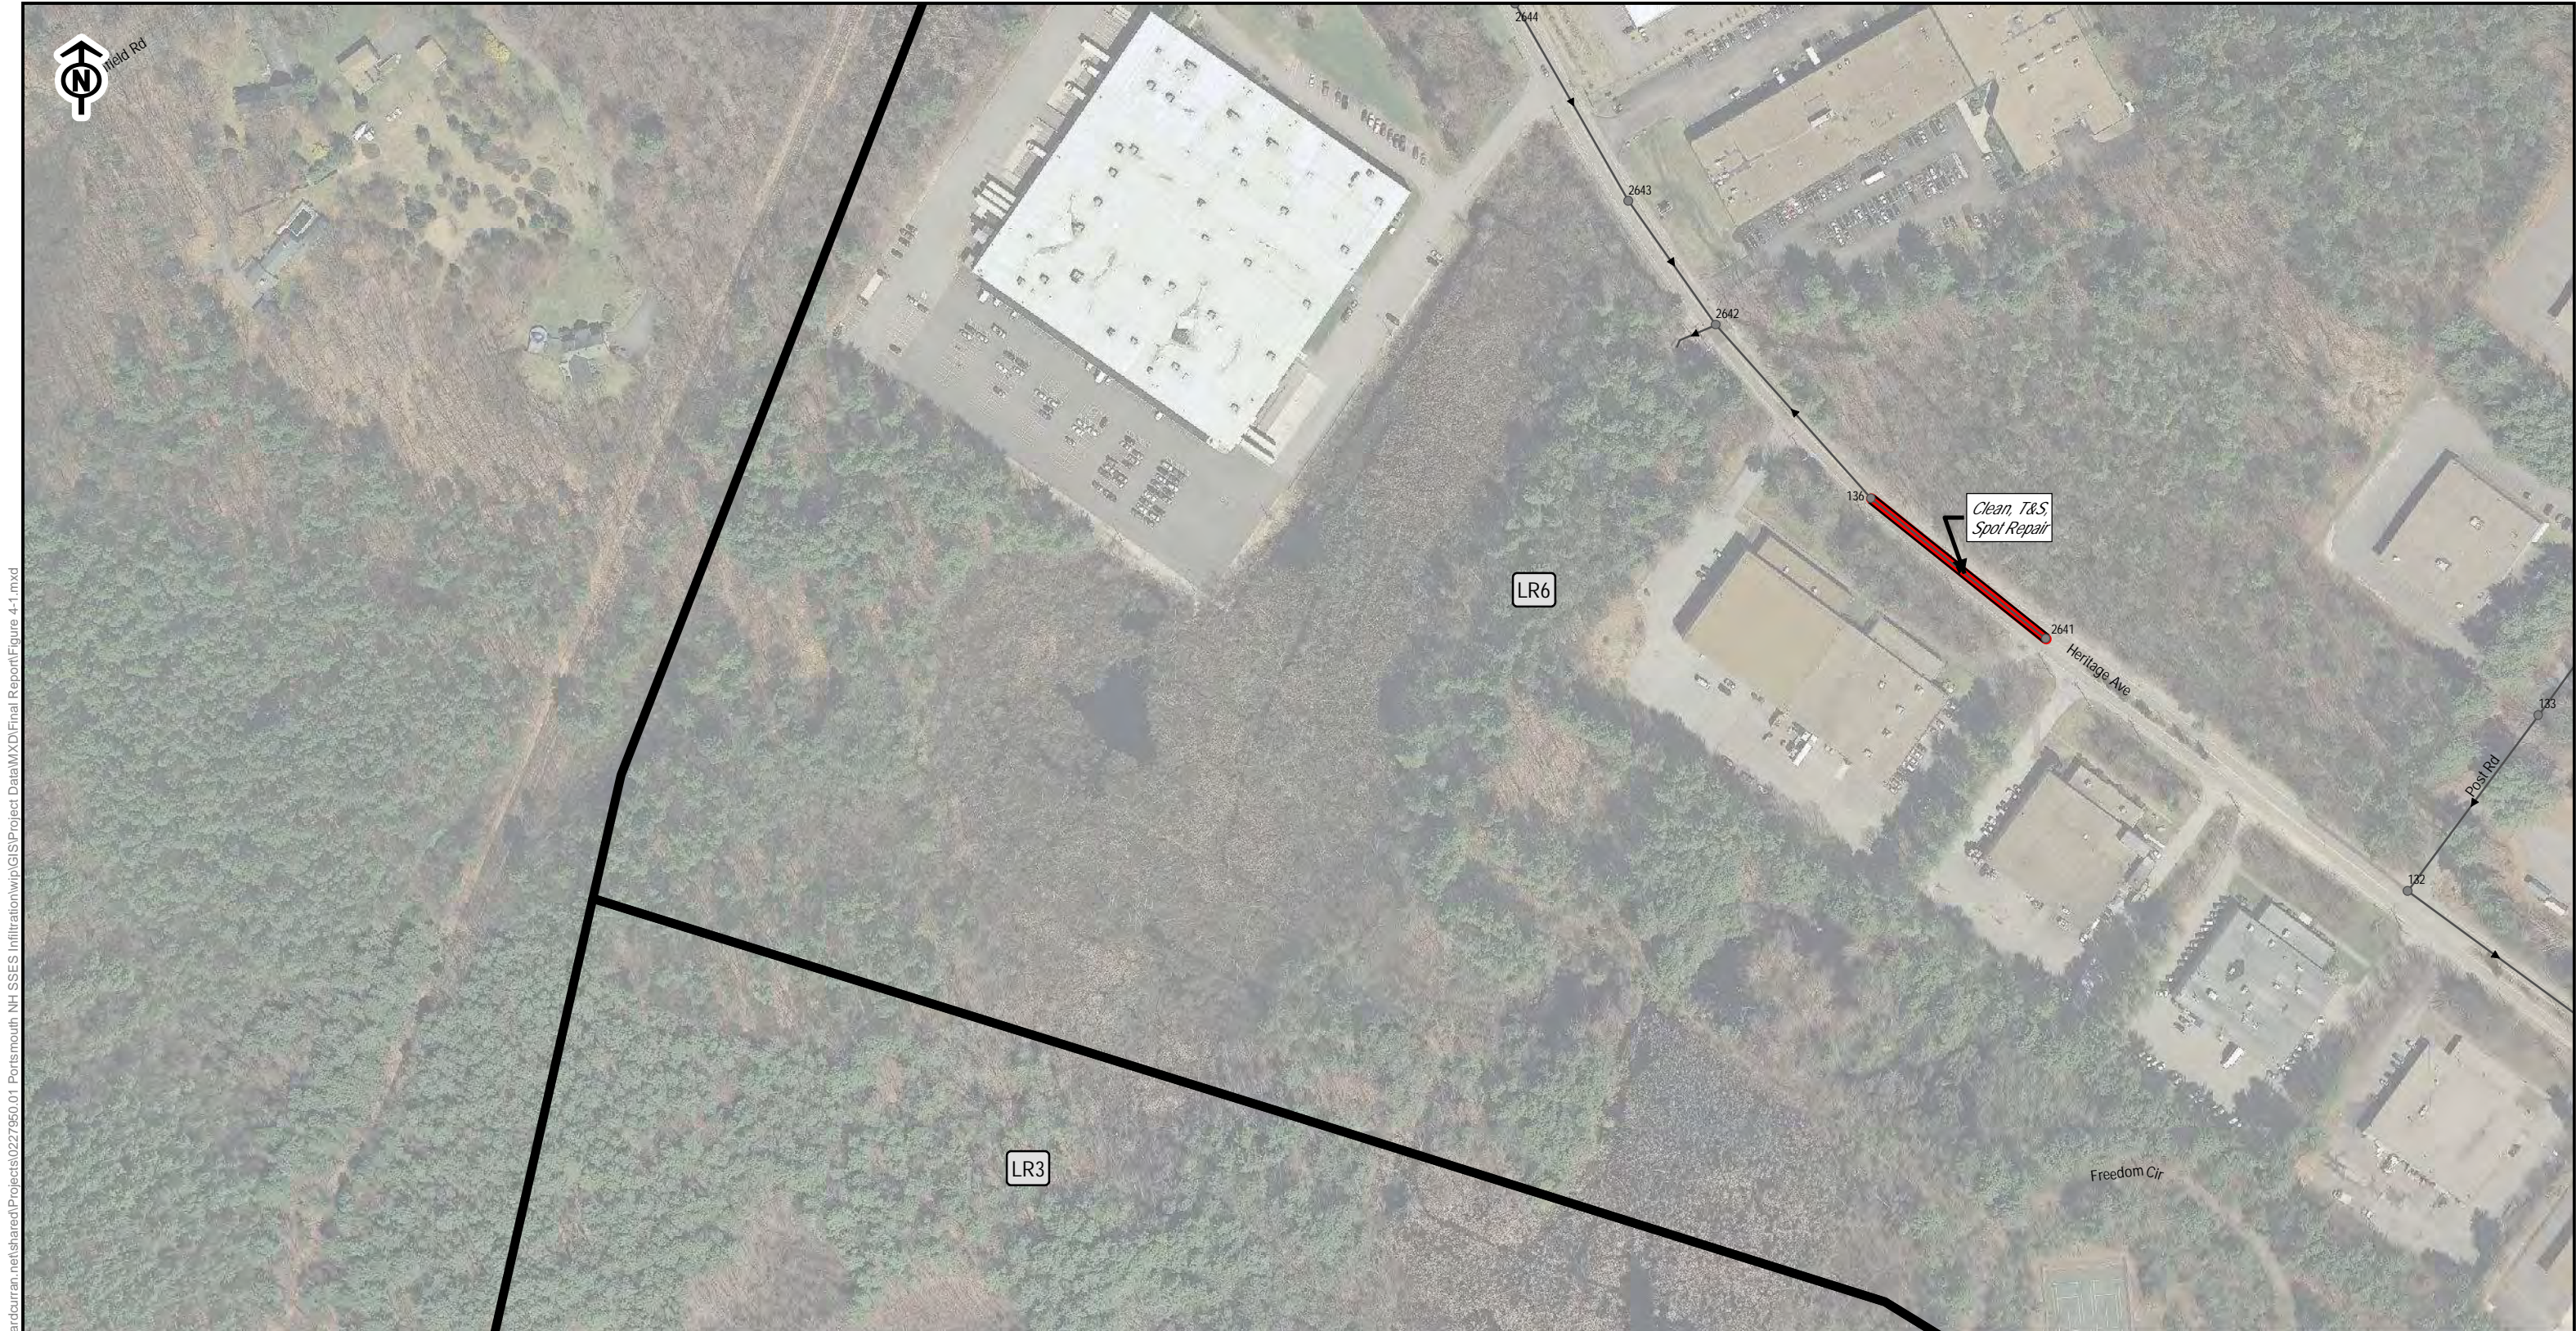
- Assets labeled in italic text reflect those with higher rehabilitation priority
- Symbology does not reflect actual position of defect and/or recommended repair.
- Refer to recommended rehabilitation tables for detailed quantities and location(s) of defects.
- Not for construction.

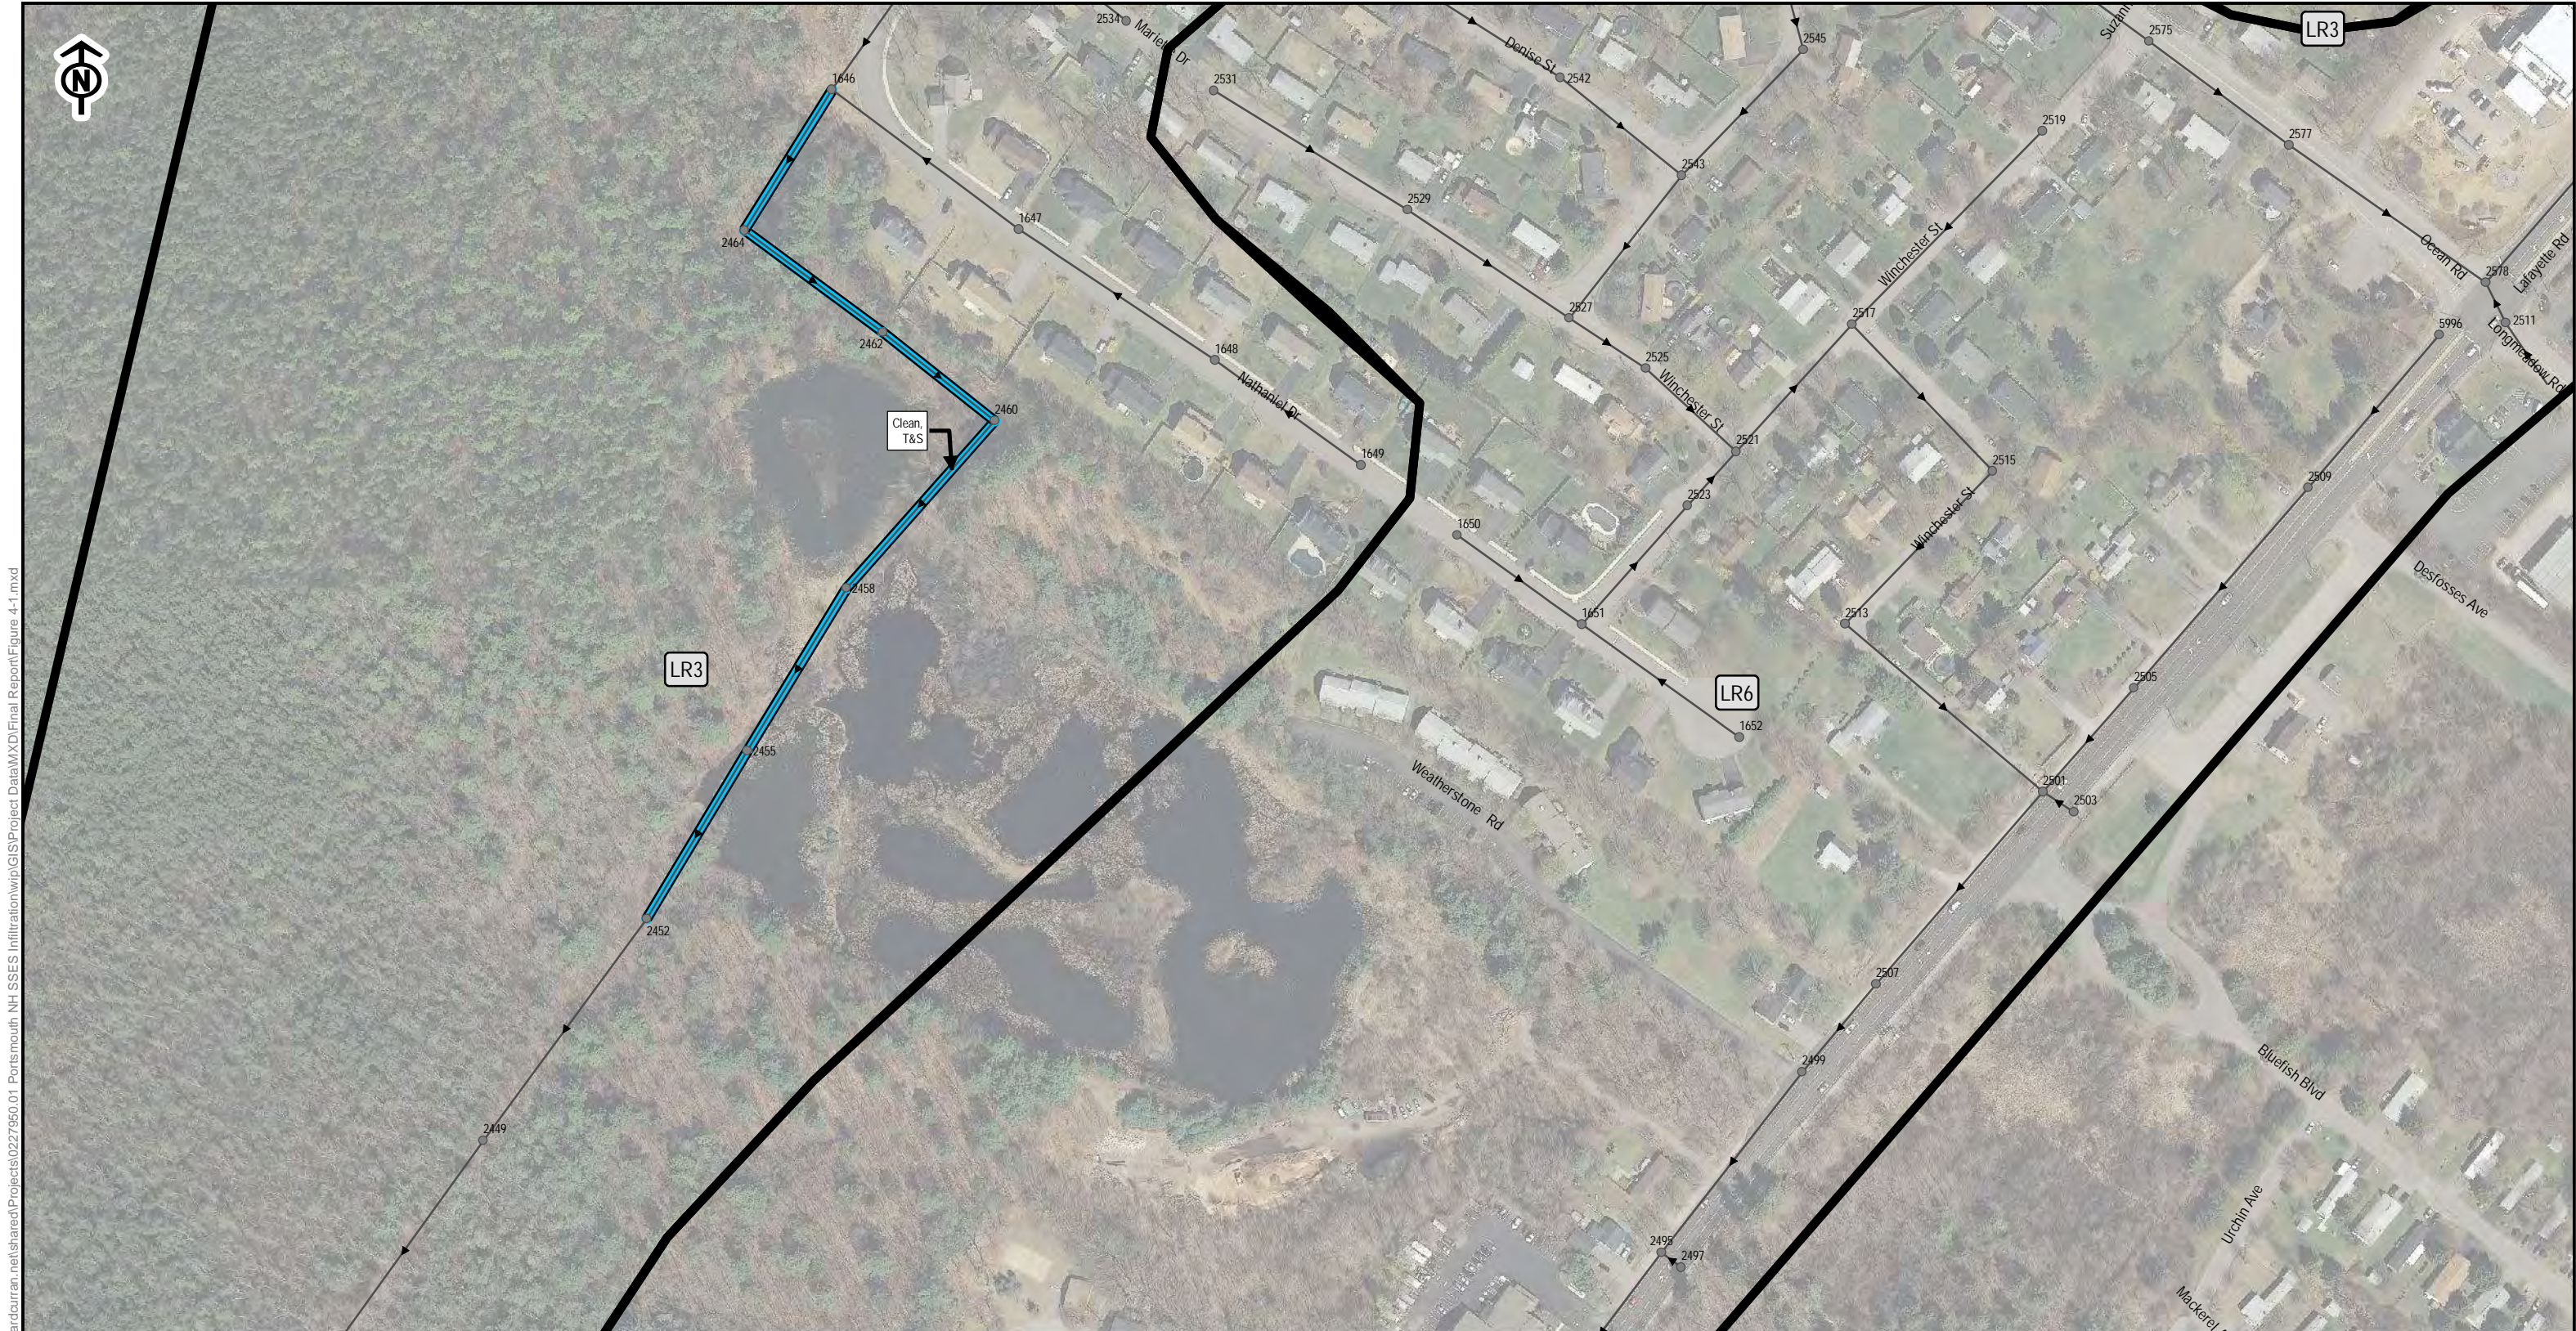
Figure 4-1: Recommended Pipeline Rehabilitation  
MAP 23 of 24

- Assets labeled in italic text reflect those with higher rehabilitation priority
- Symbology does not reflect actual position of defect and/or recommended repair.
- Refer to recommended rehabilitation tables for detailed quantities and location(s) of defects.
- Not for construction.

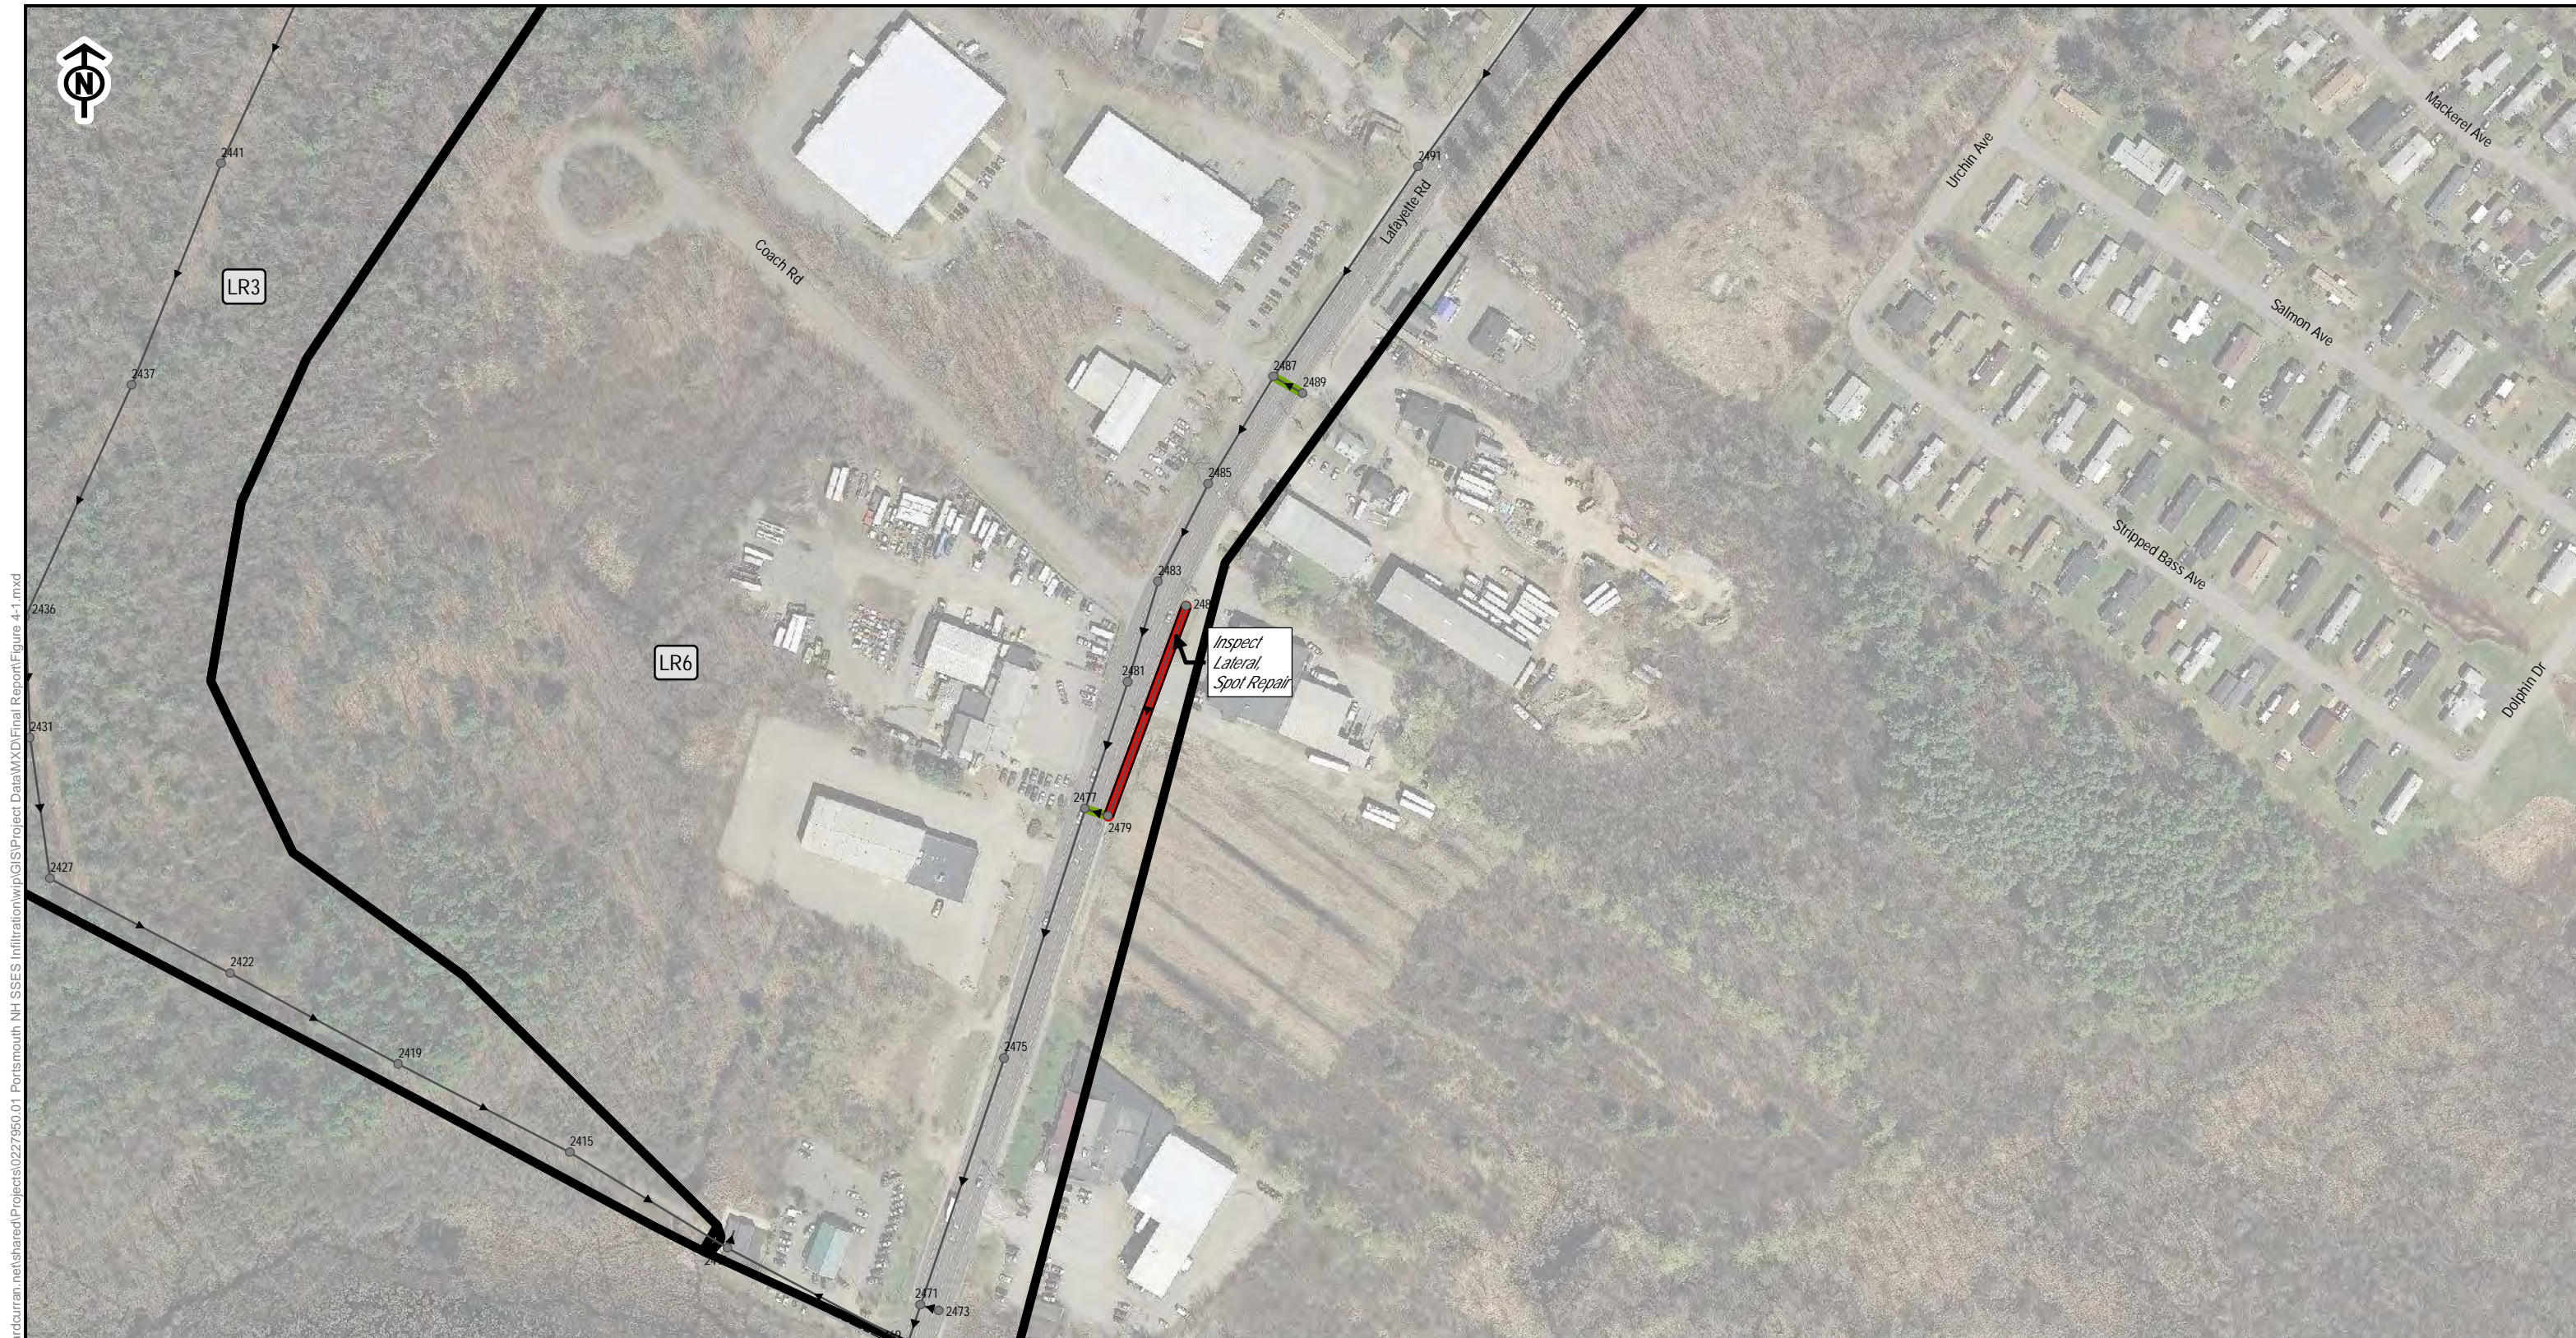
- Assets labeled in italic text reflect those with higher rehabilitation priority
- Symbology does not reflect actual position of defect and/or recommended repair.
- Refer to recommended rehabilitation tables for detailed quantities and location(s) of defects.
- Not for construction.

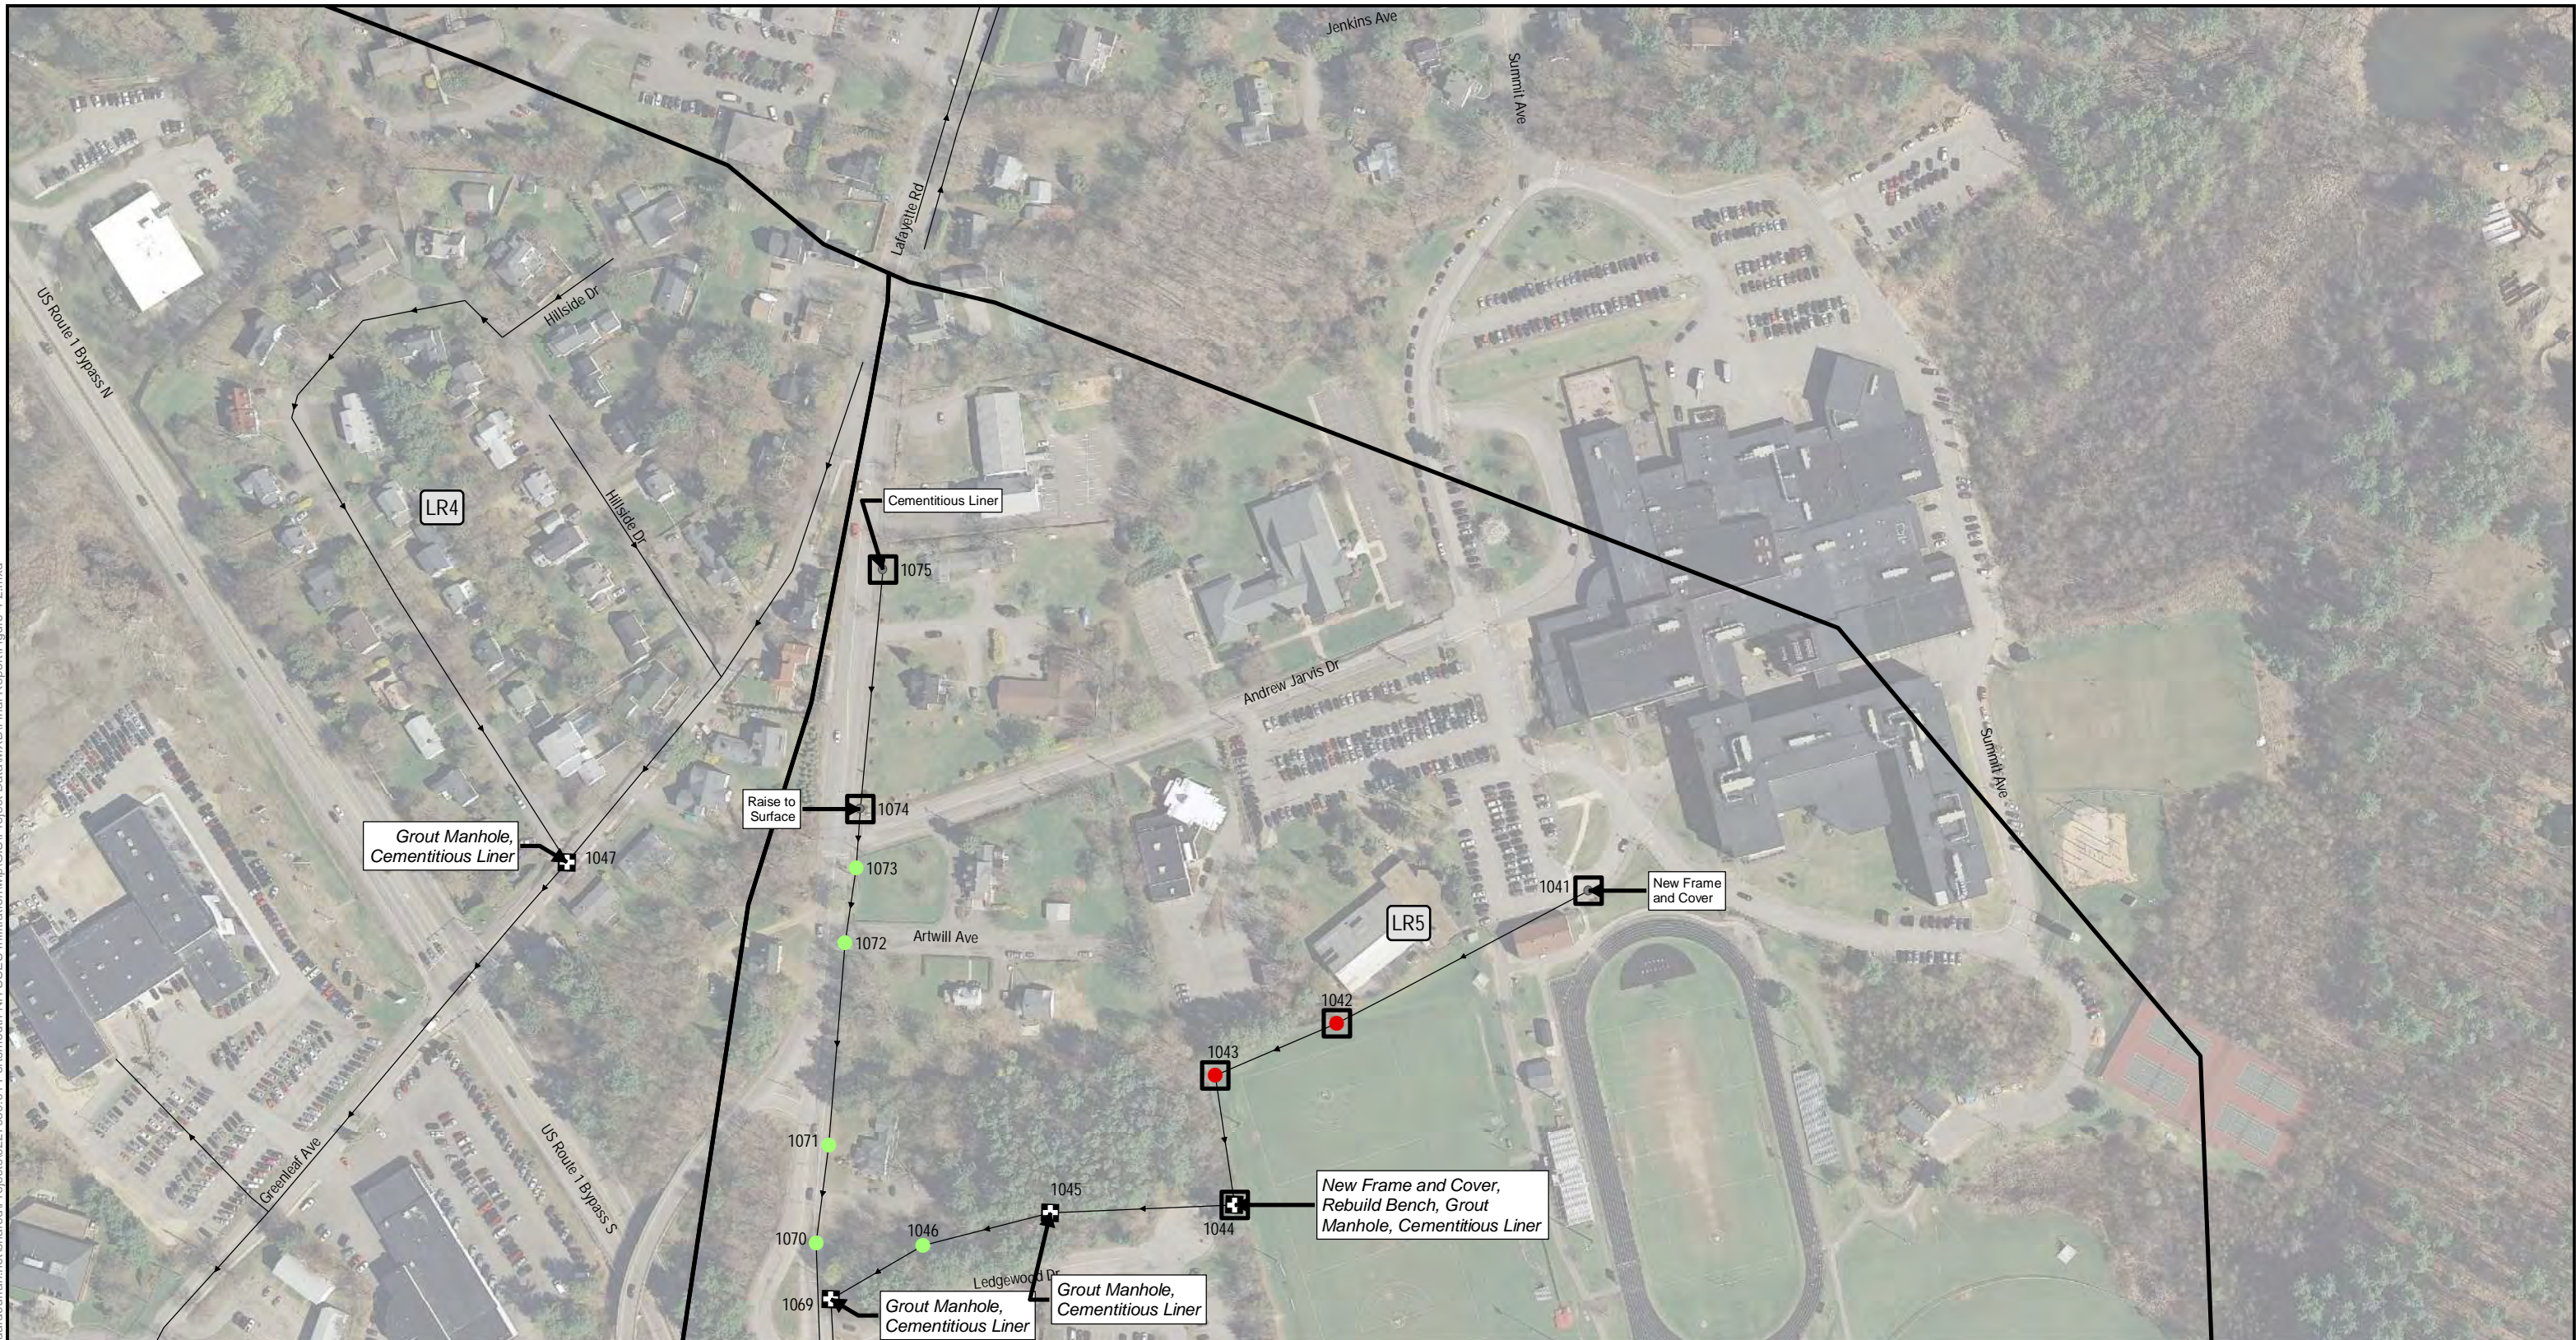
Figure 4-2: Recommended Manhole Rehabilitation  
*MAP 13 of 24*

Manhole Rehabilitation	Sanitary Sewer System Features	Geographical Features
Infiltration	Metering Basin	City/Town Boundary
Infiltration & Structural/O&M	Sewer Manhole	
Structural/O&M	Gravity Sewer Pipe	
Monitor		
Locate Manhole
