# Sewer System Evaluation Survey (SSES) Infiltration Study

227950.01  
City of Portsmouth, NH  
July 2020

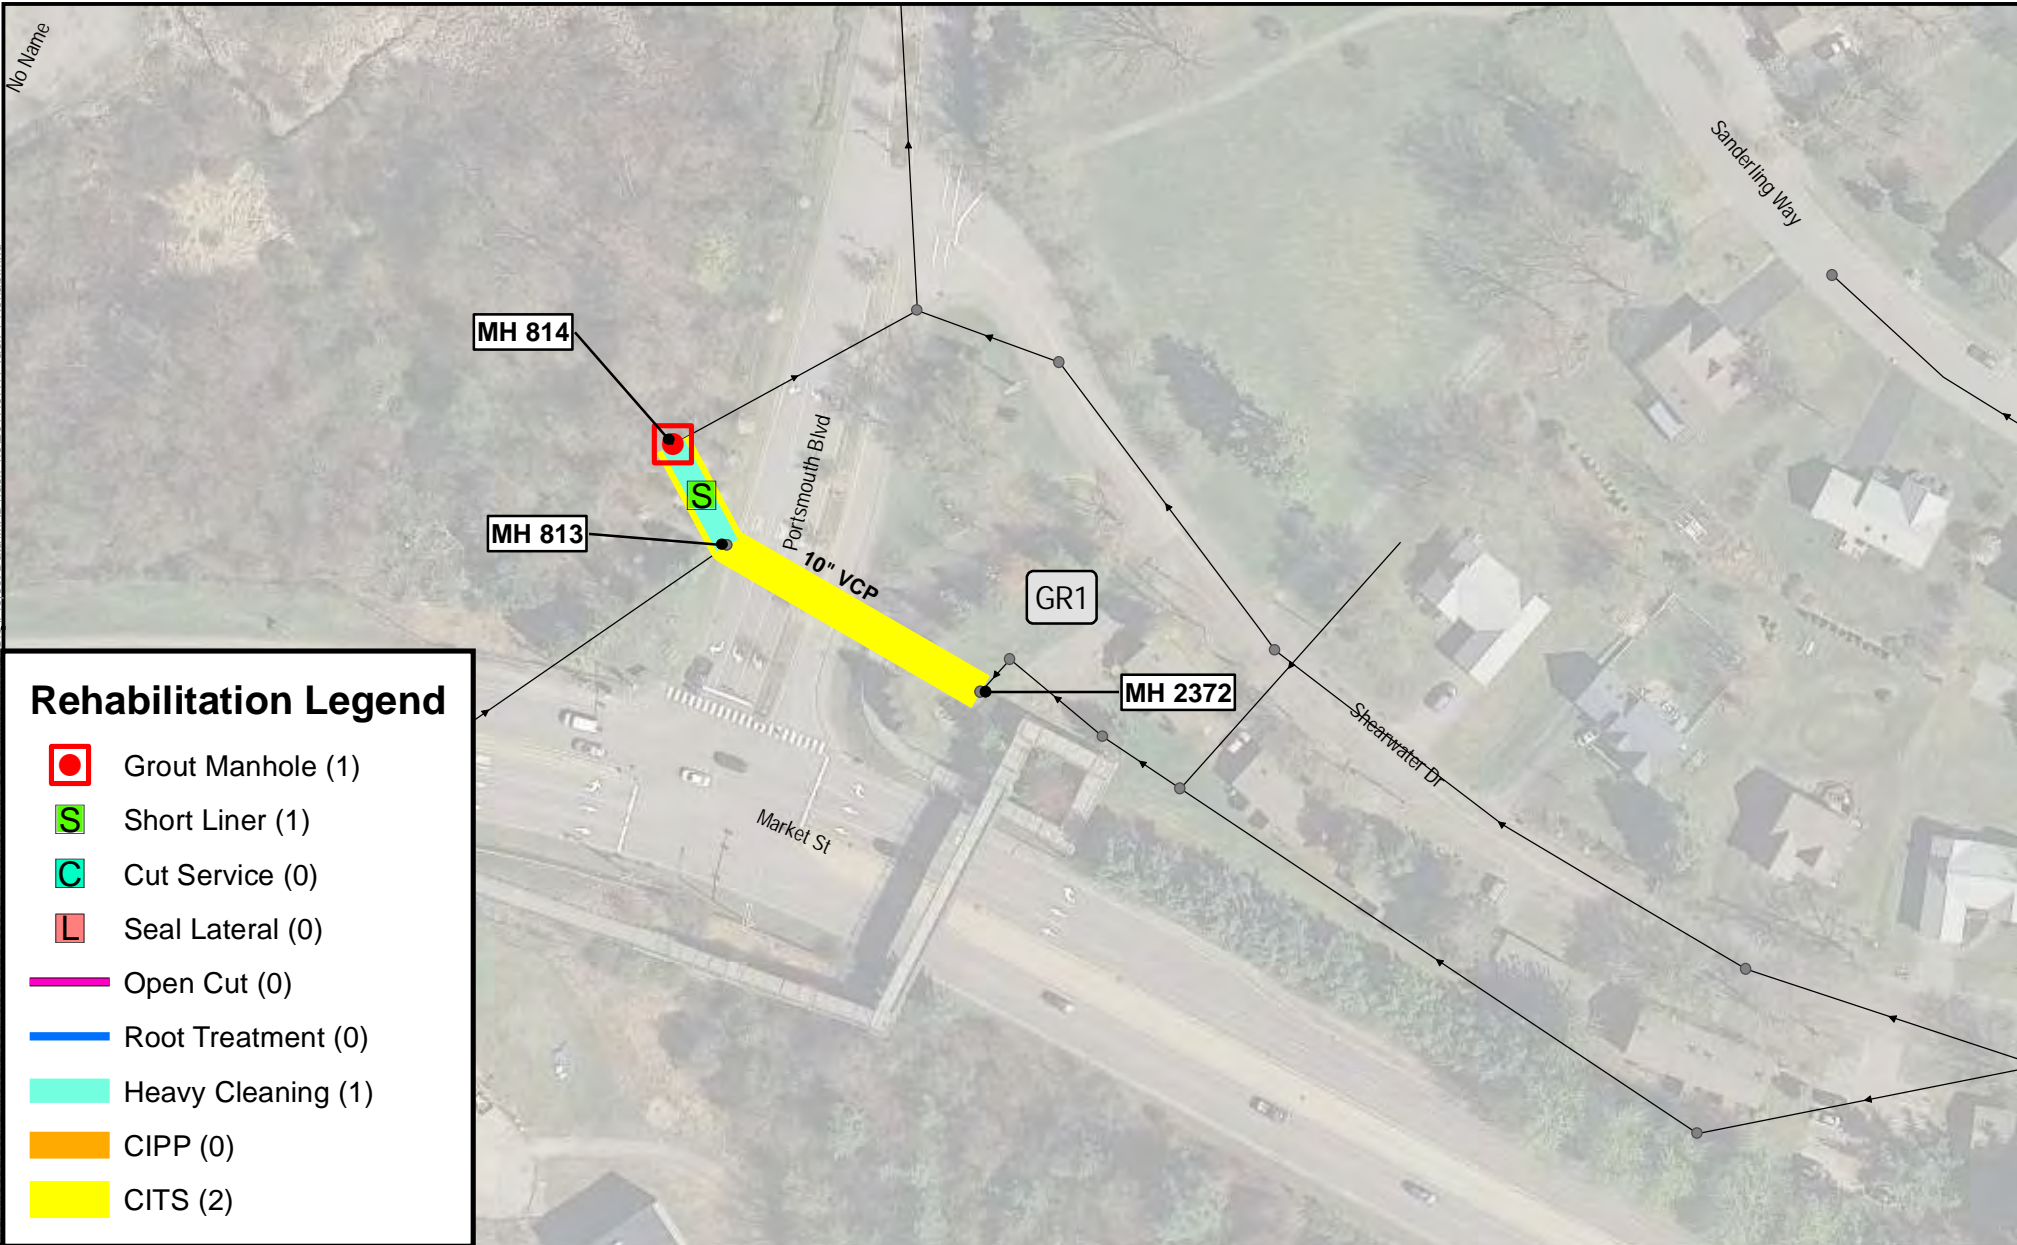
### Figure 2

- Grout Manhole (1)
- Short Liner (1)
- Cut Service (0)
- Seal Lateral (0)
- Open Cut (0)
- Root Treatment (0)
- Heavy Cleaning (1)
- CIPP (0)
- CITS (2)

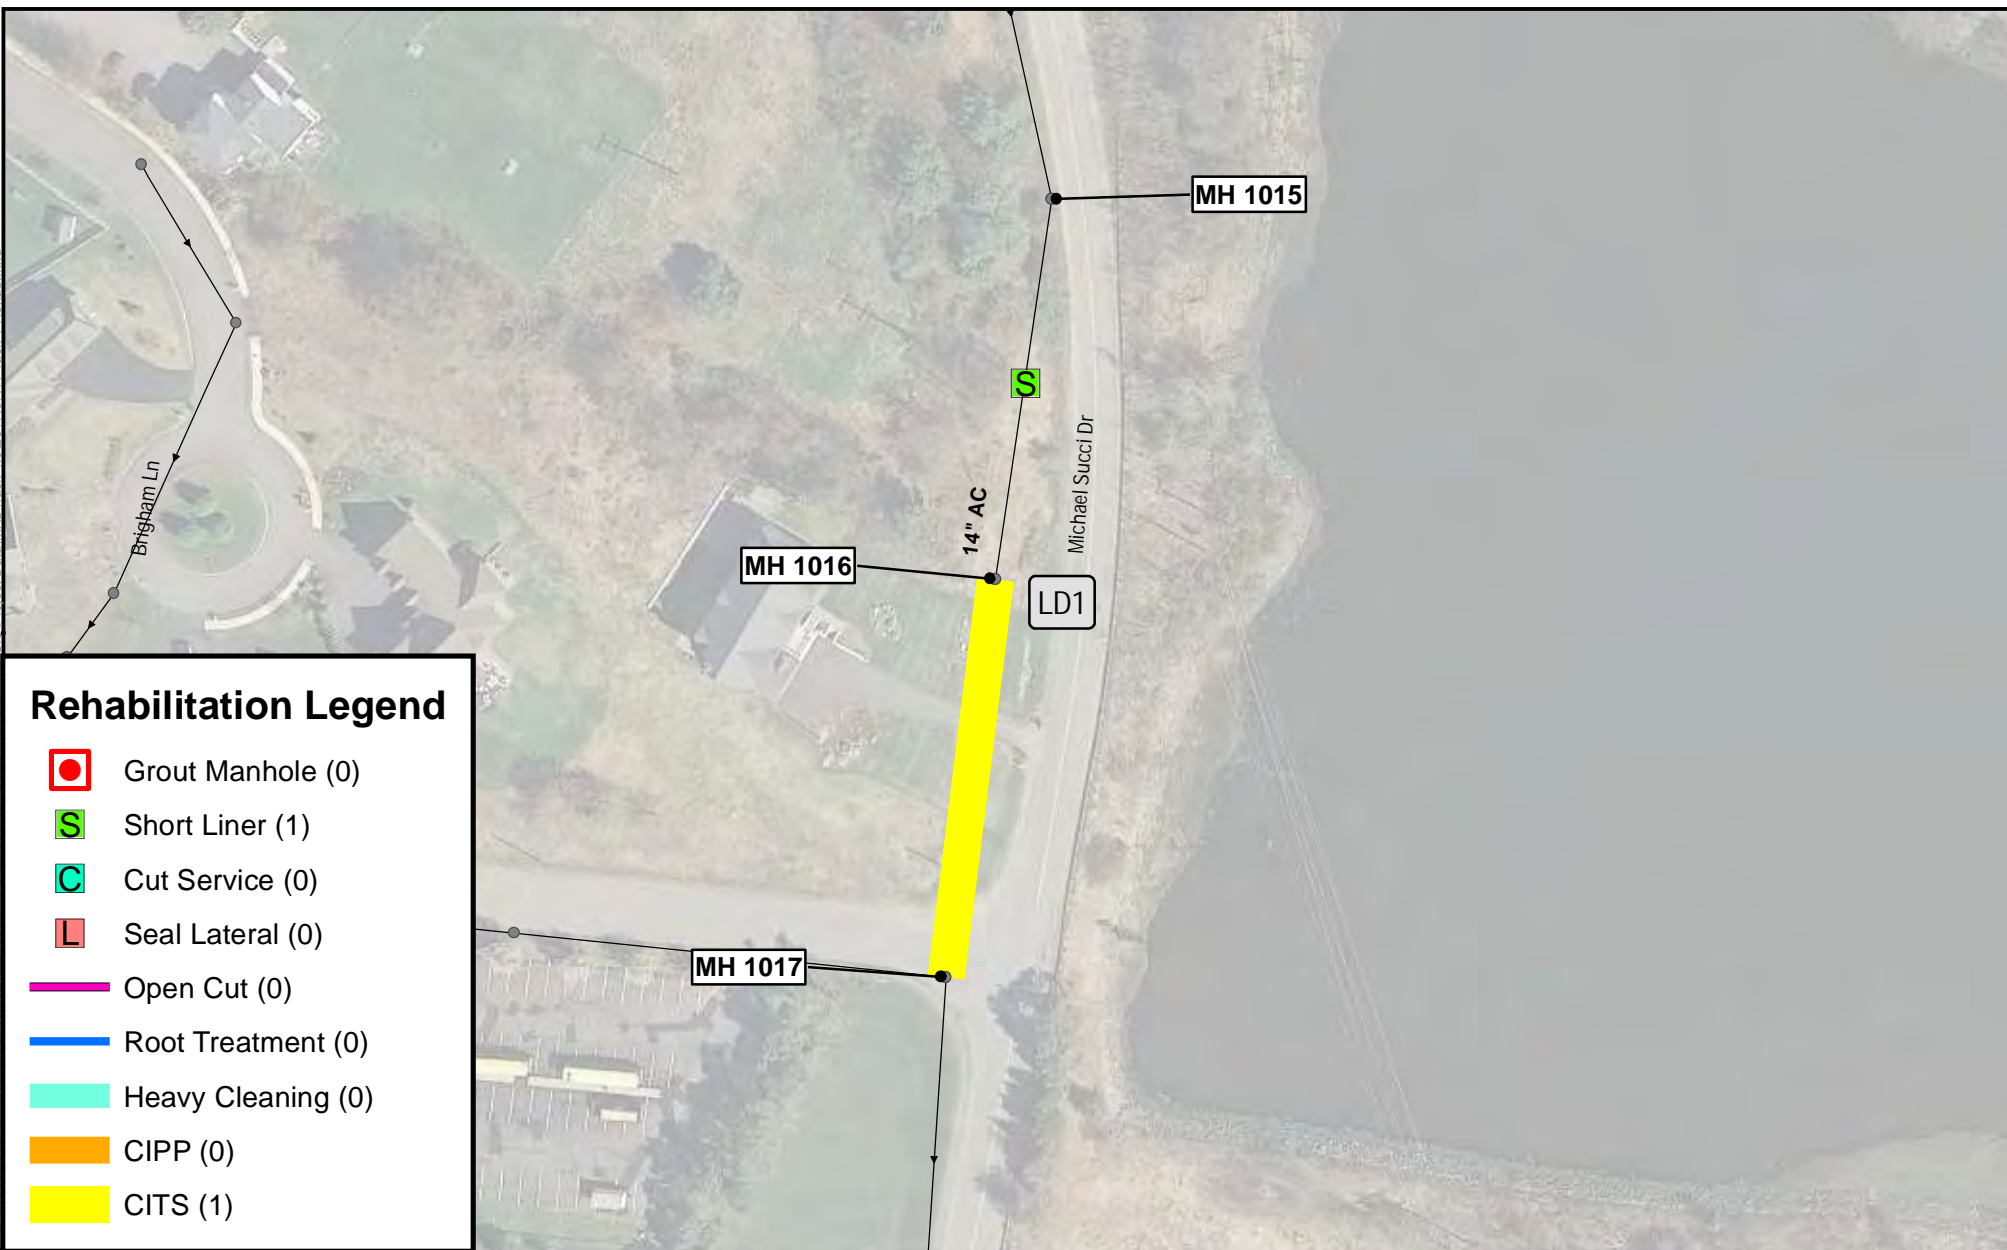
## City of Portsmouth, NH DPW CCTV Results Recommended Rehabilitation Figure 3

- Grout Manhole (0)
- Short Liner (1)
- Cut Service (0)
- Seal Lateral (0)
- Open Cut (0)
- Root Treatment (0)
- Heavy Cleaning (0)
- CIPP (0)
- CITS (1)

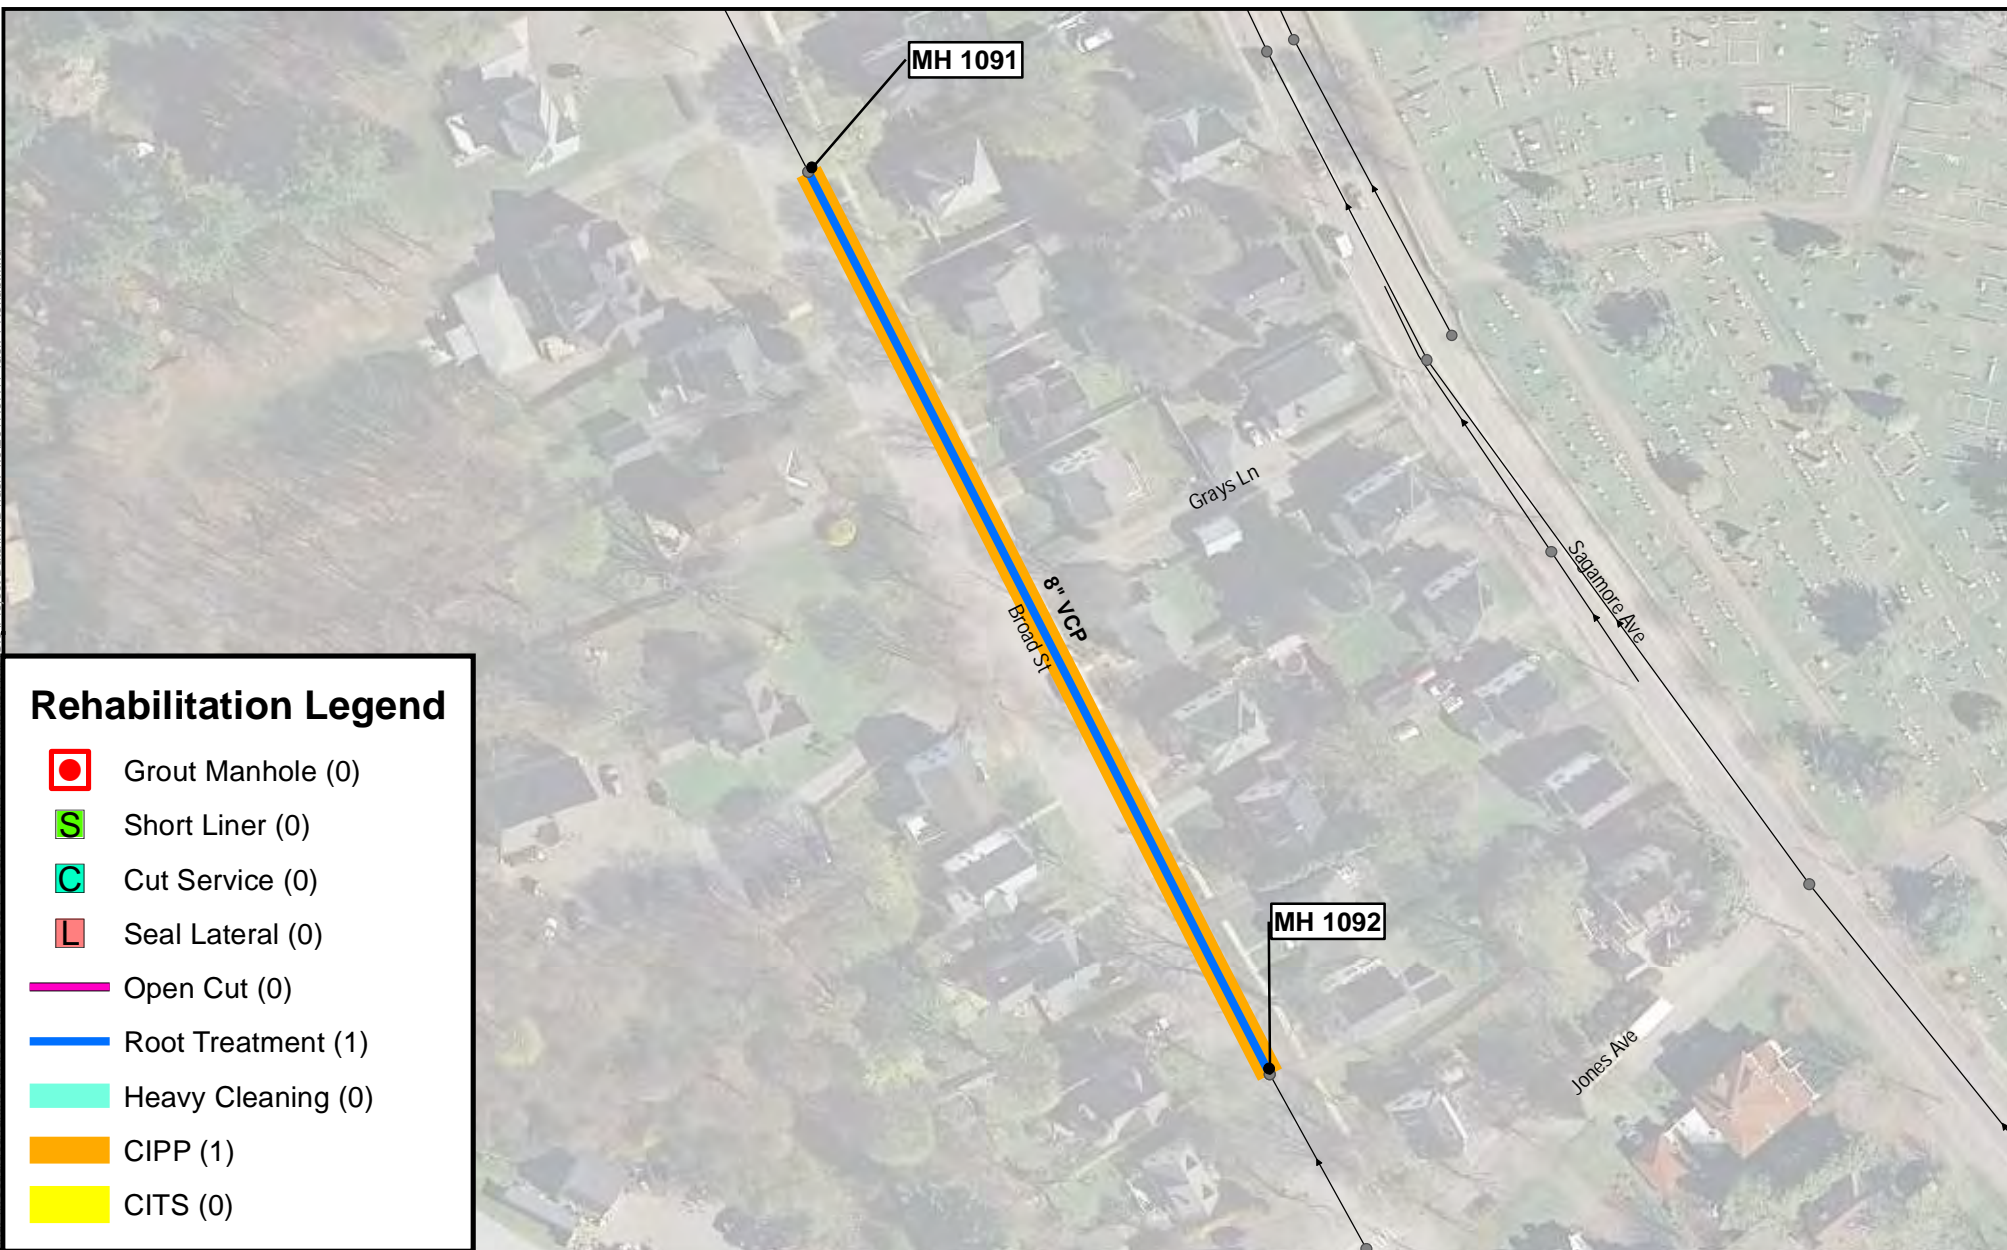
### City of Portsmouth, NH DPW CCTV Results Recommended Rehabilitation Figure 5

- Grout Manhole (0)
- Short Liner (0)
- Cut Service (0)
- Seal Lateral (0)
- Open Cut (0)
- Root Treatment (1)
- Heavy Cleaning (0)
- CIPP (1)
- CITS (0)

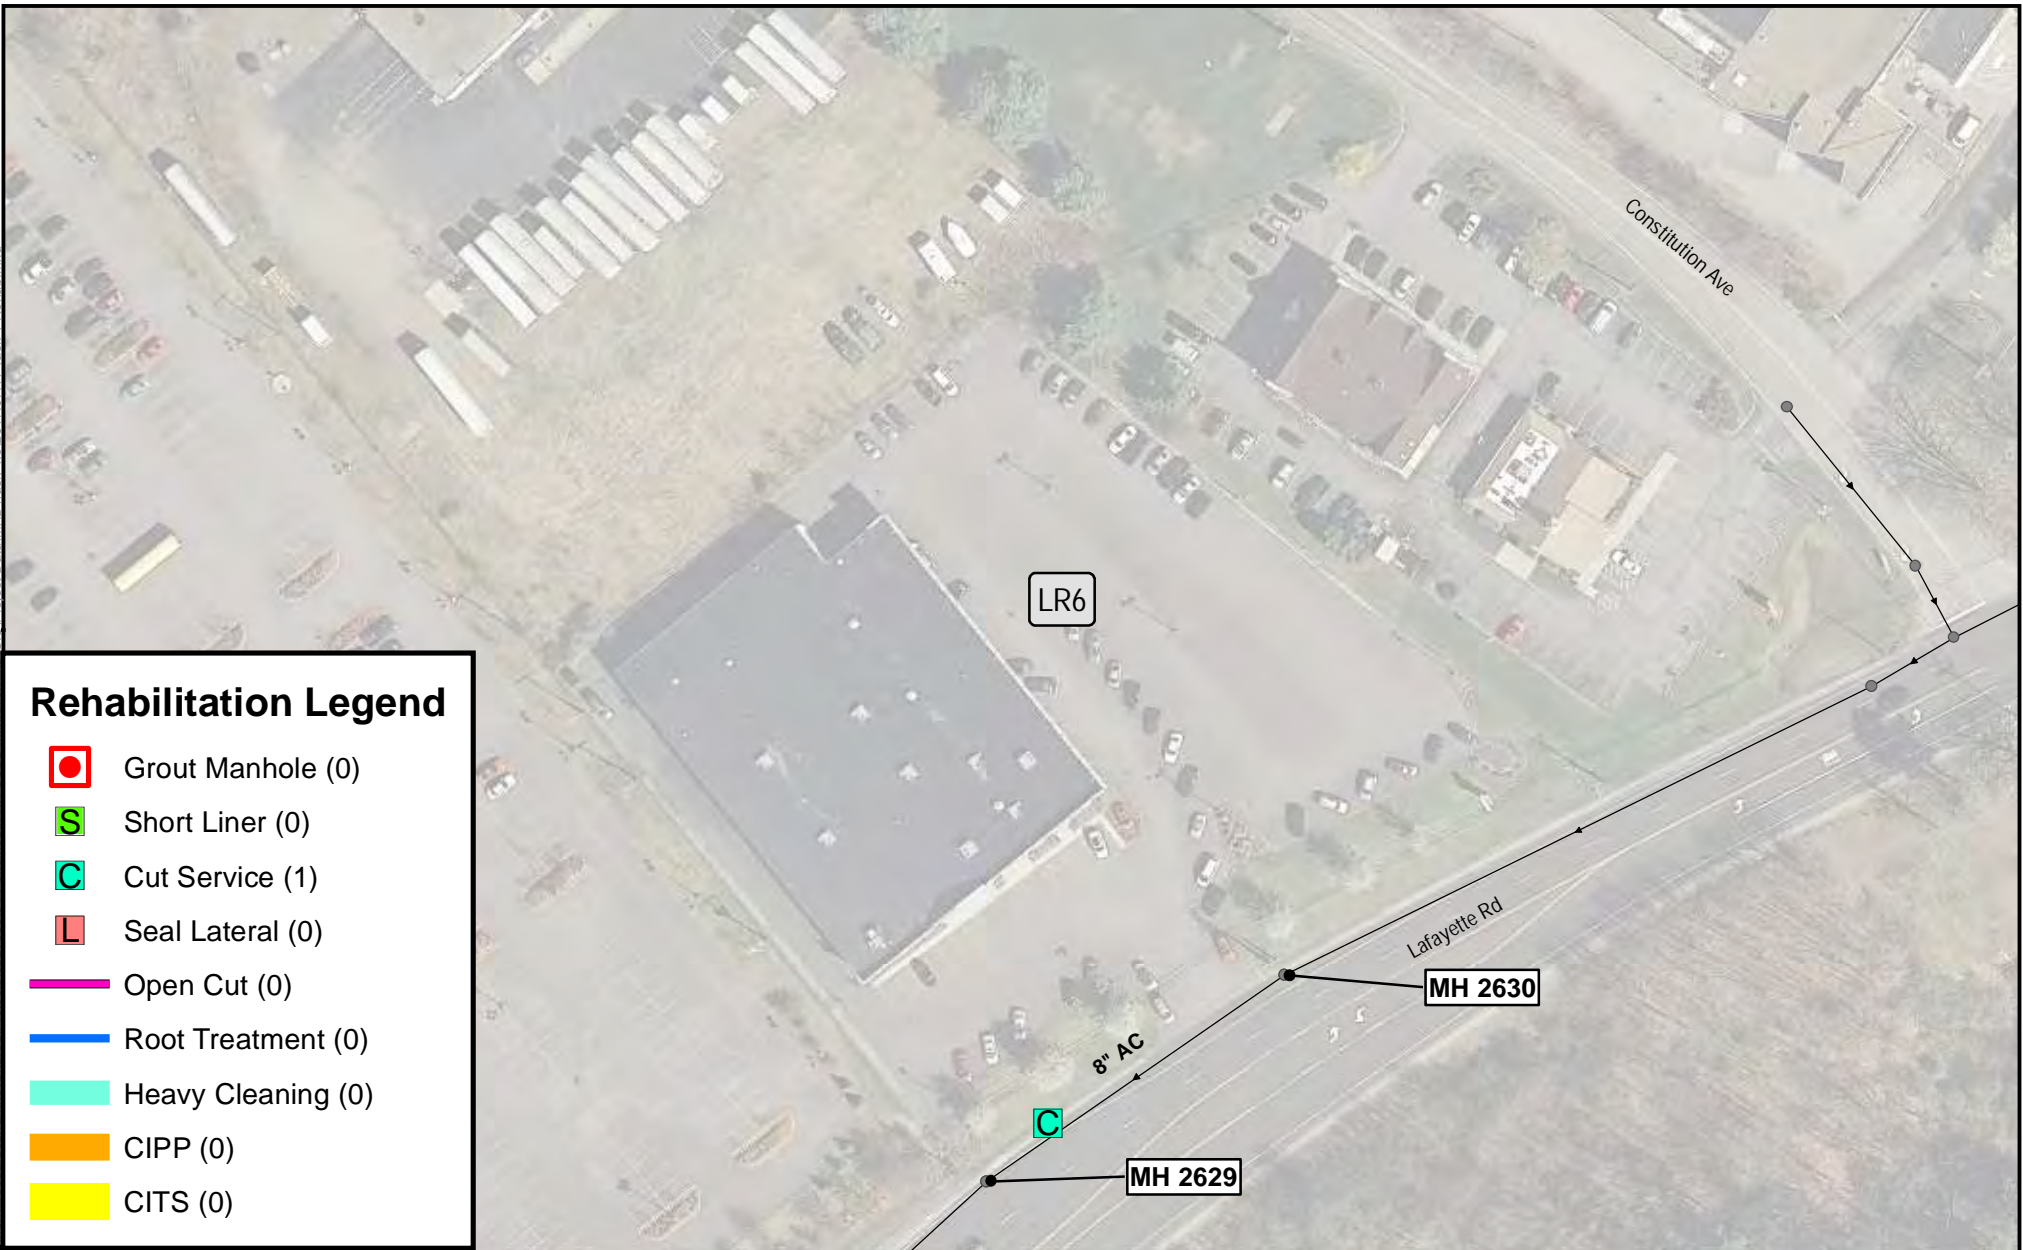
## City of Portsmouth, NH DPW CCTV Results Recommended Rehabilitation Figure 6

- Grout Manhole (0)
- S Short Liner (0)
- C Cut Service (1)
- L Seal Lateral (0)
- Open Cut (0)
- Root Treatment (0)
- Heavy Cleaning (0)
- CIPP (0)
- CITS (0)

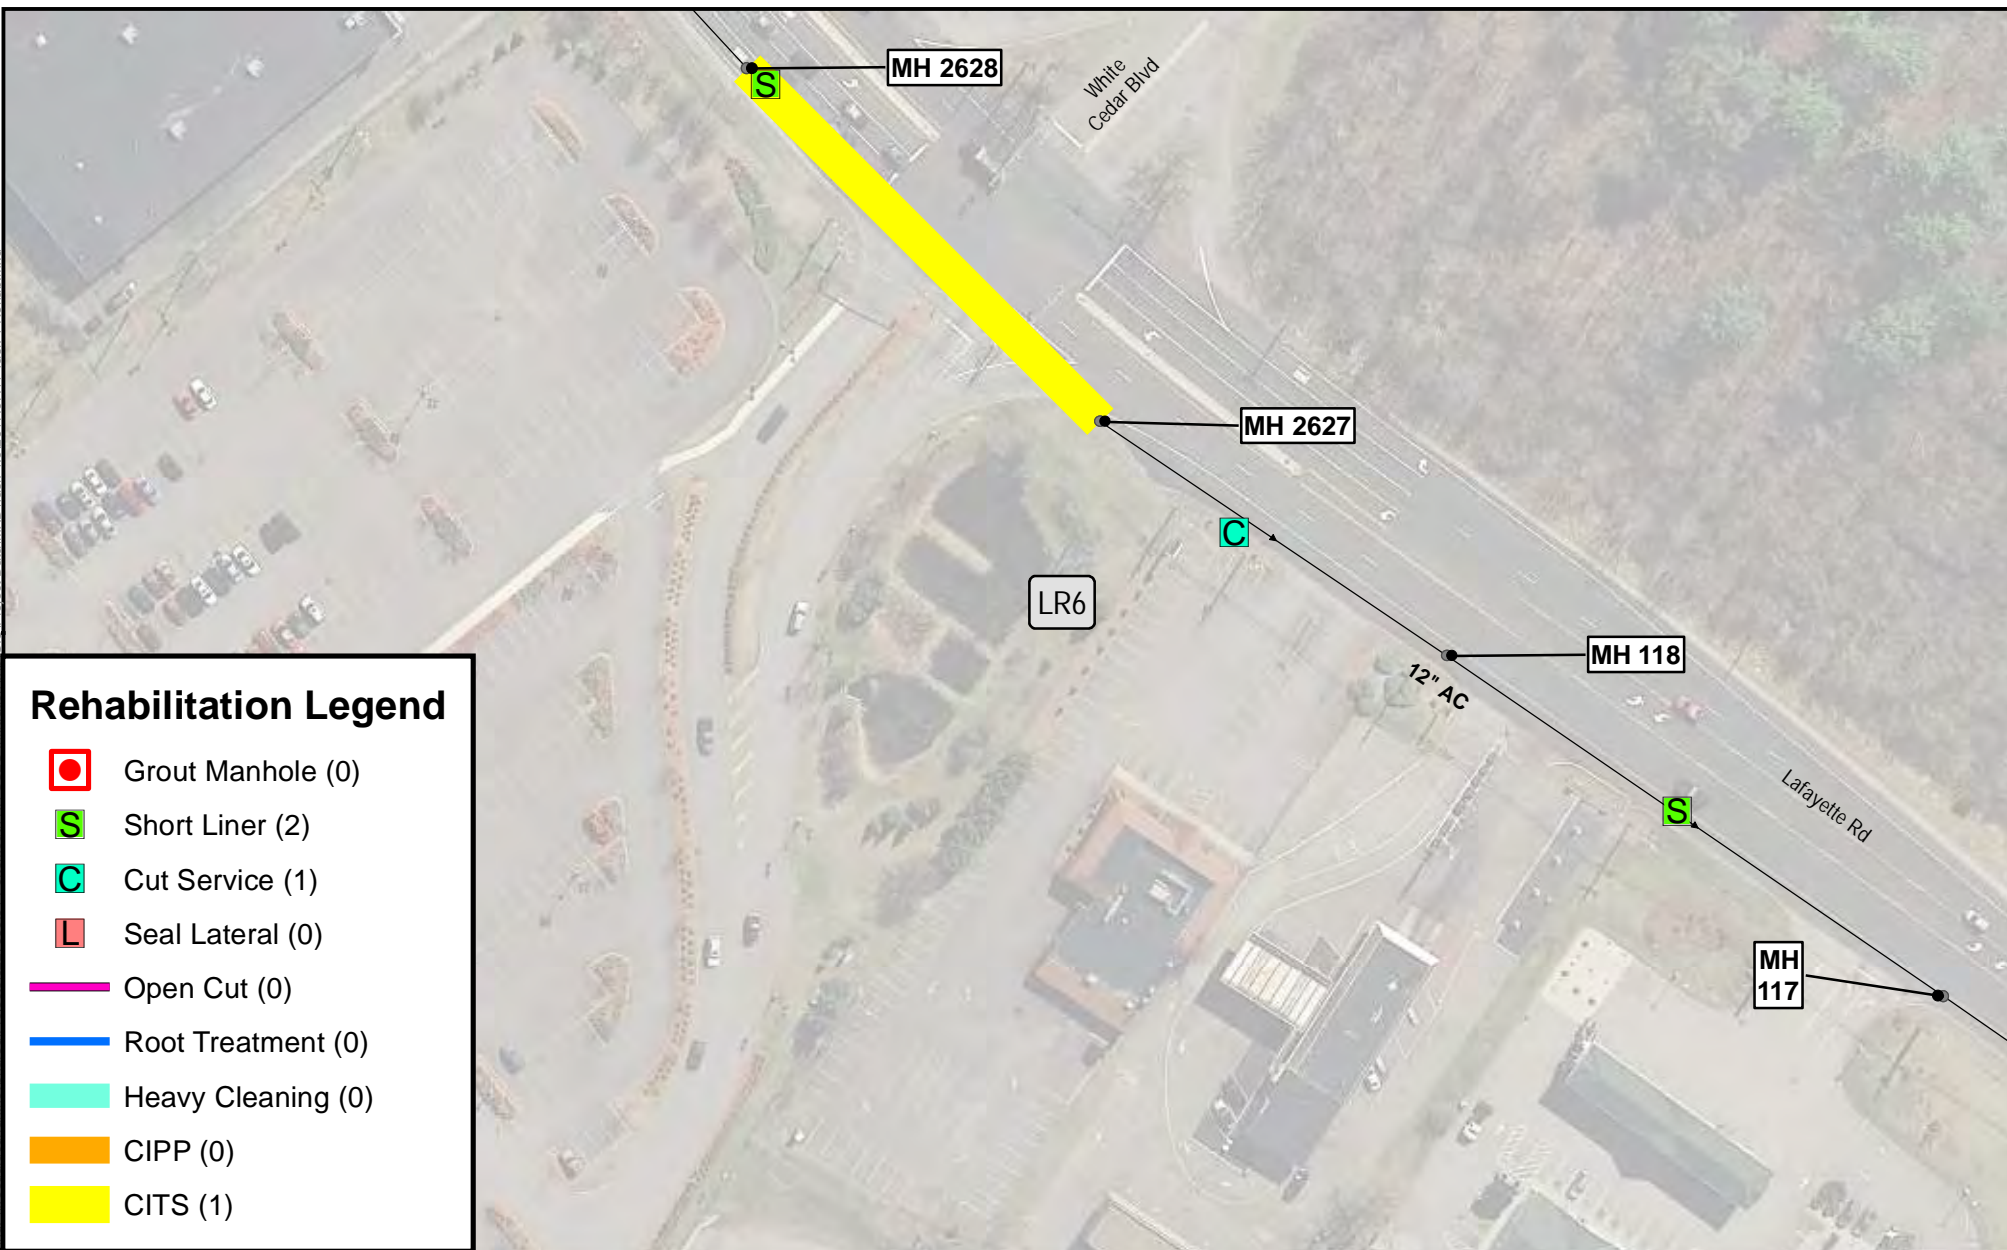
### Figure 7

- Grout Manhole (0)
- Short Liner (2)
- Cut Service (1)
- Seal Lateral (0)
- Open Cut (0)
- Root Treatment (0)
- Heavy Cleaning (0)
- CIPP (0)
- CITS (1)

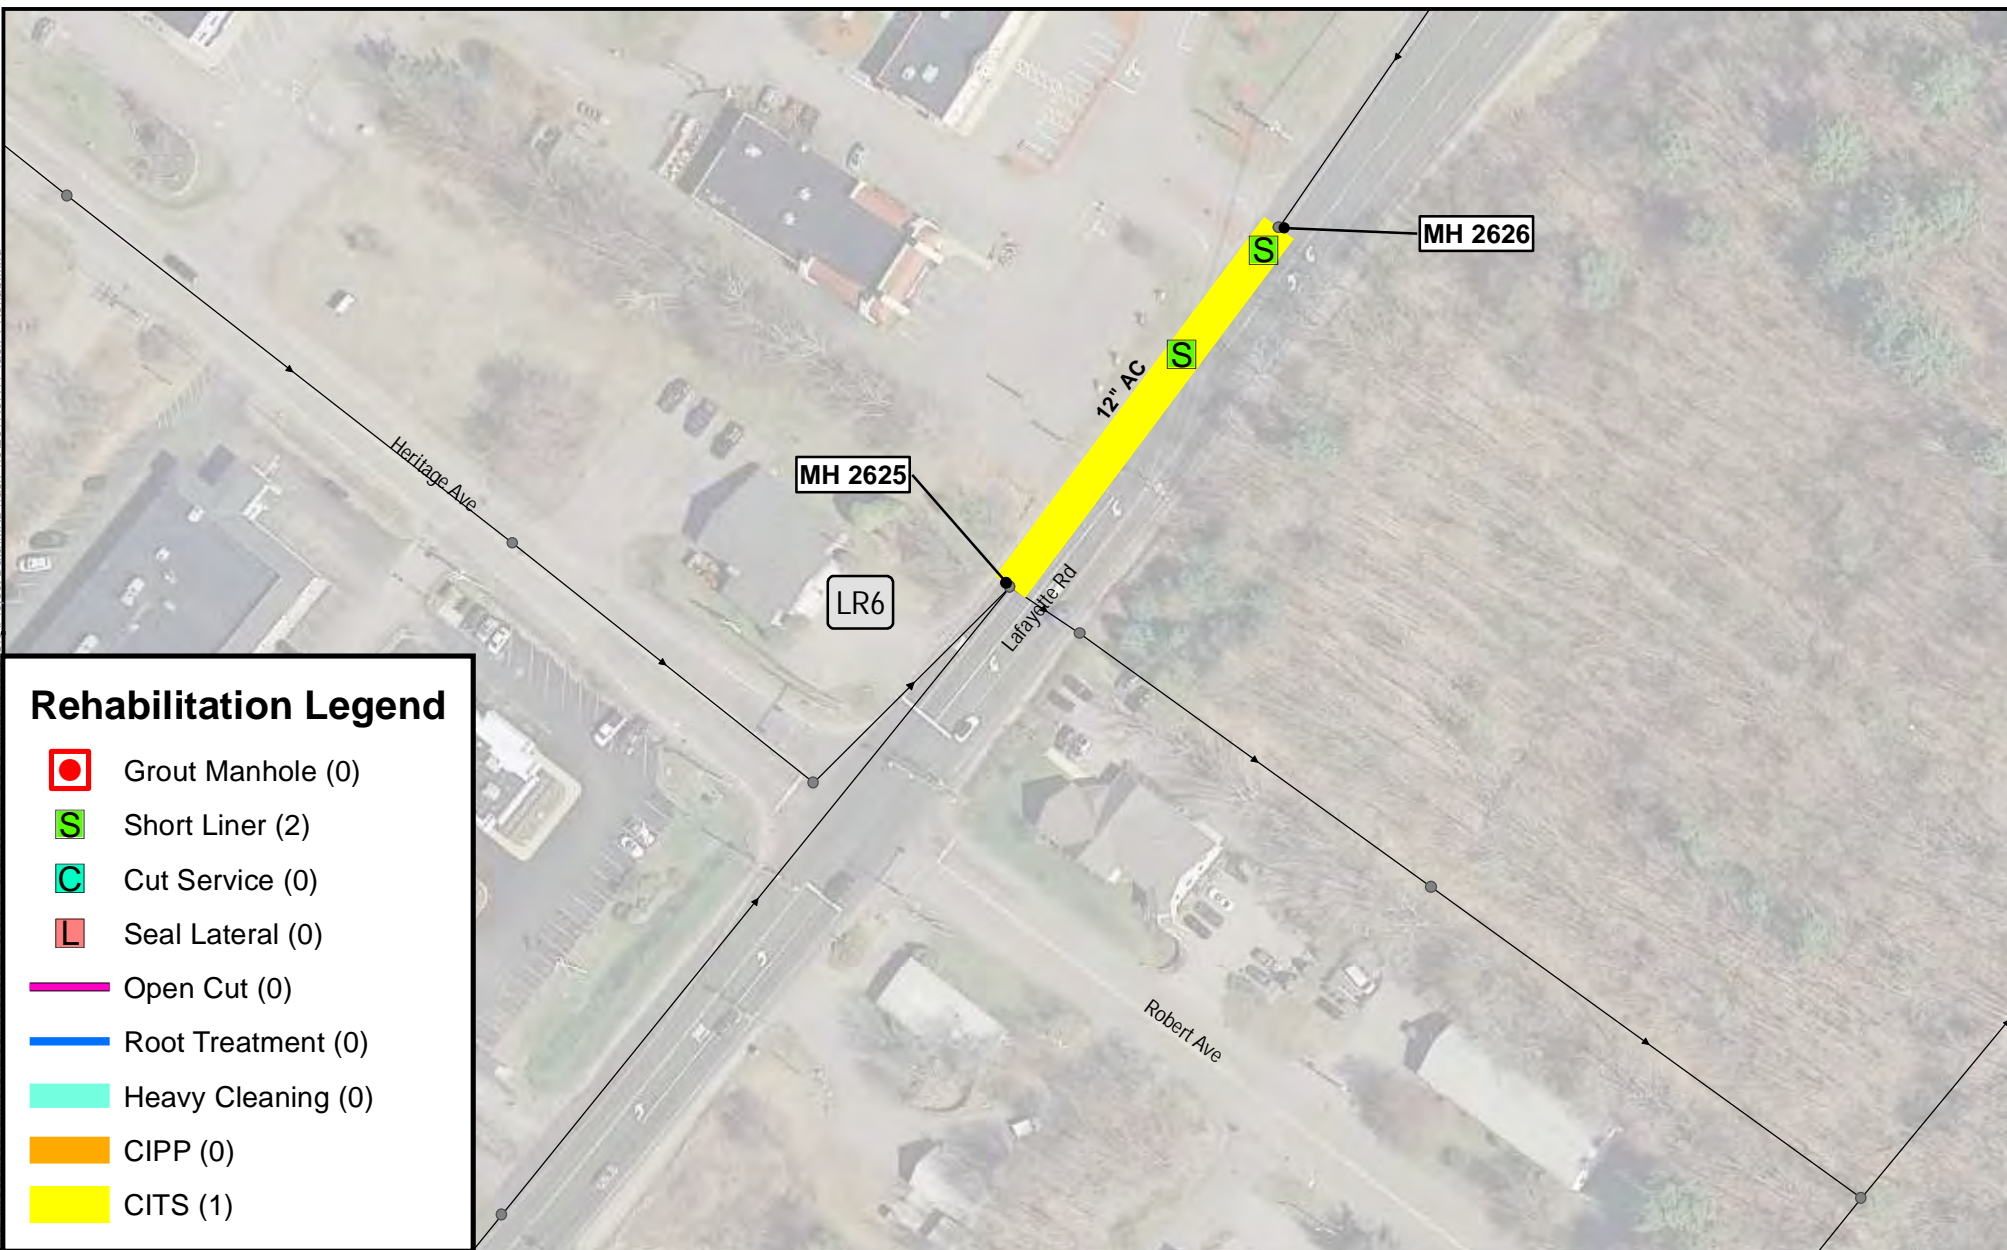
## City of Portsmouth, NH DPW CCTV Results Recommended Rehabilitation Figure 8

- Grout Manhole (0)
- Short Liner (2)
- Cut Service (0)
- Seal Lateral (0)
- Open Cut (0)
- Root Treatment (0)
- Heavy Cleaning (0)
- CIPP (0)
- CITS (1)

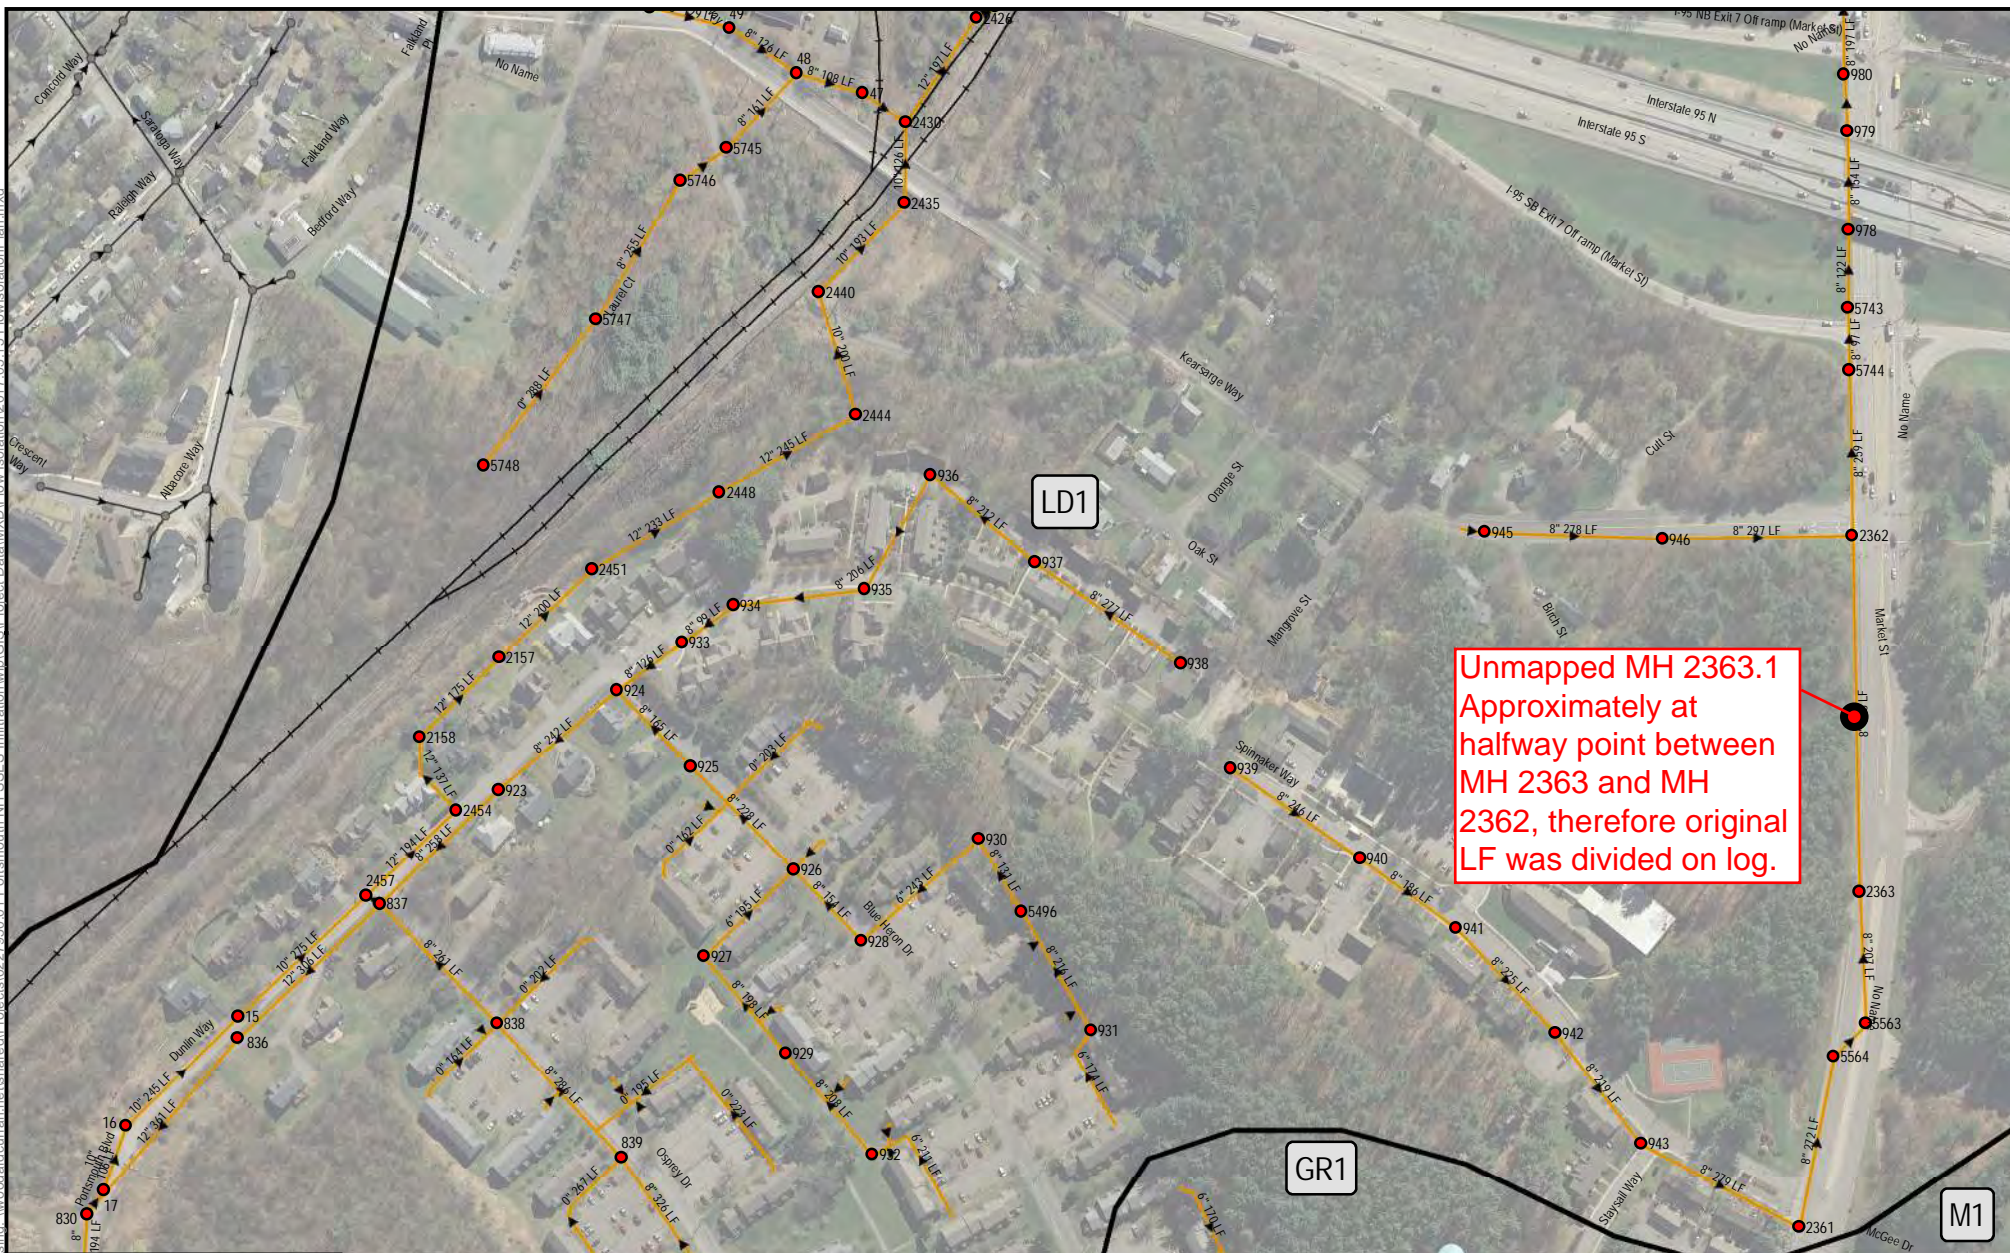
Unmapped MH 2363.1  
Approximately at  
halfway point between  
MH 2363 and MH  
2362, therefore original  
LF was divided on log.

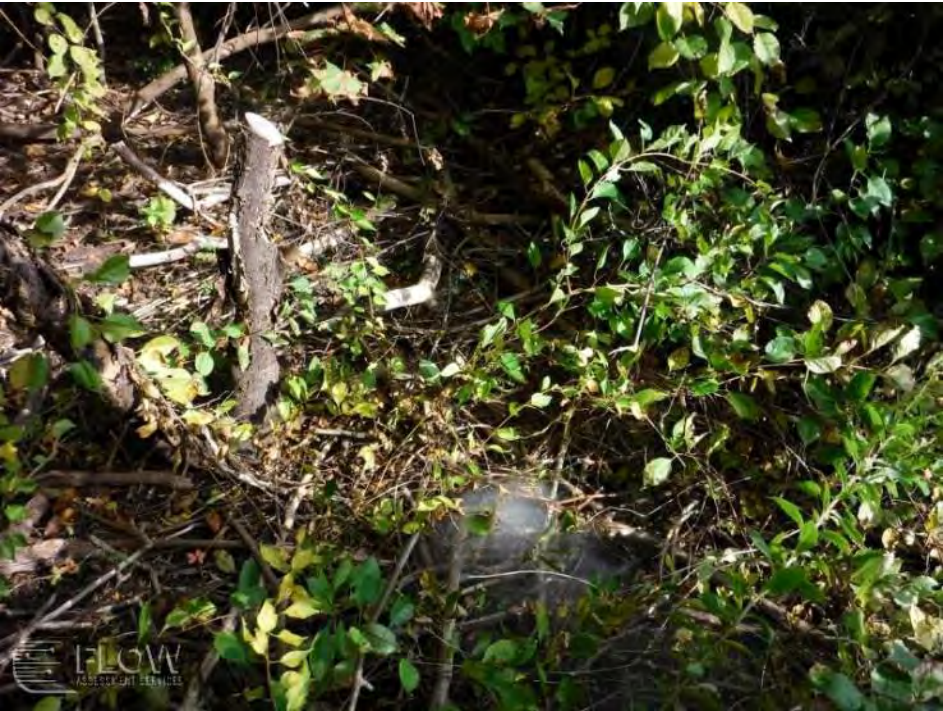
Image #: 0304.JPG

Findings:	Drainage Area SqFt	Runoff Coeff
Could not locate MH 482 - footages combined. Smoke from ground, possibly buried cleanout - direct connection	80	0.3

Findings Address	Findings	Drainage Area SqFt	Runoff Coeff	Photo No.	Sketch No.	Insp. Date
	Could not locate MH 482 - footages combined. Smoke from ground, possibly buried cleanout - direct connection	80	0.3	0304	3	10/09/18
Greenland Road	Heavy smoke from catch basin#2908 - direct connection	3600	0.9	0303	2	10/09/18
700 Greenland Road	Smoke from cleanout 1" below grade, broken cover - direct connection	24	0.3	0328	1	10/09/18

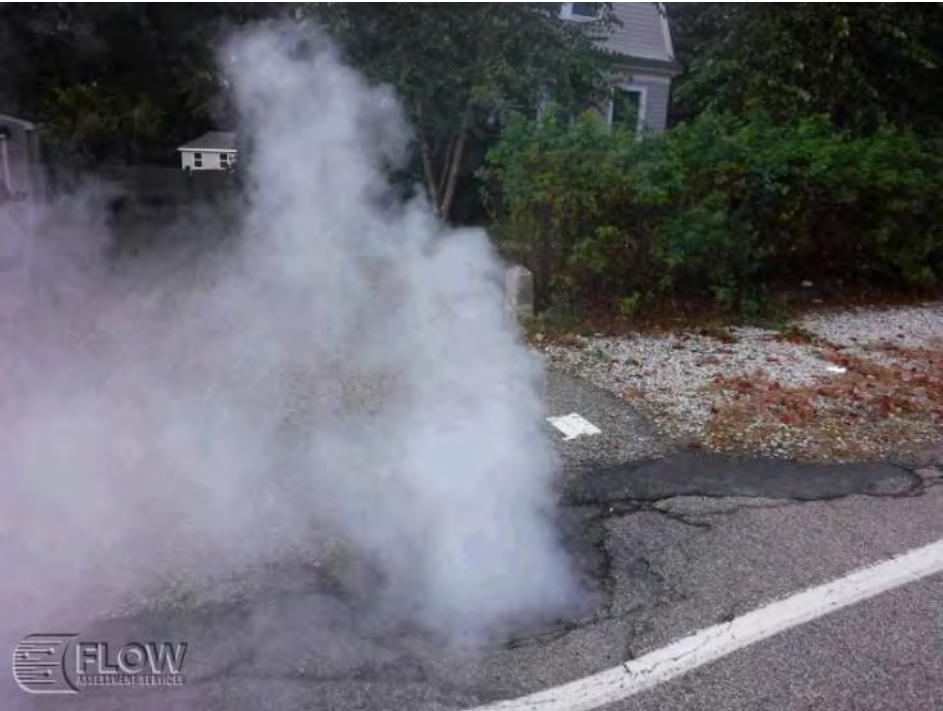
Image #: 0303.JPG

Findings:	Drainage Area SqFt	Runoff Coeff
Heavy smoke from catch basin#2908 - direct connection	3600	0.9

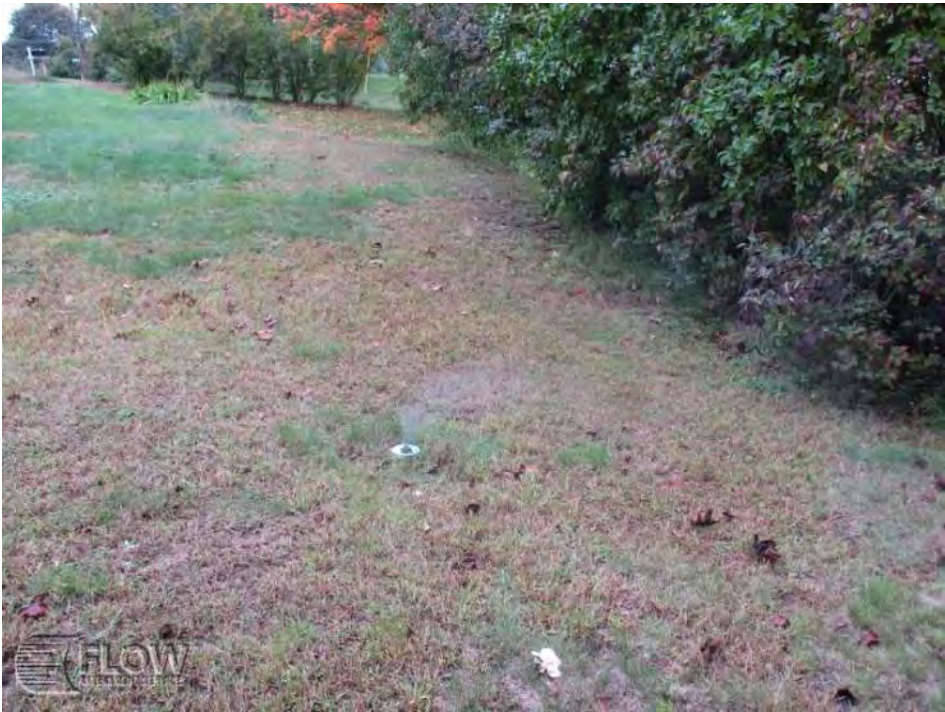
Image #: IMG\_0328.JPG

Findings:	Drainage Area SqFt	Runoff Coeff
Smoke from cleanout 1" below grade, broken cover - direct connection	24	0.3

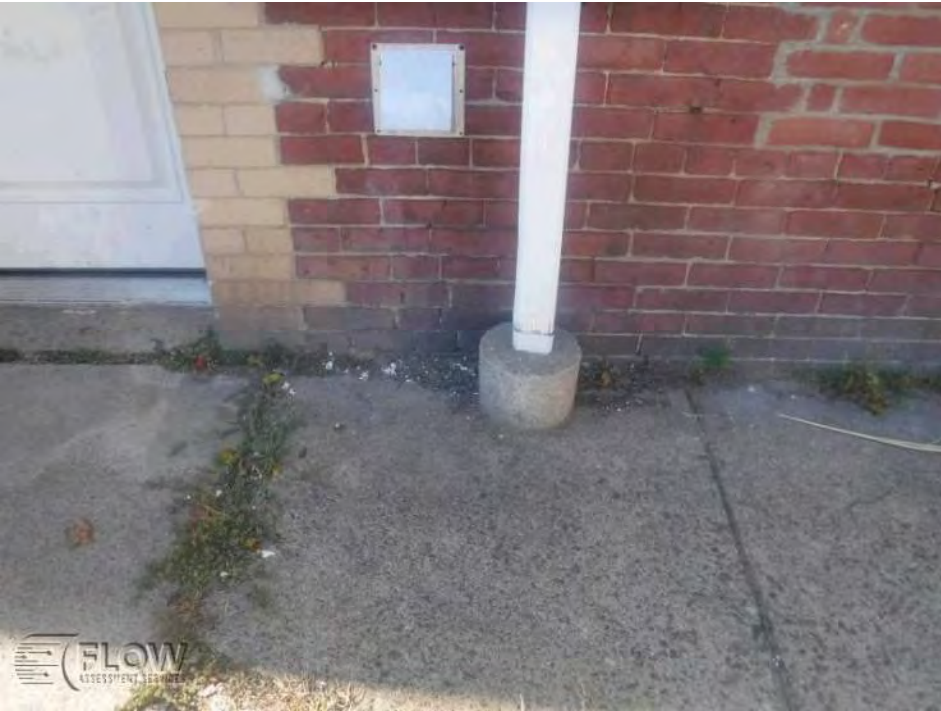
Image #: DSCF4475.JPG

Findings:	Drainage Area SqFt	Runoff Coeff
Smoke from roof leader - direct connection	0	0

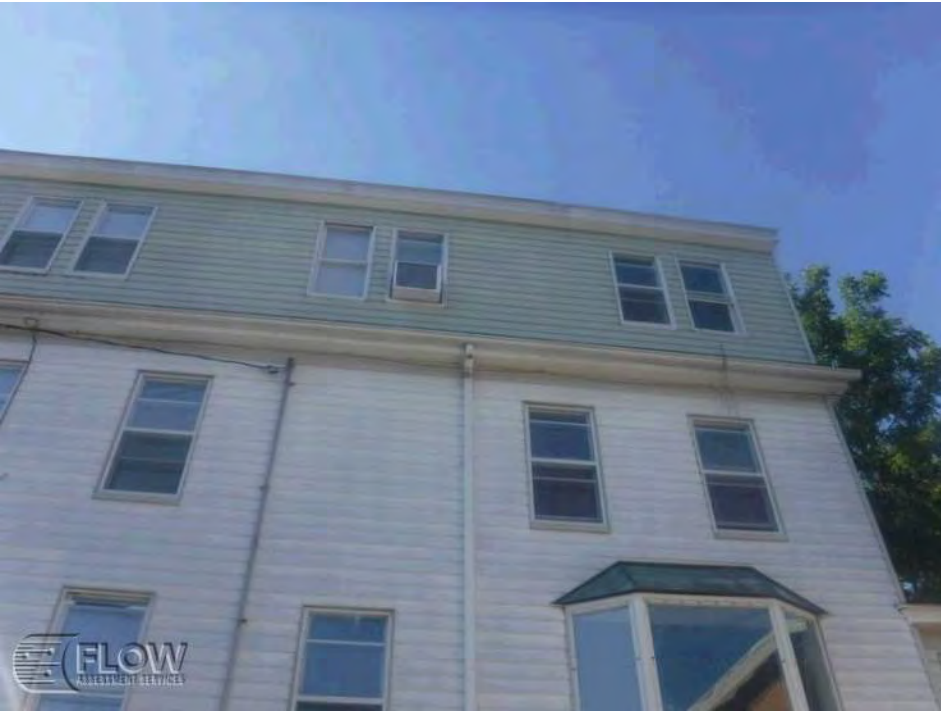
Image #: DSCF4474.JPG

Findings:	Drainage Area SqFt	Runoff Coeff
Smoke from roof leader - direct connection. MH 5839.2 unnamed on map - see revised map.	432	0.9

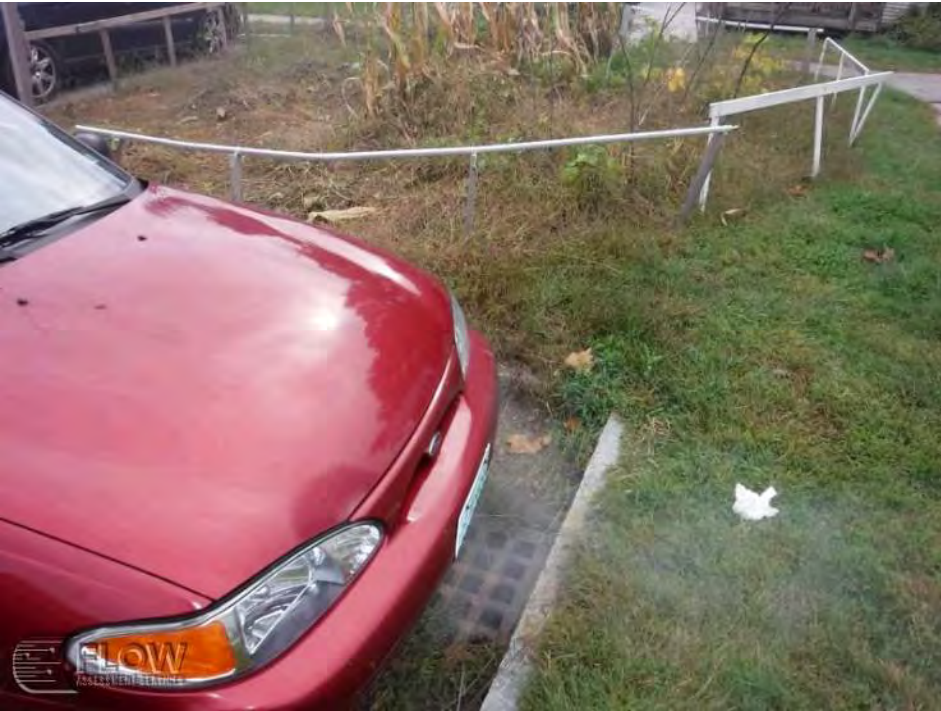
Image #: 0289.JPG

Findings:	Drainage Area SqFt	Runoff Coeff
Smoke from catch basin#2179 - direct connection (MH 5109.1 is unmapped manhole - see revised map)	9600	0.9
