# Sewer System Evaluation Survey (SSES) Infiltration Study

227950.01  
City of Portsmouth, NH  
July 2020

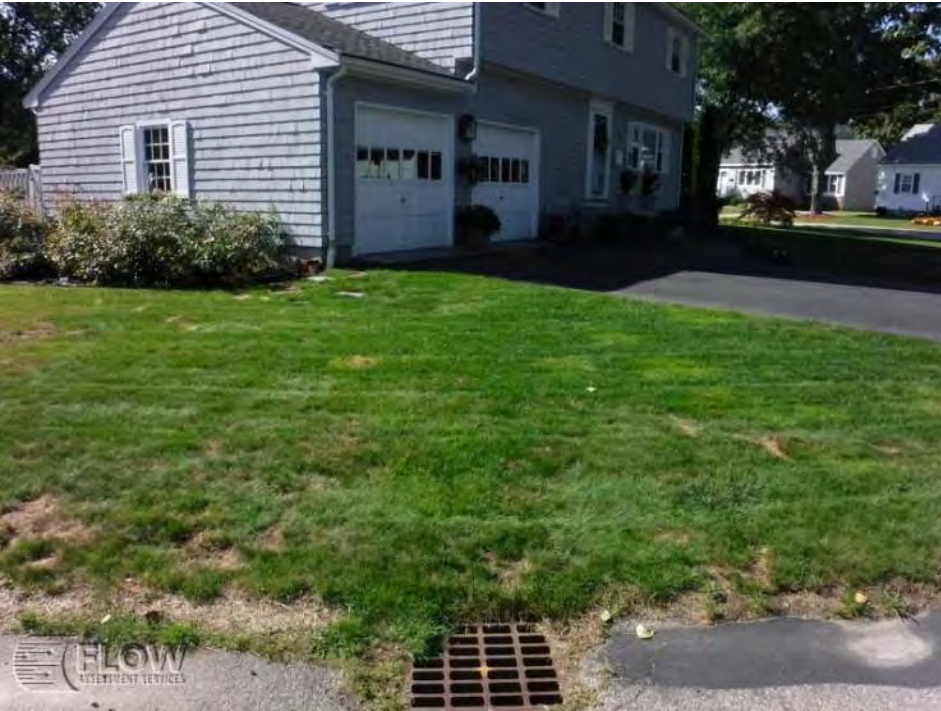
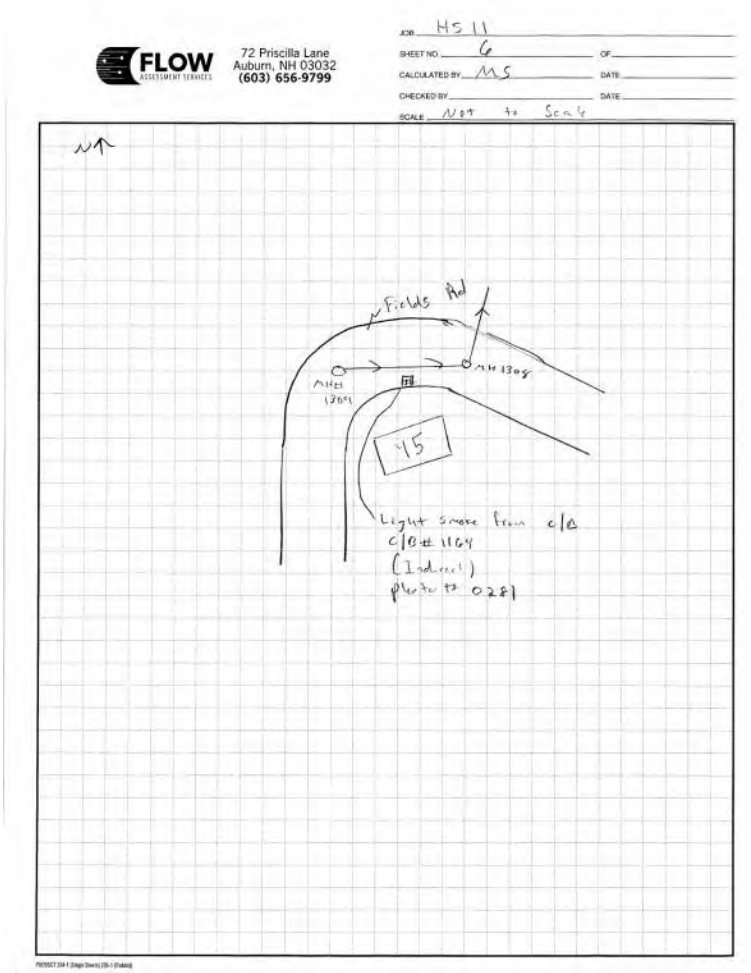
Image #: 0281.JPG

Findings:	Drainage Area SqFt	Runoff Coeff
Light smoke from catch basin#1164 - indirect connection	0	0

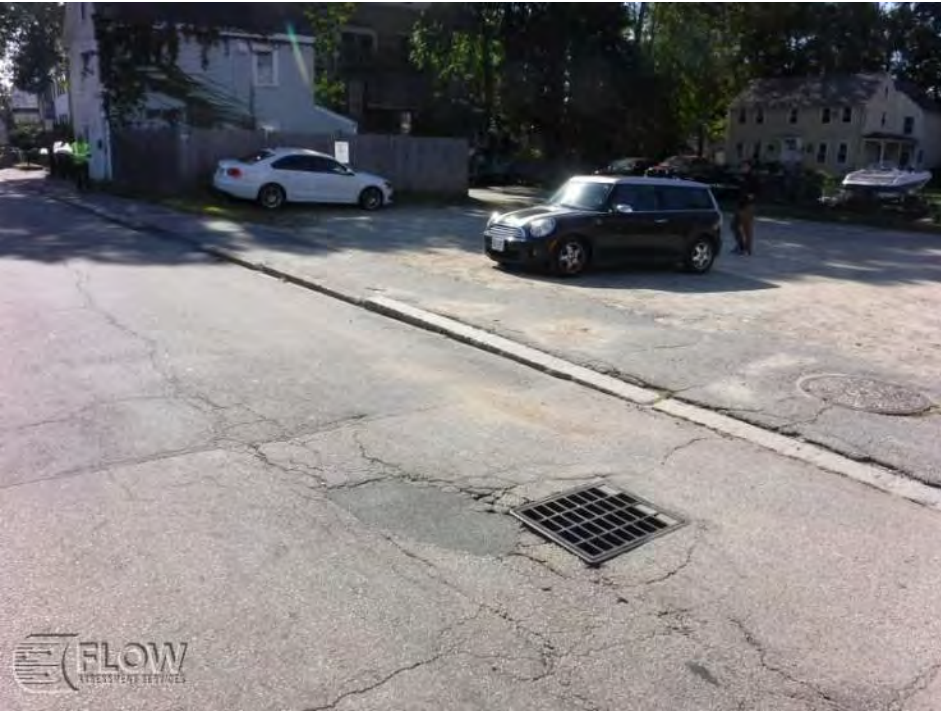
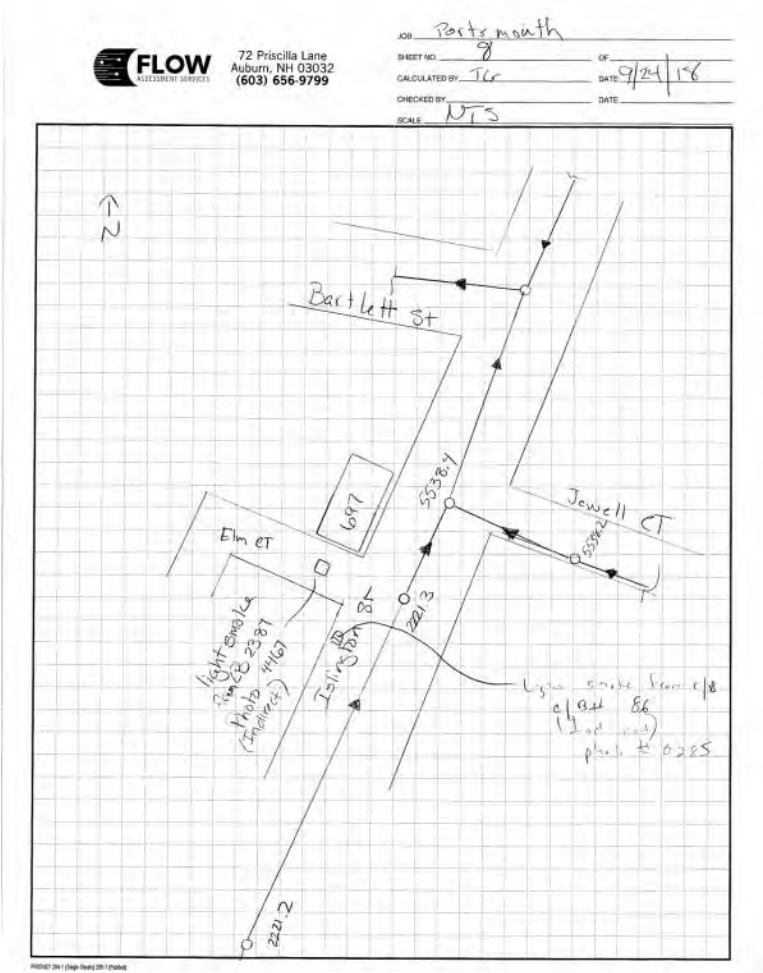
Image #: 0285.JPG

Findings:	Drainage Area SqFt	Runoff Coeff
Light smoke from catch basin#86 - indirect connection. MH 2221.3 unnamed on map - see revised map	0	0

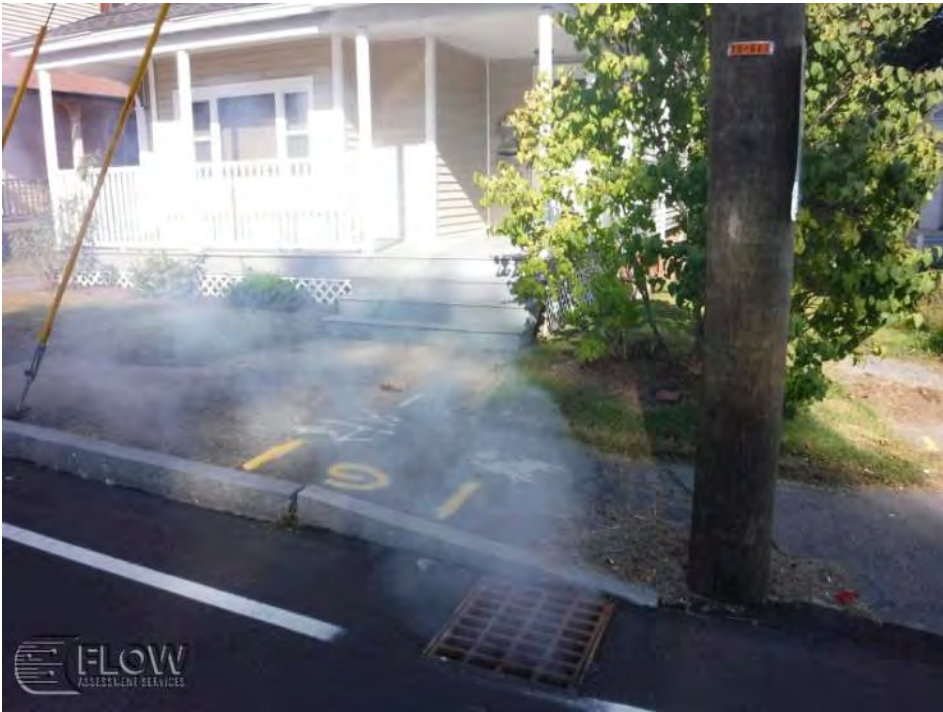
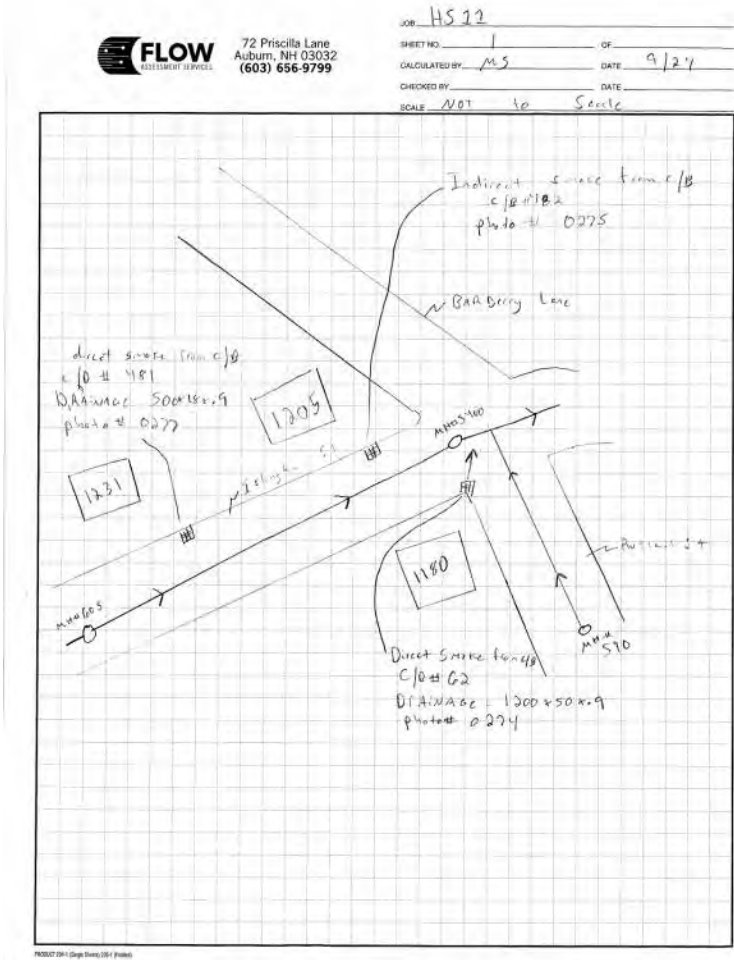
Image #: 0277.JPG

Findings:	Drainage Area SqFt	Runoff Coeff
Smoke from catch basin#481 - direct connection	9000	0.9

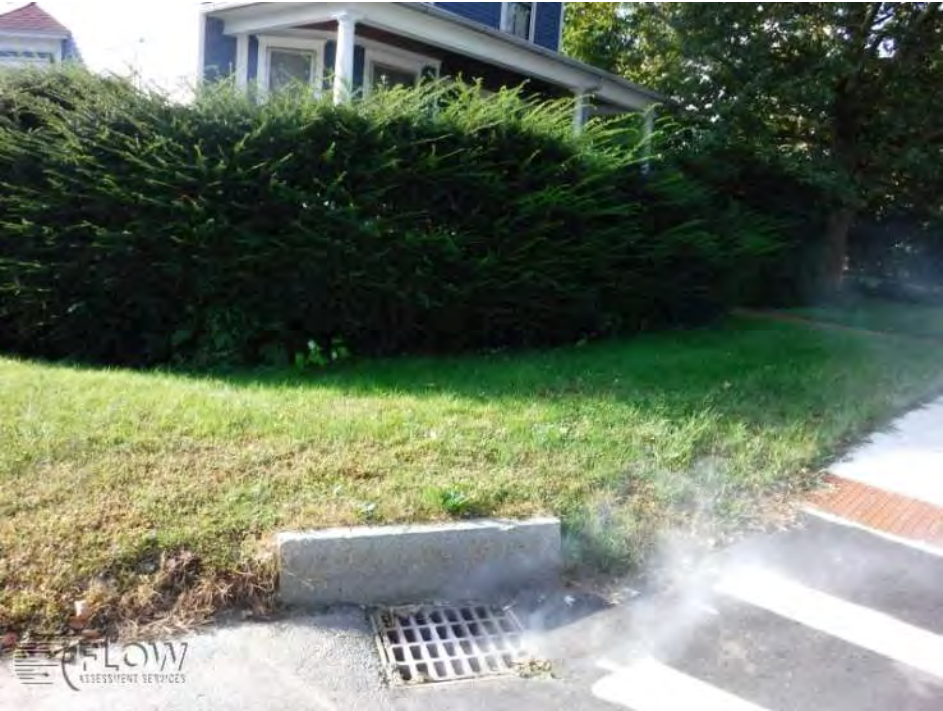
Image #: 0274.JPG

Findings:	Drainage Area SqFt	Runoff Coeff
Smoke from catch basin#62 - direct connection	60000	0.9

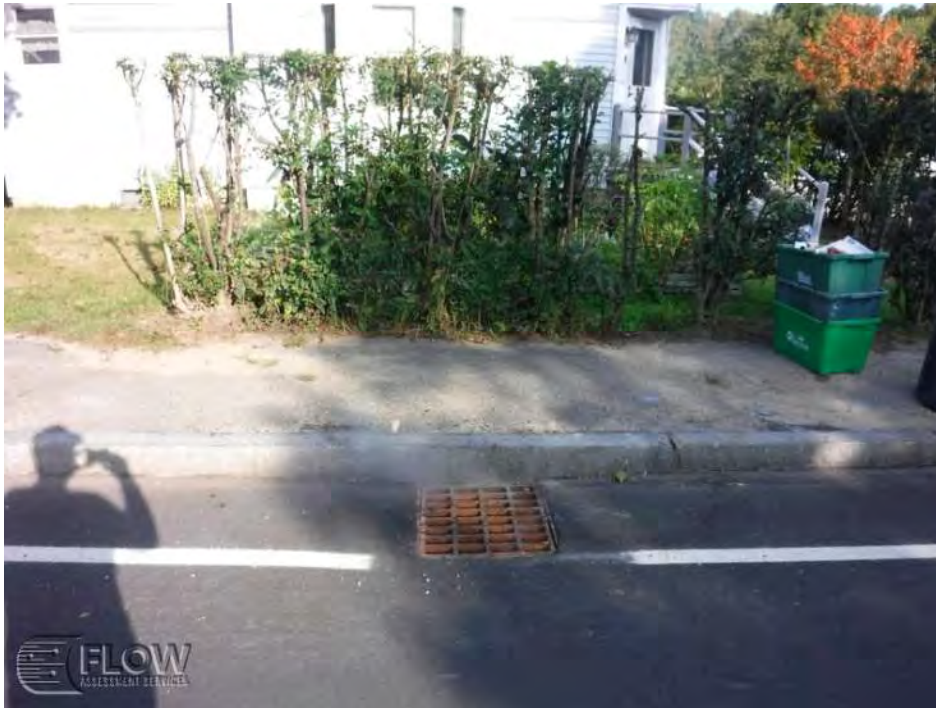
Image #: 0275.JPG

Light smoke from catch basin#2387 - indirect connection. MH 5538.4 unnamed on map - see revised map

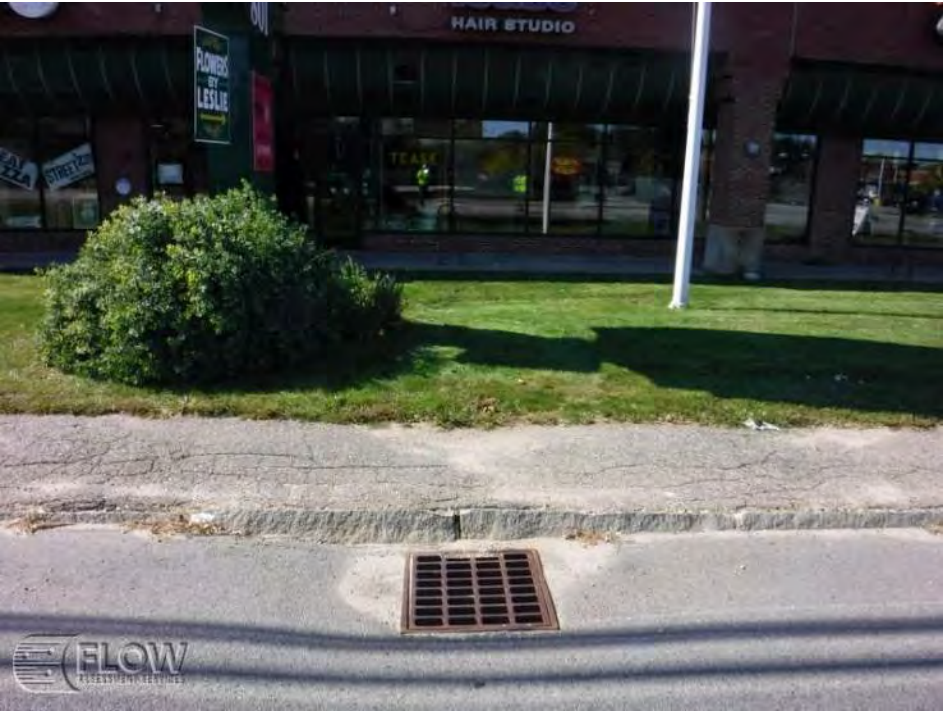
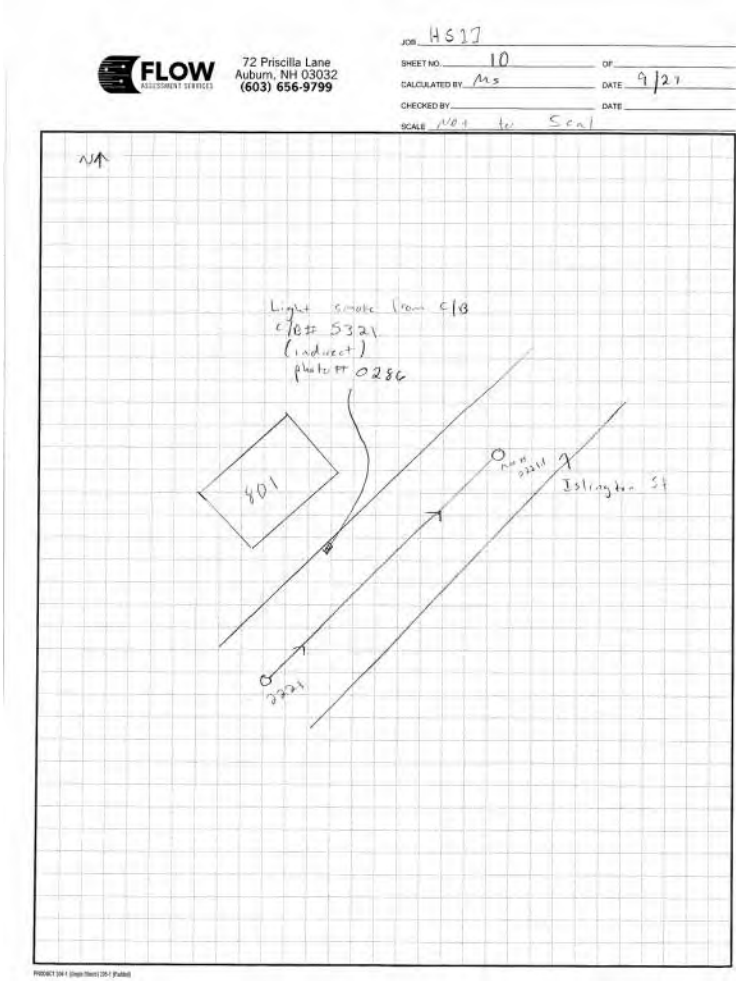
Image #: 0286.JPG

Findings:	Drainage Area SqFt	Runoff Coeff
Light smoke from catch basin#5321 - indirect connection. MH 2221.1 unnamed on map - see revised map.	0	0

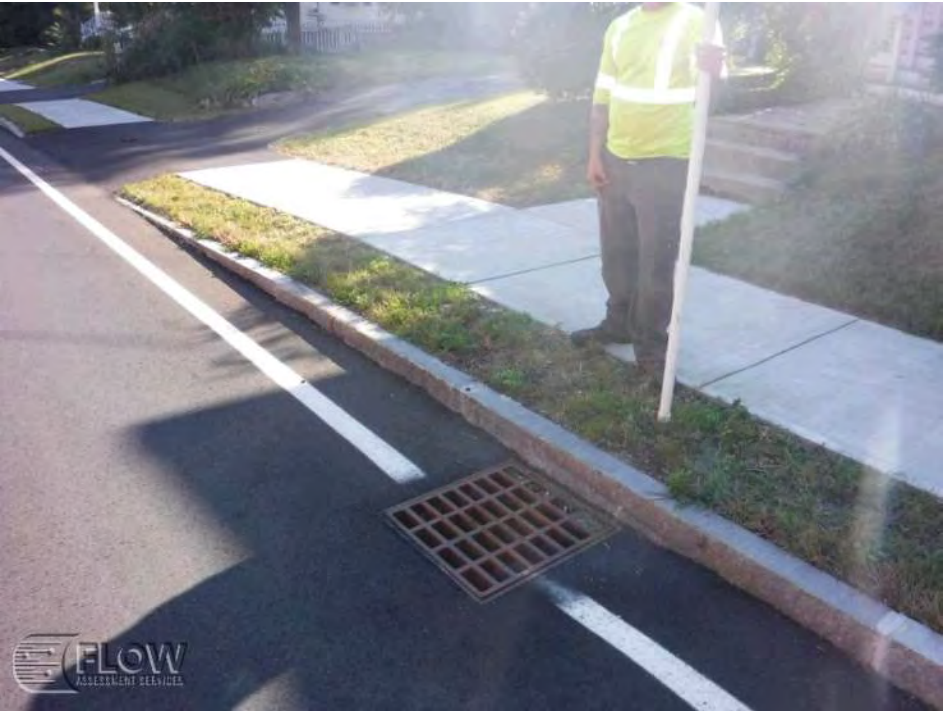
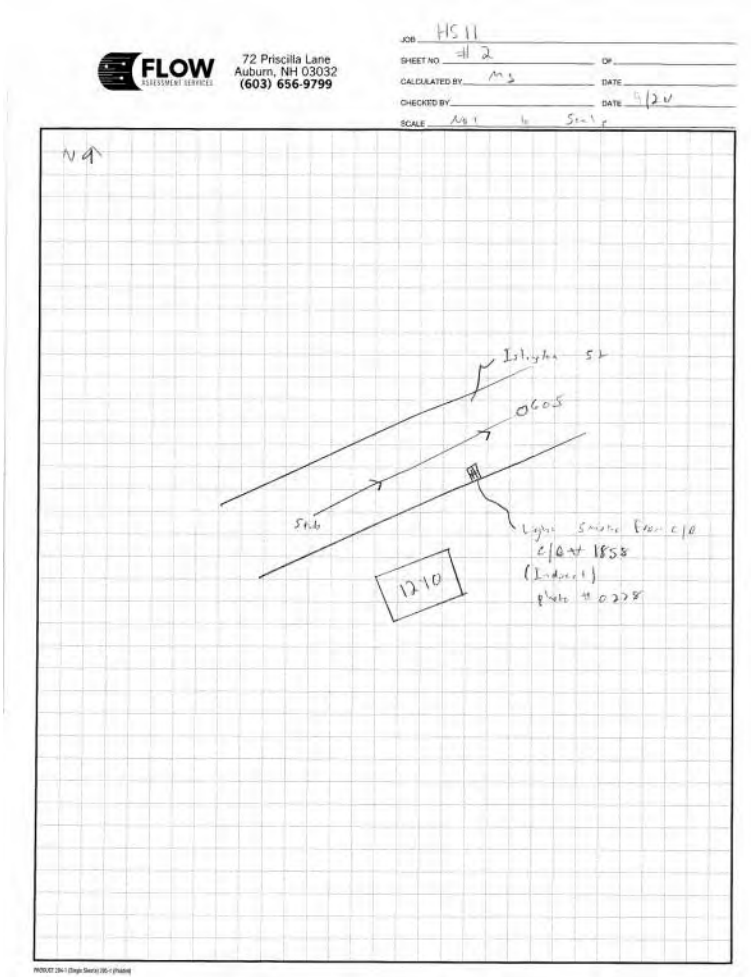
Image #: 0278.JPG

Findings:	Drainage Area SqFt	Runoff Coeff
Light smoke from catch basin#1858 - indirect connection	0	0

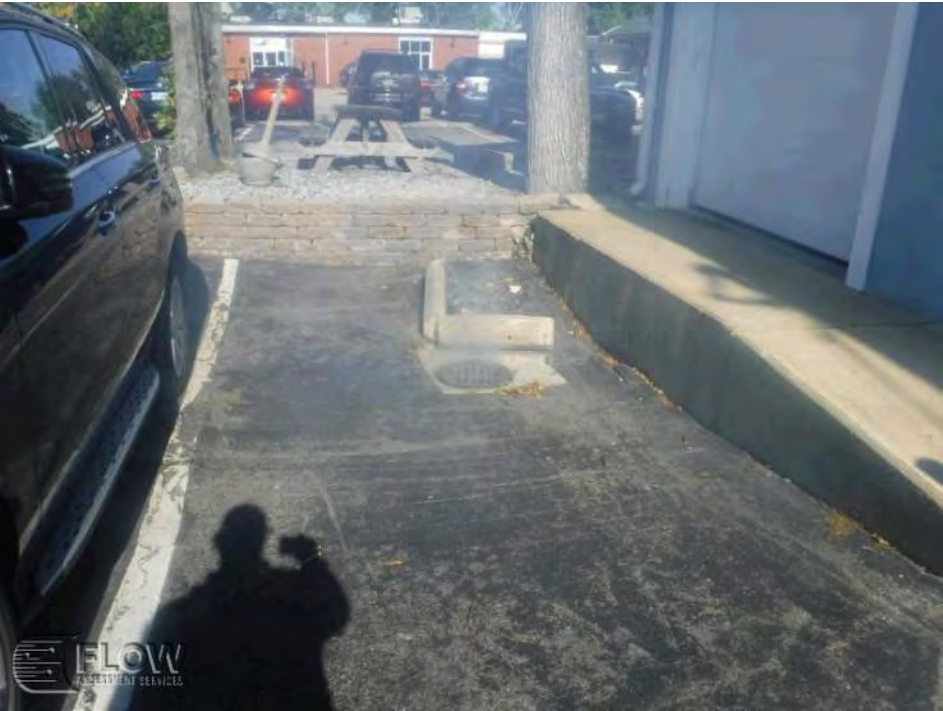
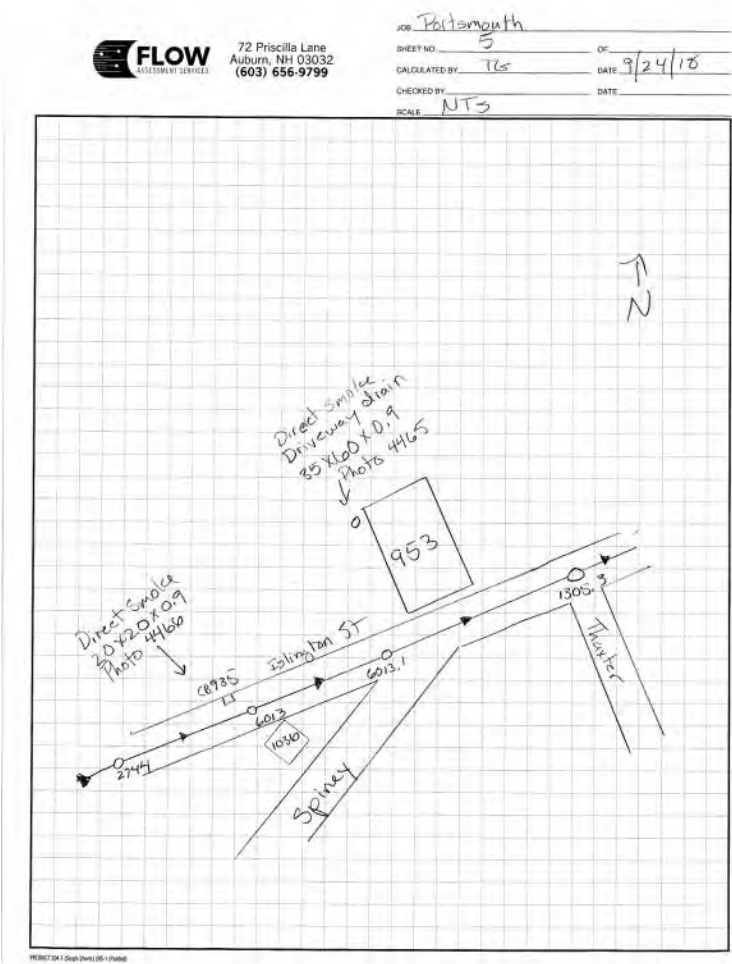
Image #: DSCF4465.JPG

Findings:	Drainage Area SqFt	Runoff Coeff
Smoke from driveway drain - direct connection. MH 1305.3 unnamed on map - see revised map.	2100	0.9

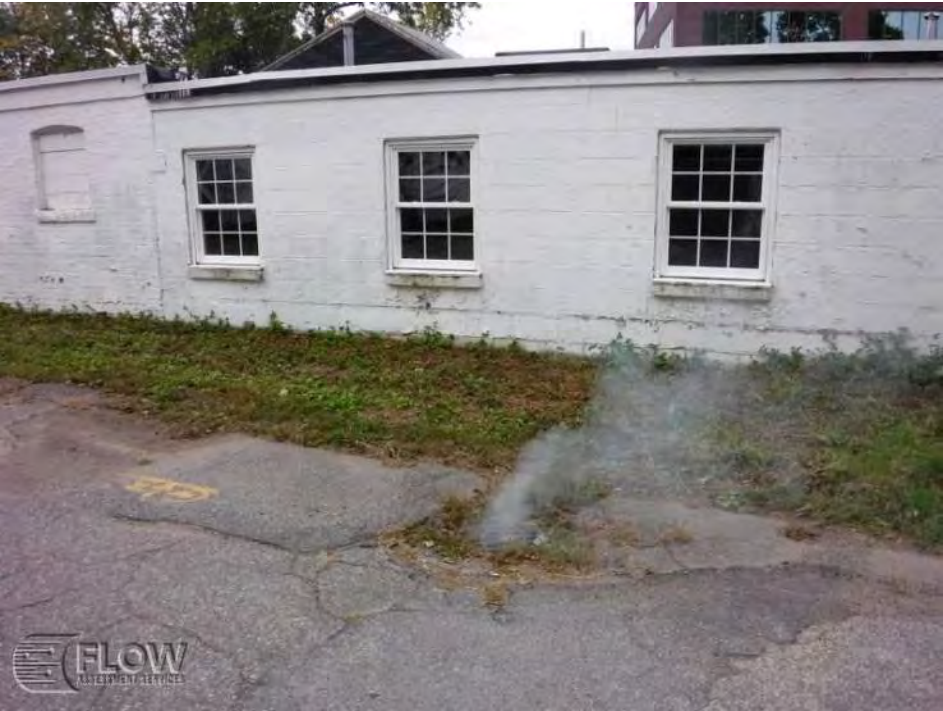
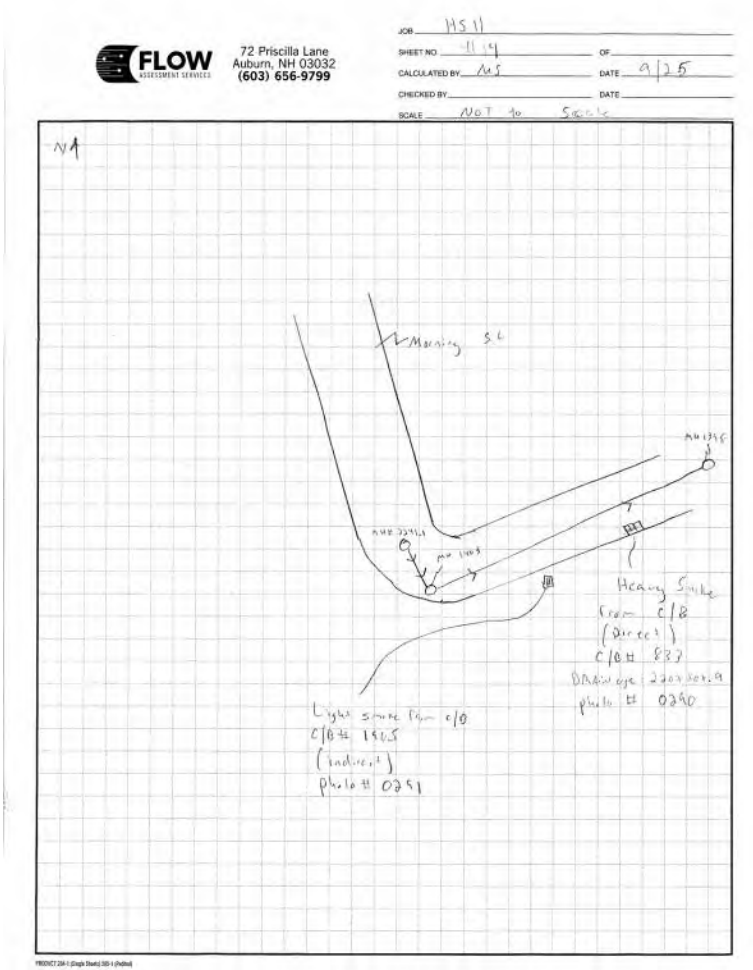
Image #: 0290.JPG

Findings:	Drainage Area SqFt	Runoff Coeff
Heavy smoke from catch basin#833 - direct connection	4400	0.9

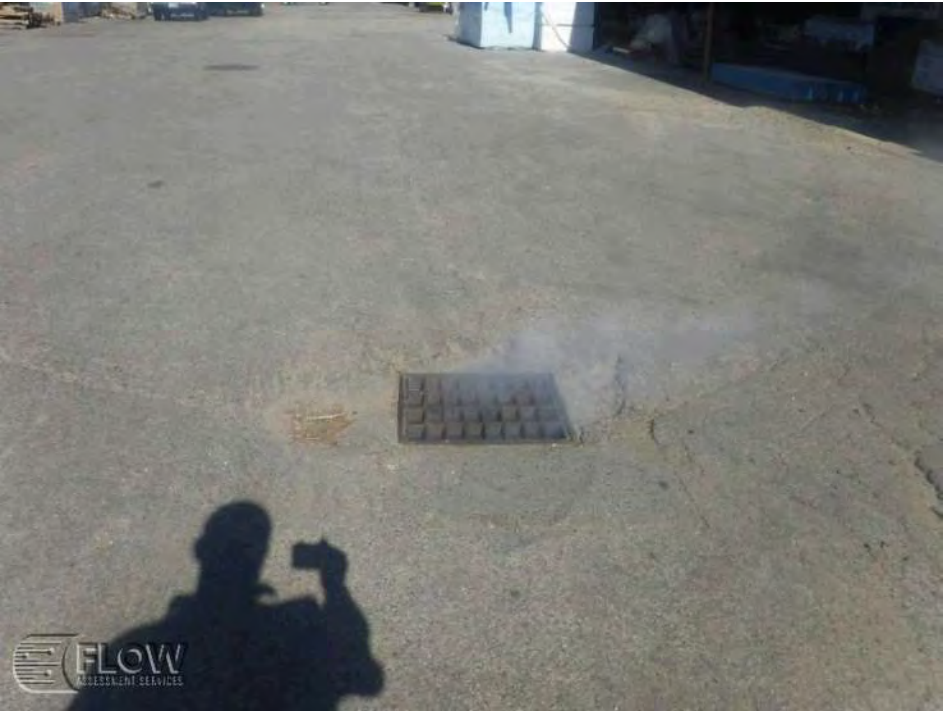
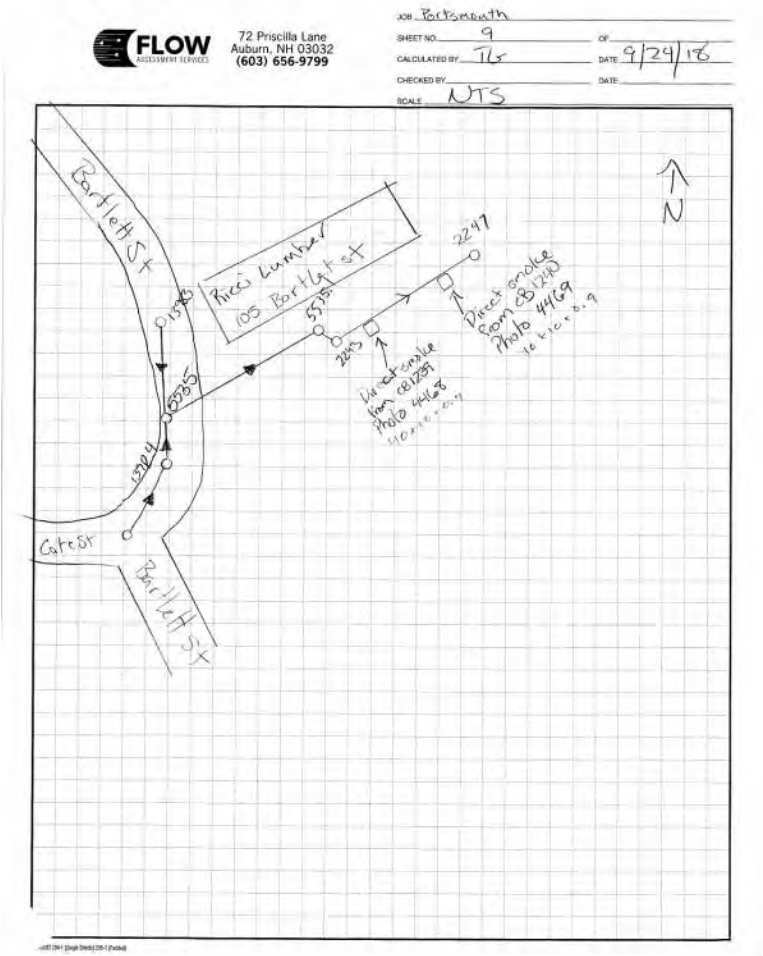
Image #: DSCF4469.JPG

Findings:	Drainage Area SqFt	Runoff Coeff
Smoke from catch basin#1240 - direct connection	400	0.9

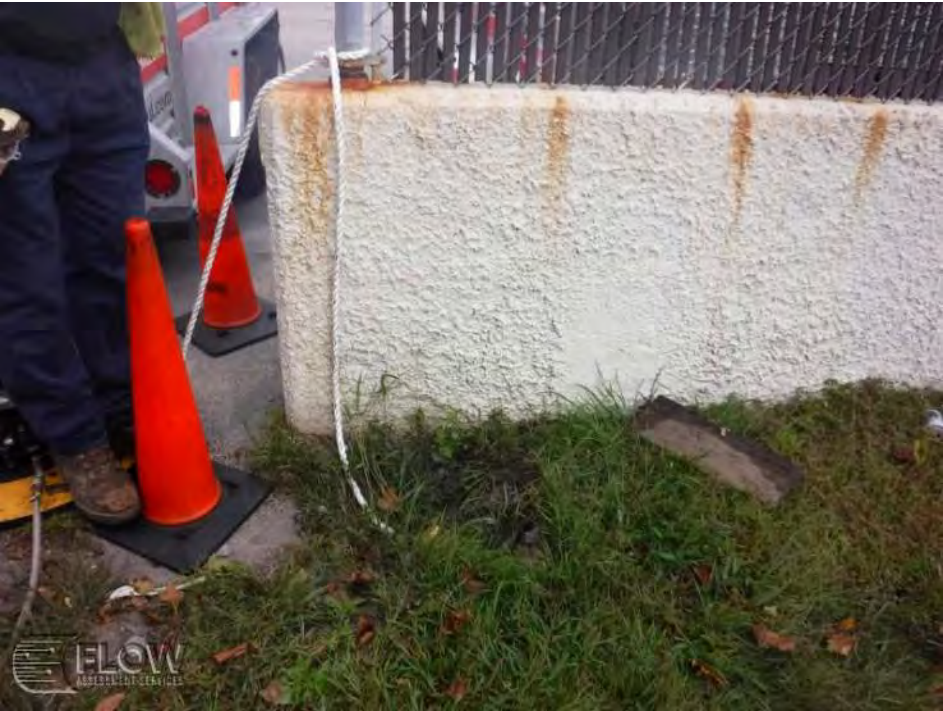
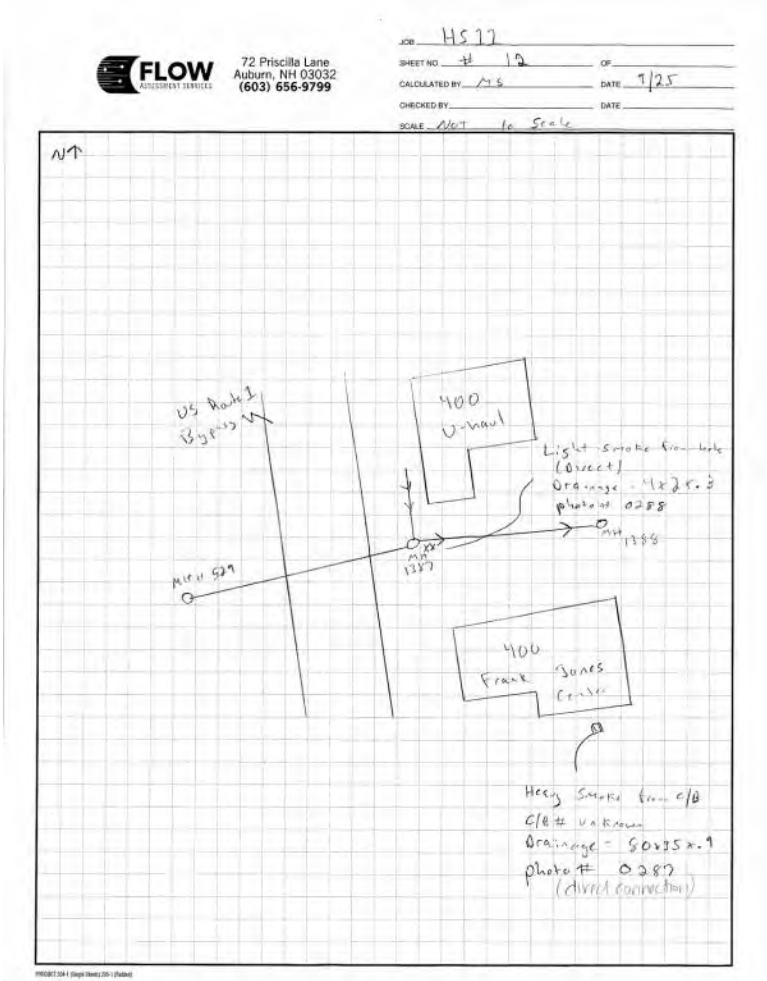
Image #: 0288.JPG

Findings:	Drainage Area SqFt	Runoff Coeff
Light smoke from hole next to MH 1387 - direct connection	8	0.3

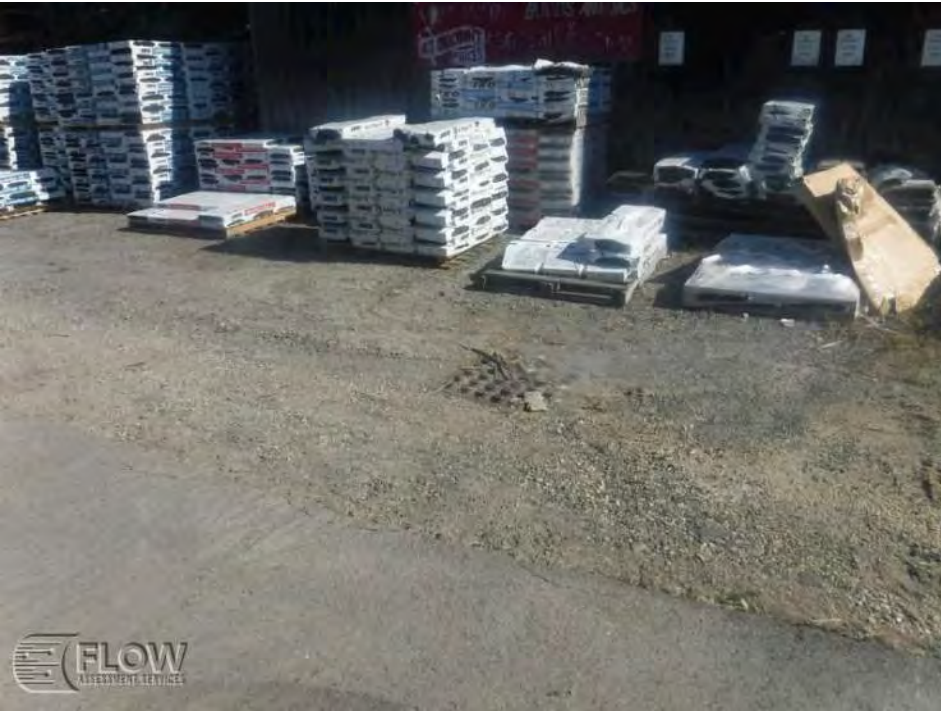
Image #: DSCF4468.JPG

Findings:	Drainage Area SqFt	Runoff Coeff
Smoke from catch basin#1239 - direct connection	400	0.9

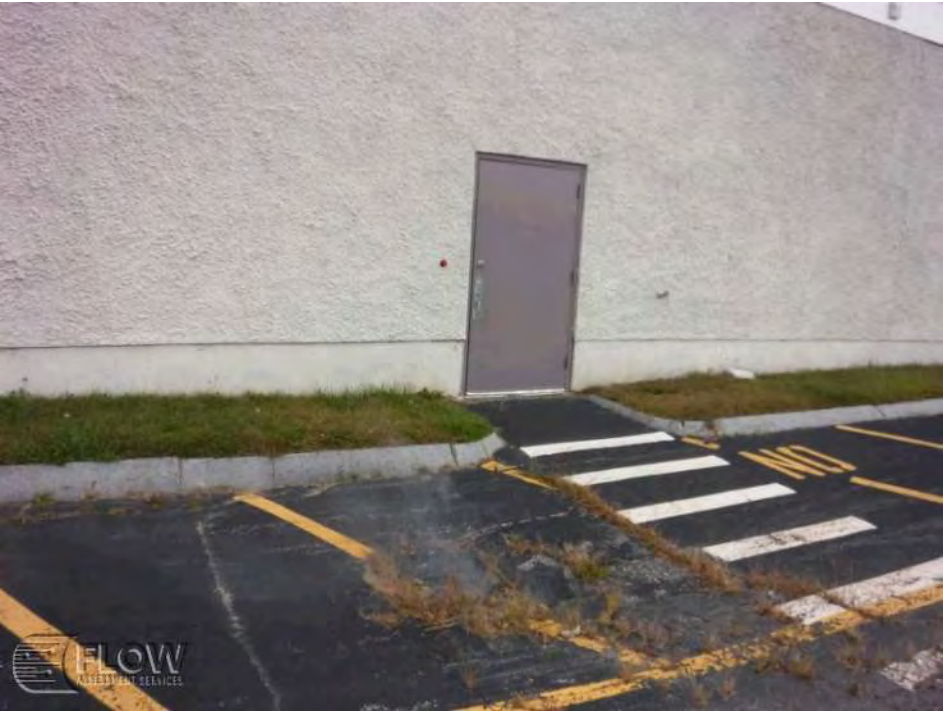
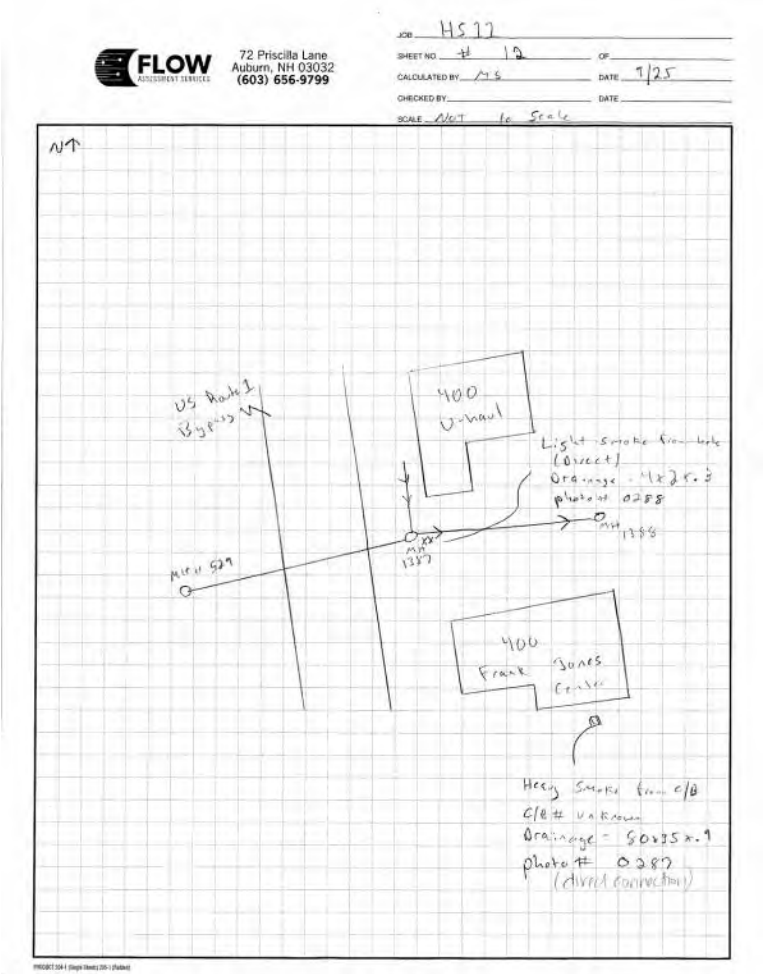
Image #: 0287.JPG

Findings:	Drainage Area SqFt	Runoff Coeff
Heavy smoke from catch basin - direct connection	2800	0.9

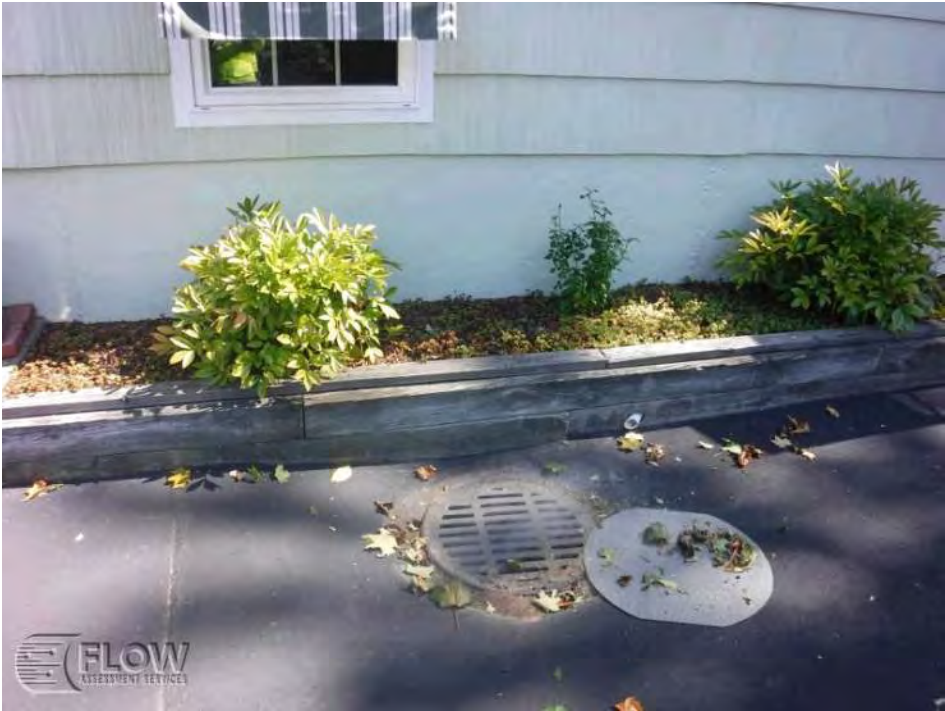
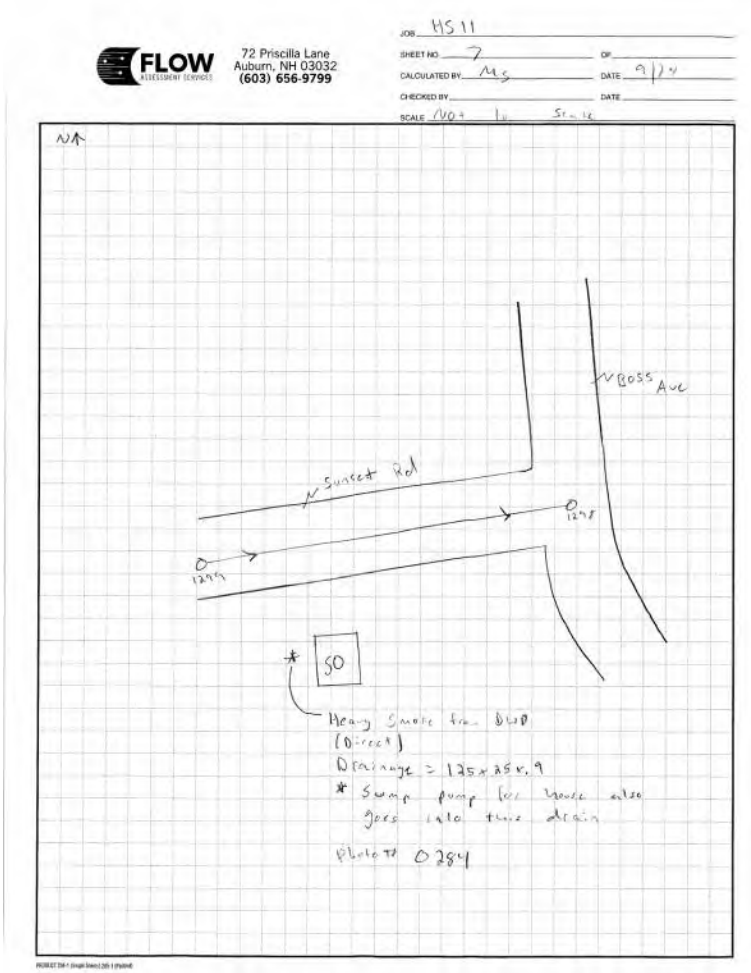
Image #: 0284.JPG

Findings:	Drainage Area SqFt	Runoff Coeff
Heavy smoke from driveway drain - direct connection	3125	0.9

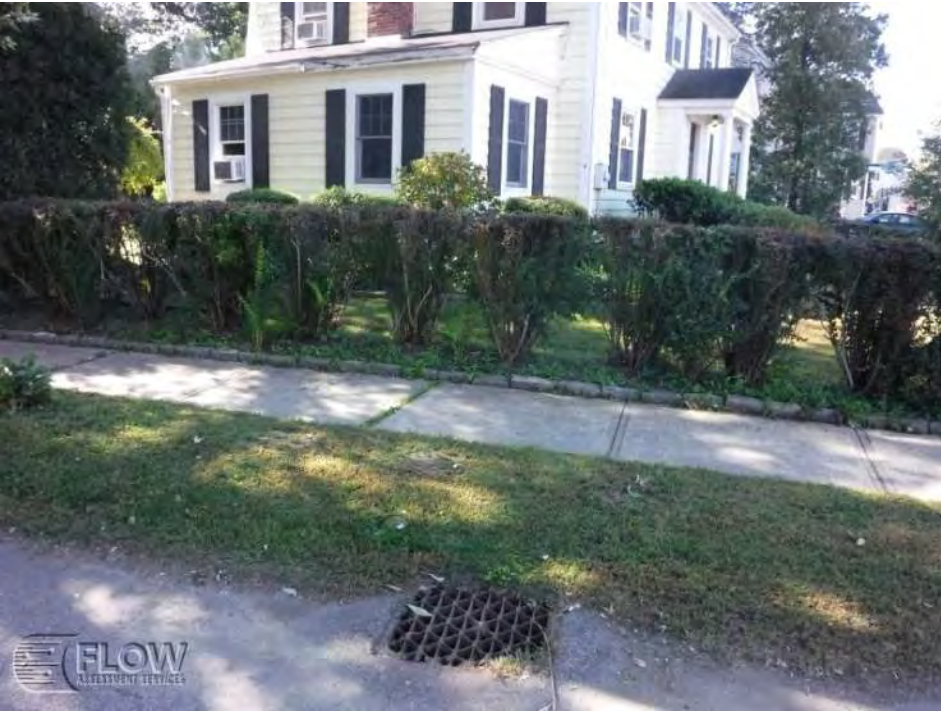
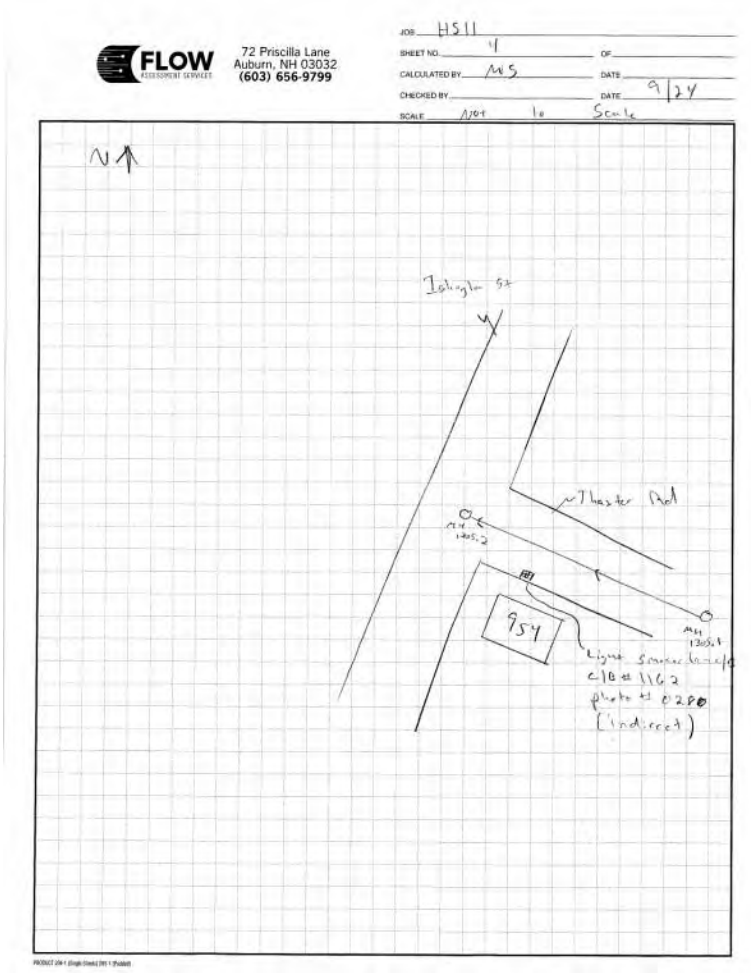
Image #: 0280.JPG

Findings:	Drainage Area SqFt	Runoff Coeff
Light smoke from catch basin#1162 - indirect connection. MH 1305.2 unnamed on map - see revised map.	0	0

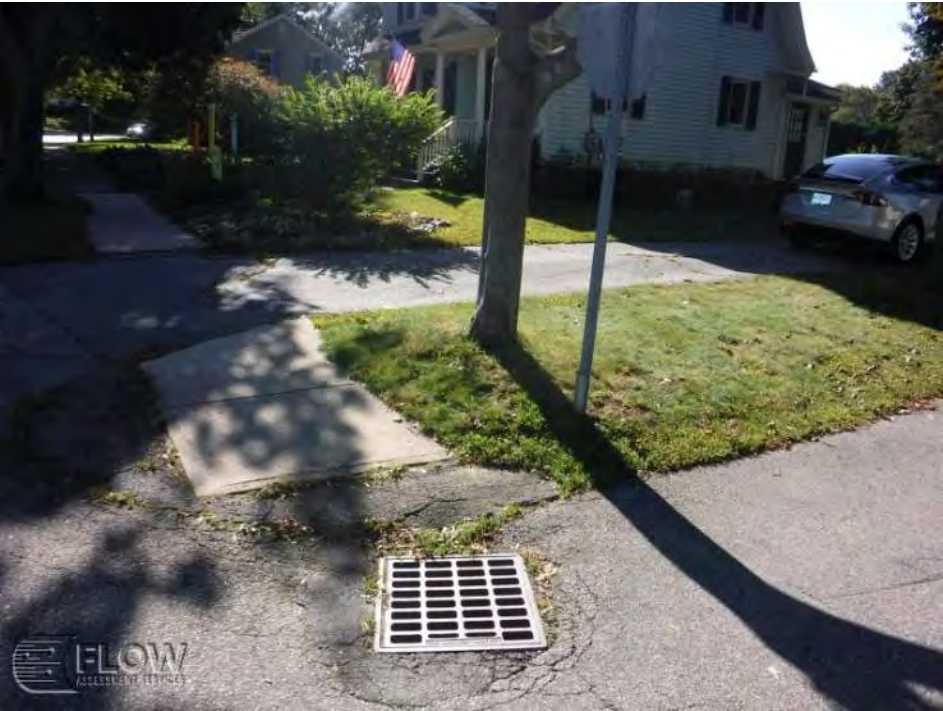
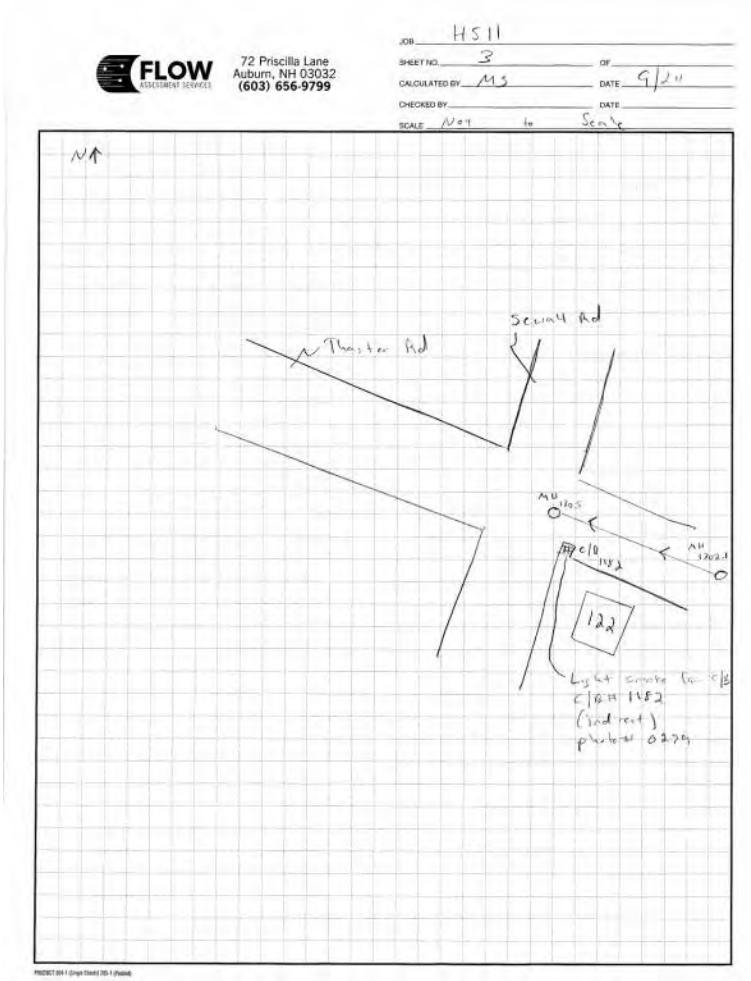
Image #: 0279.JPG

Findings:	Drainage Area SqFt	Runoff Coeff
Light smoke from catch basin#1182 - indirect connection	0	0

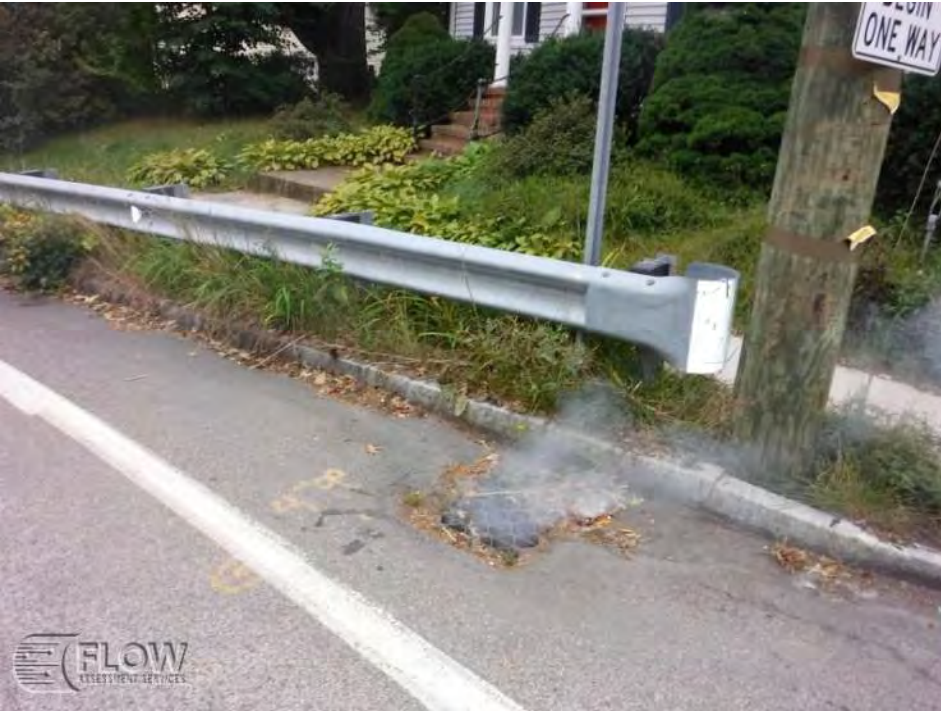
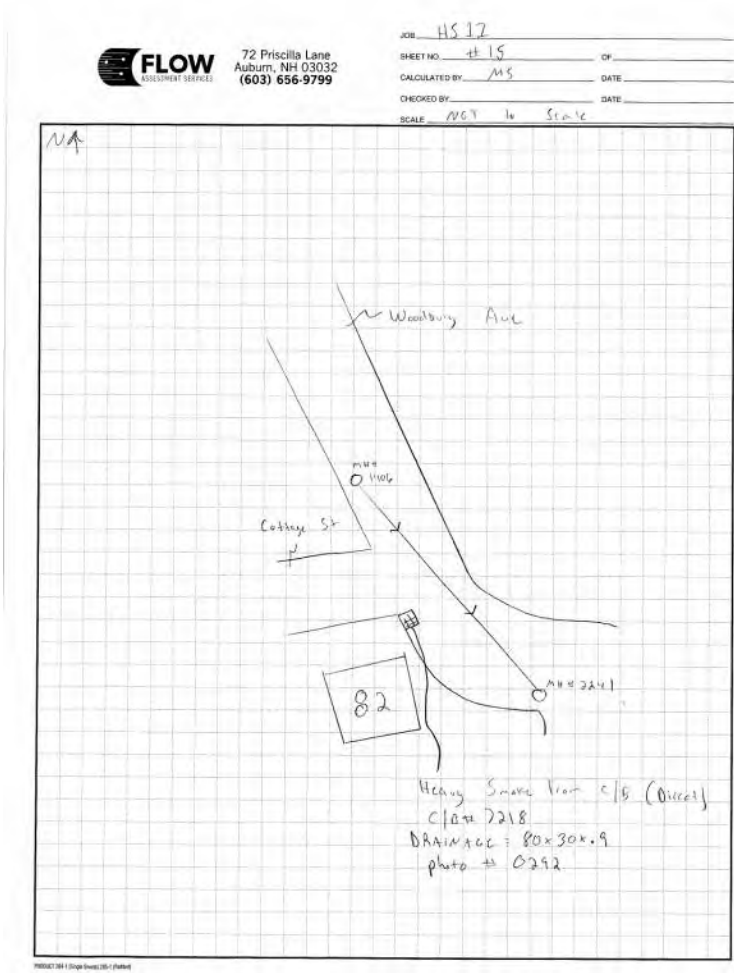
Image #: 0292.JPG

Findings:	Drainage Area SqFt	Runoff Coeff
Smoke from catch basin#7218 - direct connection	2400	0.9

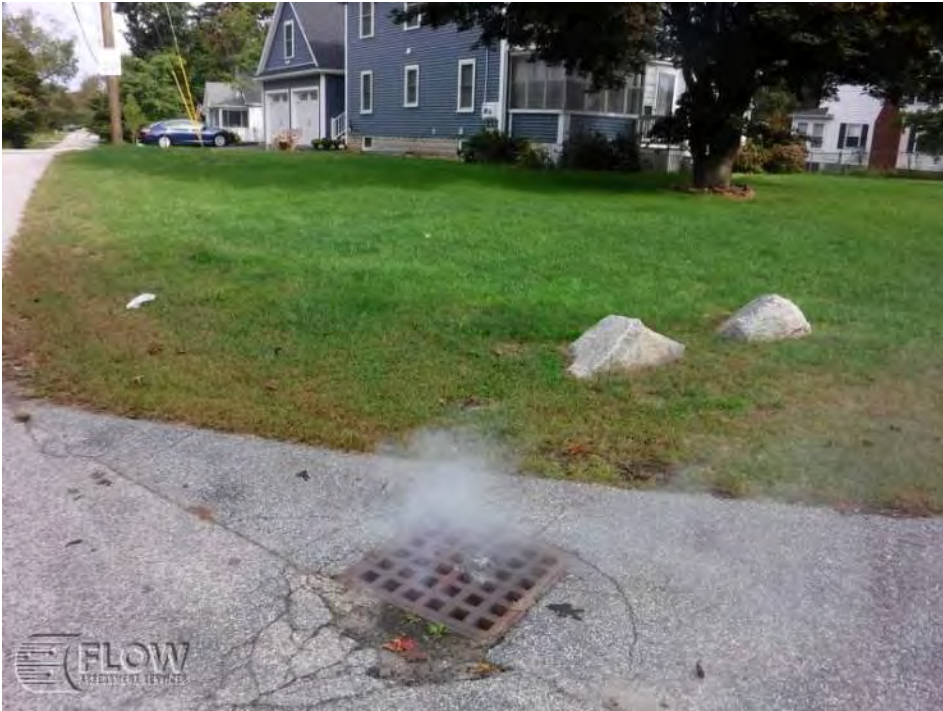
Image #: 0273.JPG

Findings:	Drainage Area SqFt	Runoff Coeff
Heavy smoke from catch basin#493 - direct connection	3960	0.9
