# Sewer System Evaluation Survey (SSES) Infiltration Study

227950.01  
City of Portsmouth, NH  
July 2020

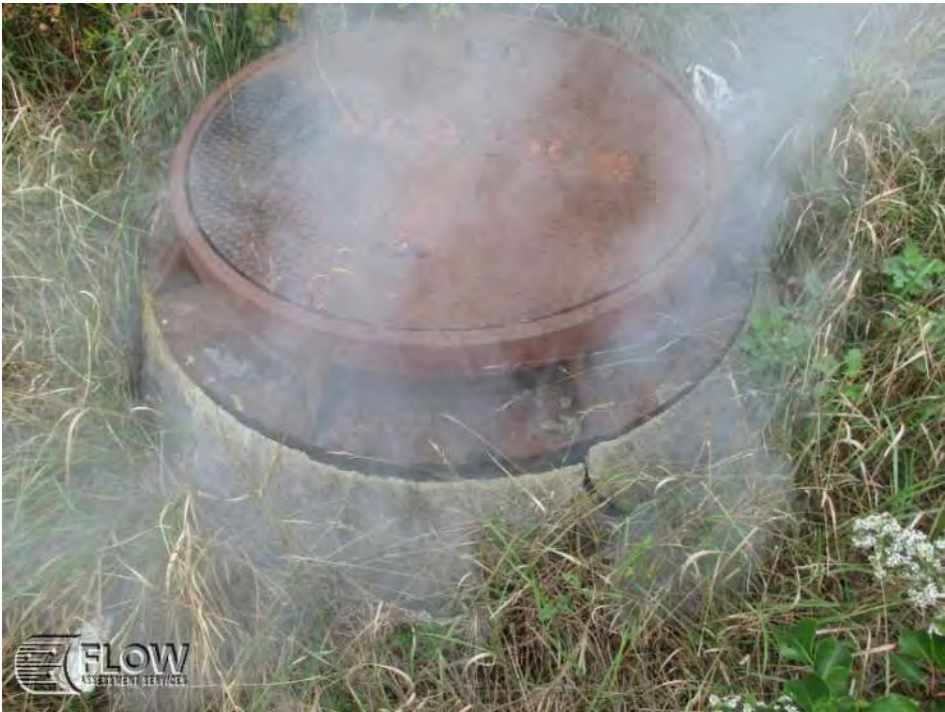
Image #: IMG\_0325.JPG

Findings:	Drainage Area SqFt	Runoff Coeff
MH 65.1 unnamed on map - see revised map. Smoke from broken concrete outside of MH 65.1 - direct connection	80	0.3

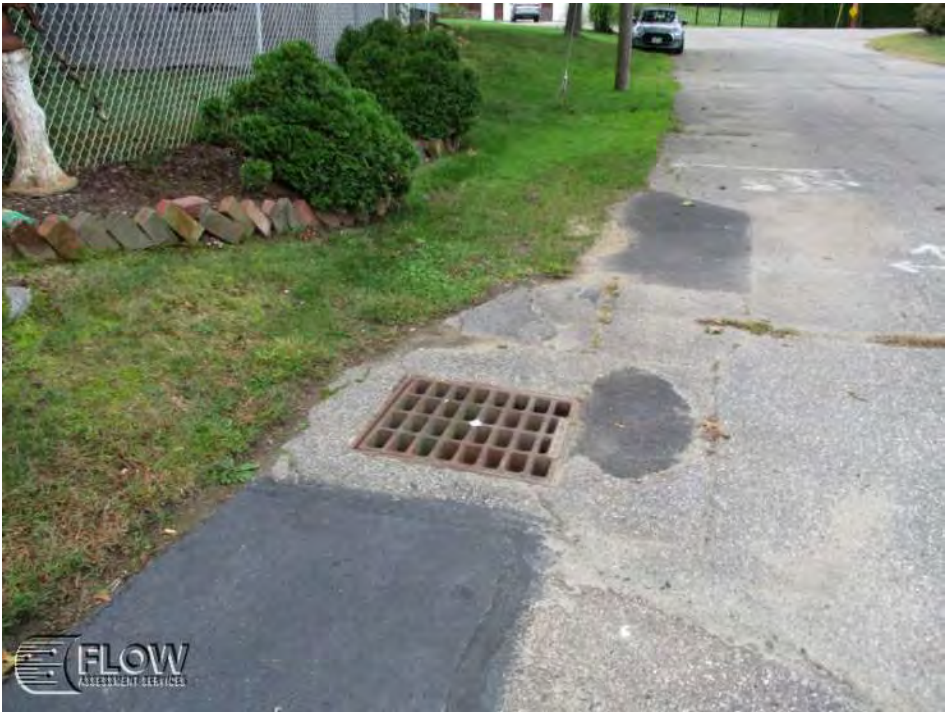
Image #: IMG\_0324.JPG

Findings:	Drainage Area SqFt	Runoff Coeff
Light smoke from catch basin#3734 - indirect connection	0	0

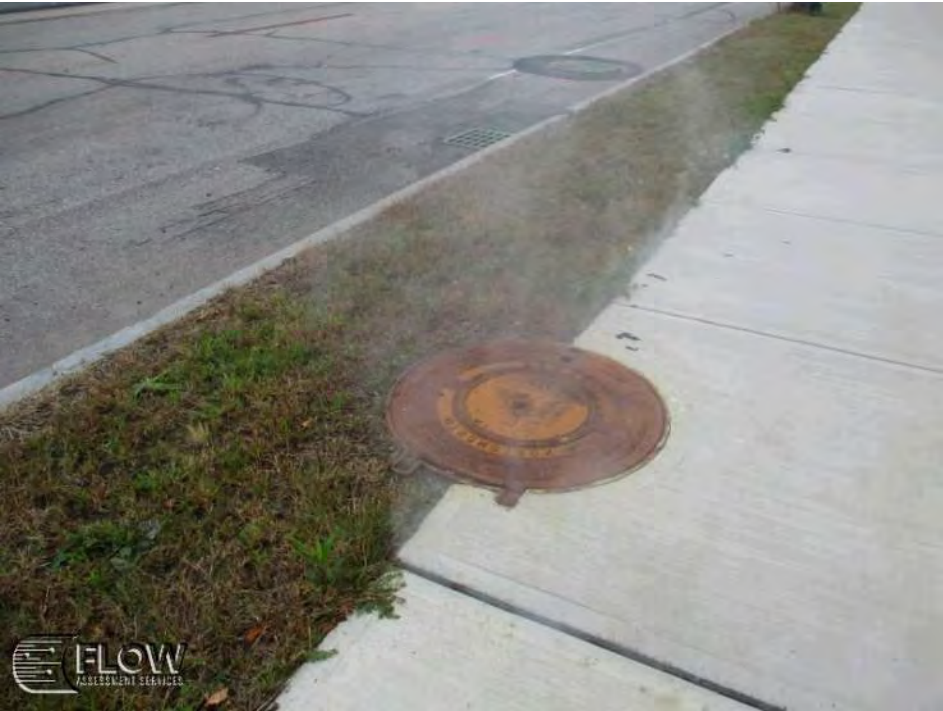
Image #: IMG\_0326.JPG

Findings:	Drainage Area SqFt	Runoff Coeff
Smoke from ground near sidewalk - direct connection	48	0.3

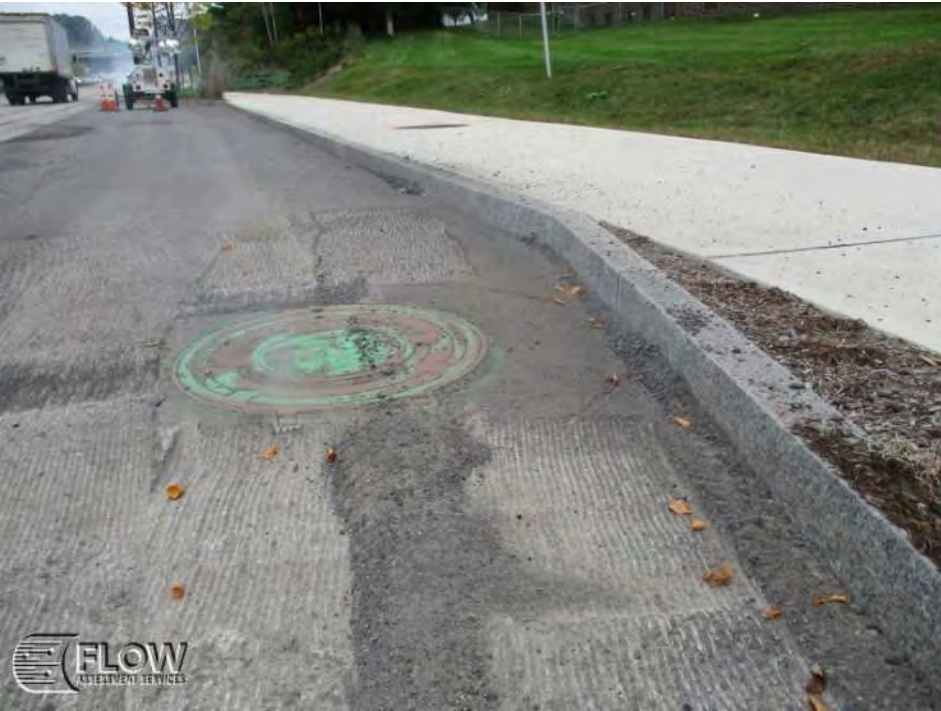
Image #: IMG\_0327.JPG

Findings:	Drainage Area SqFt	Runoff Coeff
Light smoke from curb - direct connection	32	0.9

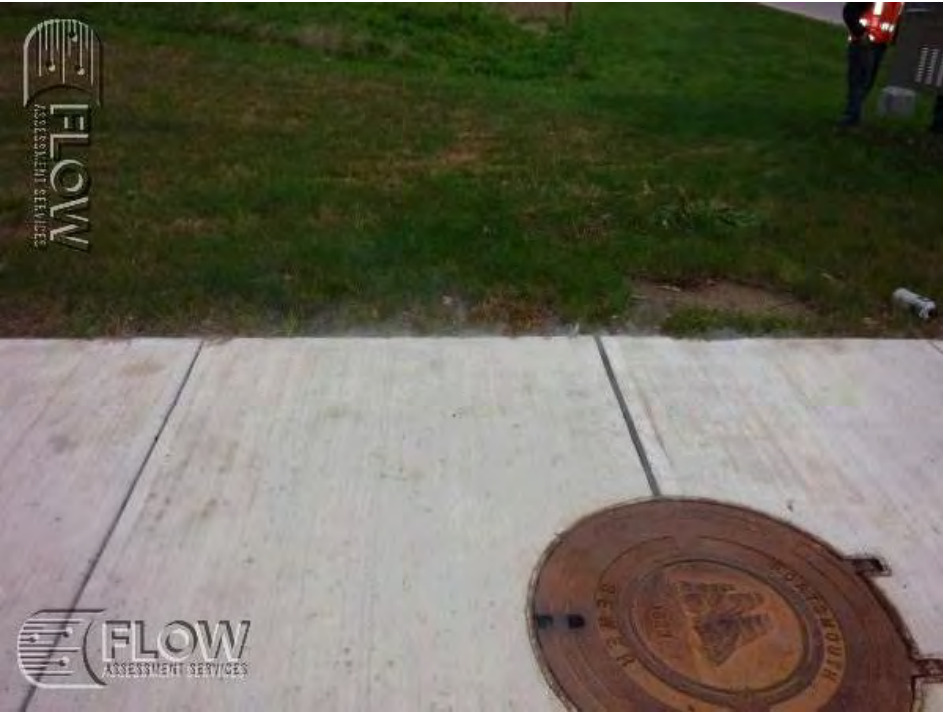
Image #: 0296.JPG

Findings:	Drainage Area SqFt	Runoff Coeff
Smoke from sidewalk/curb - direct connection	0	0

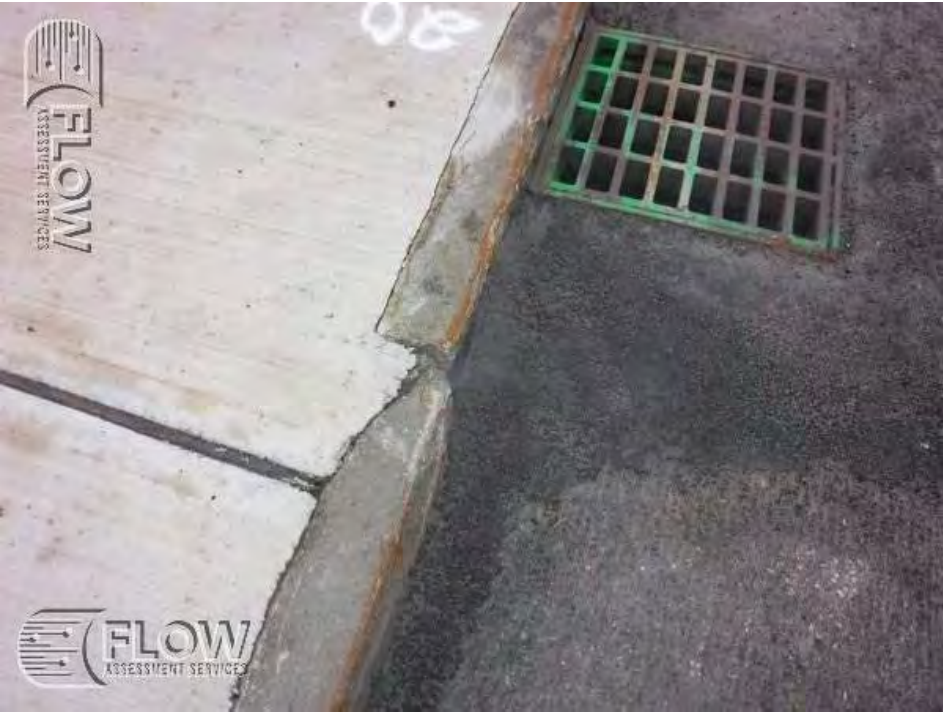
Image #: 0295.JPG

Findings:	Drainage Area SqFt	Runoff Coeff
Smoke from sidewalk/curb - direct connection	30	0.3

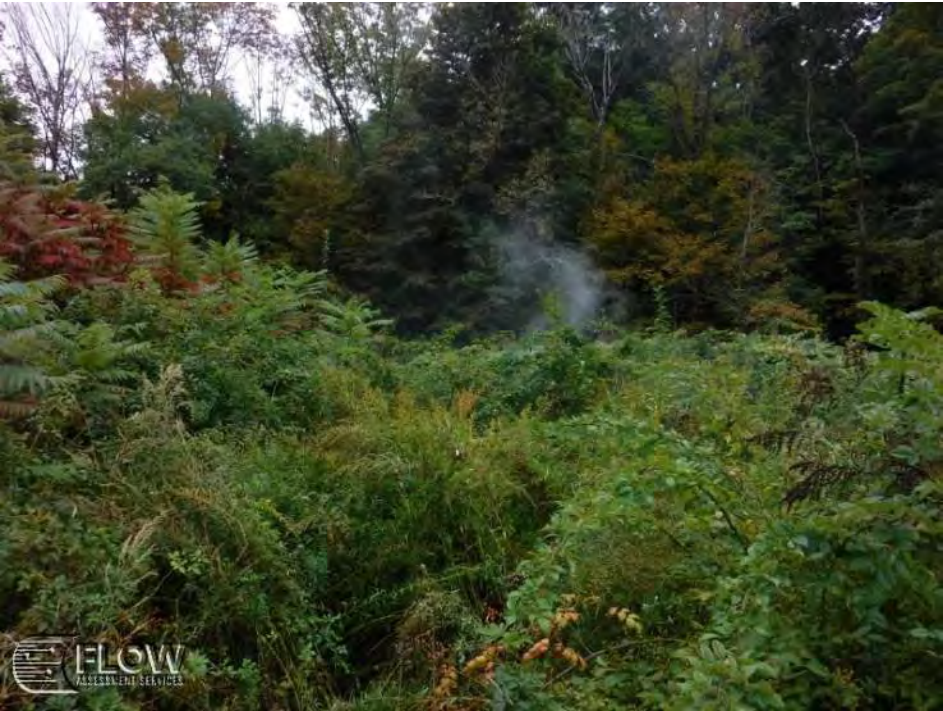
Image #: 0300.JPG

Findings:	Drainage Area SqFt	Runoff Coeff
Smoke from cleanout 1" below grade, missing cover - direct connection (Line abandoned)	0	0

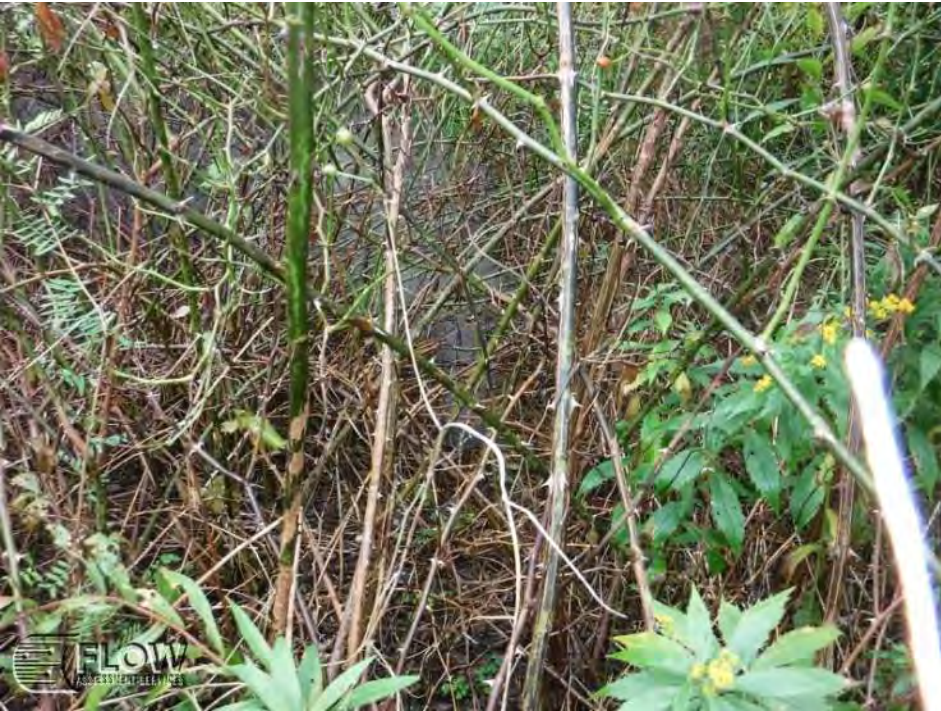
Image #: 0299.JPG

Findings:	Drainage Area SqFt	Runoff Coeff
Smoke from cleanout 1" below grade, missing cover - direct connection (Line abandoned)	750	0.3

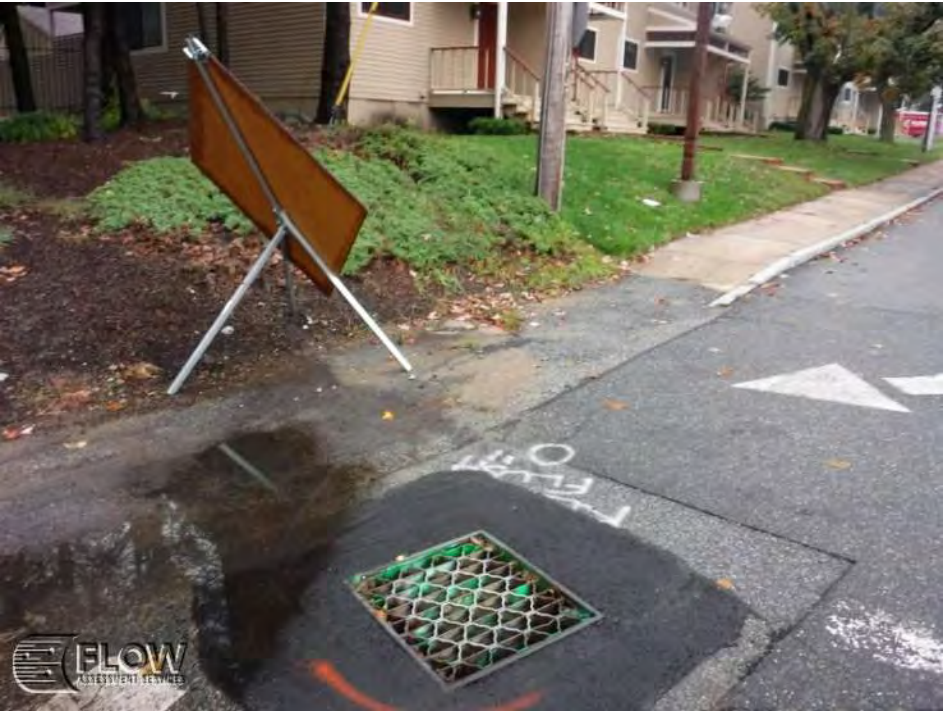
Image #: 0297.JPG

Findings:	Drainage Area SqFt	Runoff Coeff
Light smoke from catch basin#444 - indirect connection	0	0

Findings Address	Findings	Drainage Area SqFt	Runoff Coeff	Photo No.	Sketch No.	Insp. Date
	MH 65.1 unnamed on map - see revised map. Smoke from broken concrete outside of MH 65.1 - direct connection	80	0.3	0325	2	10/01/18
Beechwood Street	Light smoke from catch basin#3734 - indirect connection	0	0	0324	1	10/01/18
29 Brigham Lane	Smoke from cleanout 1" below grade, missing cover - direct connection	24	0.3	0294	3	10/01/18
Market Street	Smoke from sidewalk/curb - direct connection	30	0.3	0295	5	10/01/18
Market Street	Smoke from ground near sidewalk - direct connection	48	0.3	0326	4	10/01/18
Market Street	Light smoke from curb - direct connection	32	0.9	0327	4	10/01/18
Portsmouth Boulevard	Smoke from cleanout 1" below grade, missing cover - direct connection (Line abandoned)	750	0.3	0299	7	10/01/18
Spinnaker Way	Light smoke from catch basin#444 - indirect connection	0	0	0297	6	10/01/18

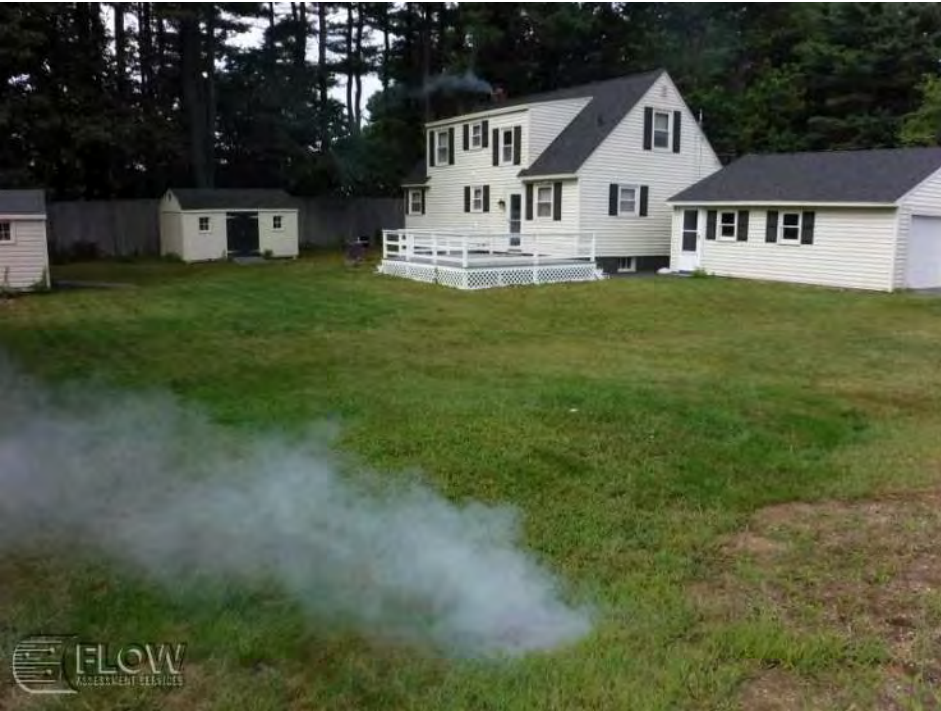
Image #: 0260.JPG

Findings:	Drainage Area SqFt	Runoff Coeff
Heavy smoke from yard drain behind home -direct connection	6250	0.3

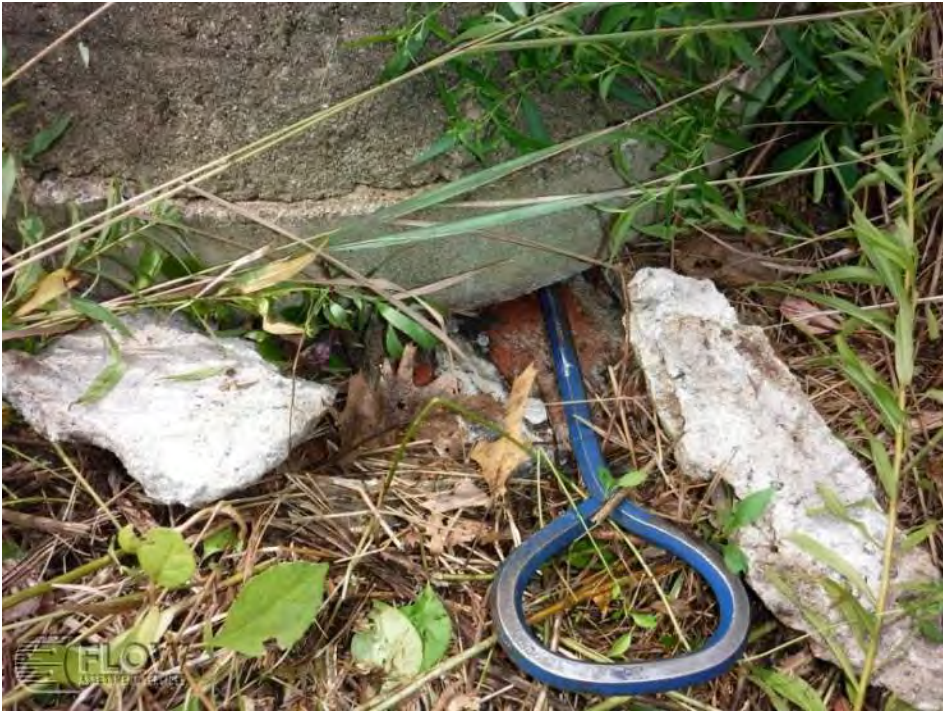
Image #: 0257.JPG

Findings:	Drainage Area SqFt	Runoff Coeff
Smoke from around corbel of MH 343 - direct connection	0	0

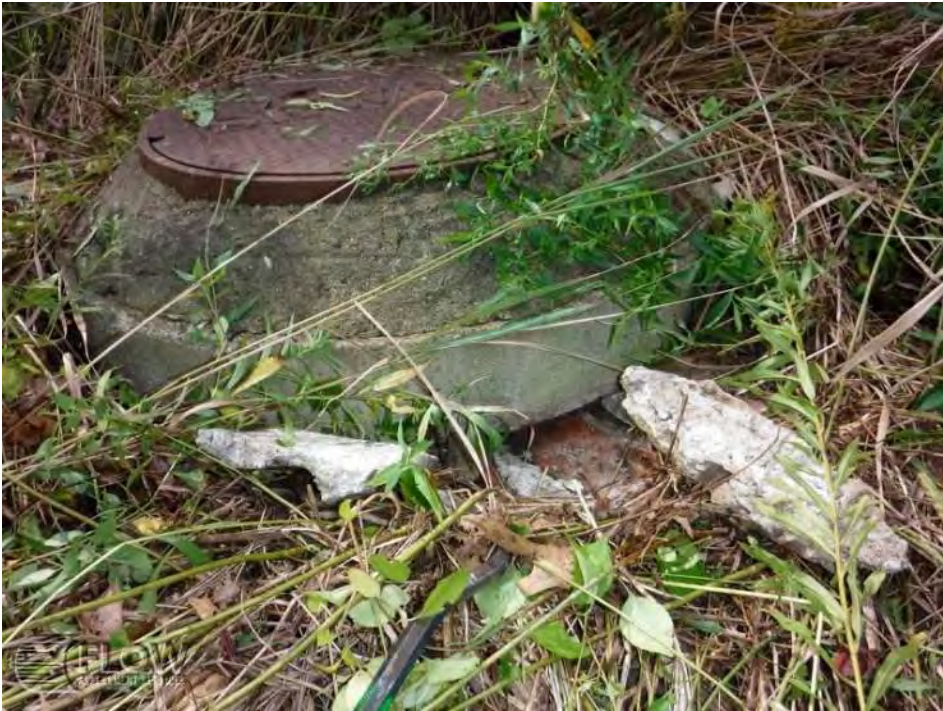
Image #: 0256.JPG

Findings:	Drainage Area SqFt	Runoff Coeff
Smoke from around corbel of MH 343 - direct connection	0	0

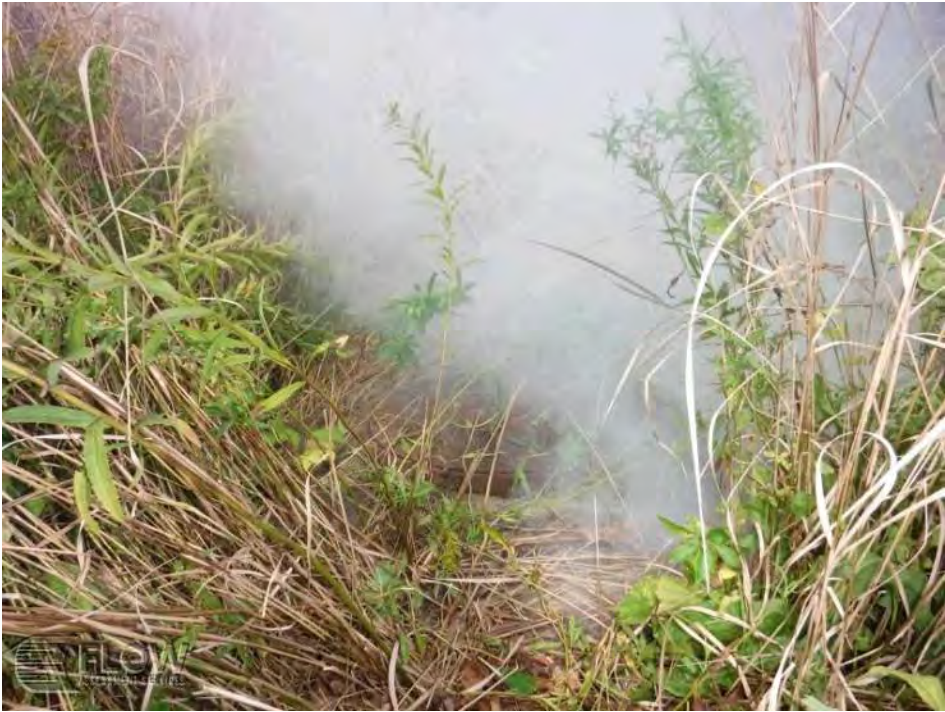
Image #: 0255.JPG

Findings:	Drainage Area SqFt	Runoff Coeff
Smoke from around corbel of MH 343 - direct connection	2	0.9

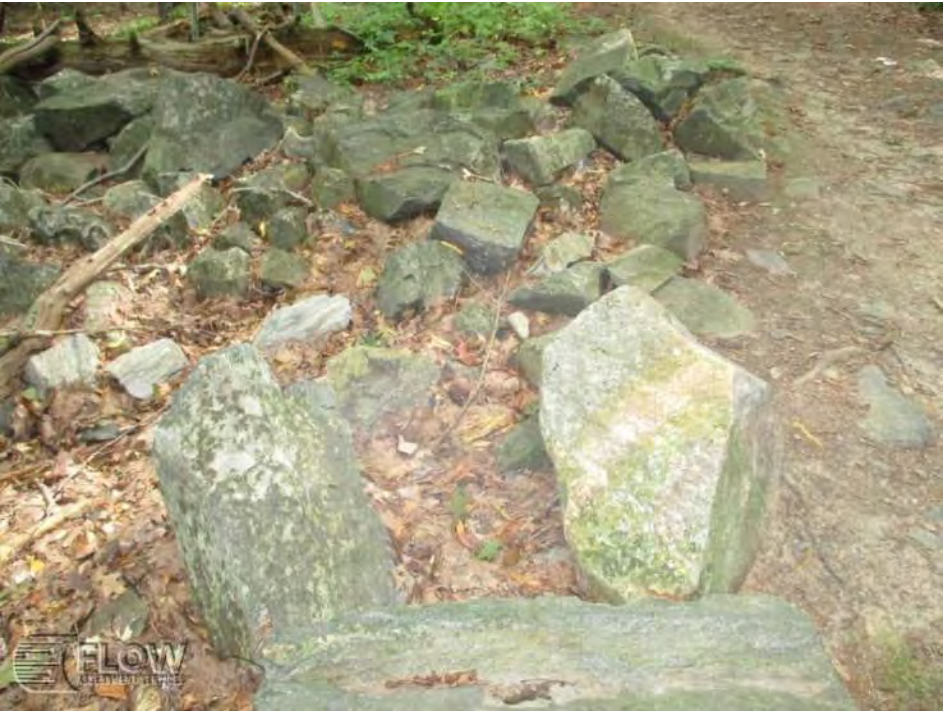
Image #: IMG\_0135.JPG

Findings:	Drainage Area SqFt	Runoff Coeff
Smoke from rock pile near MH 338 - direct connection	0	0

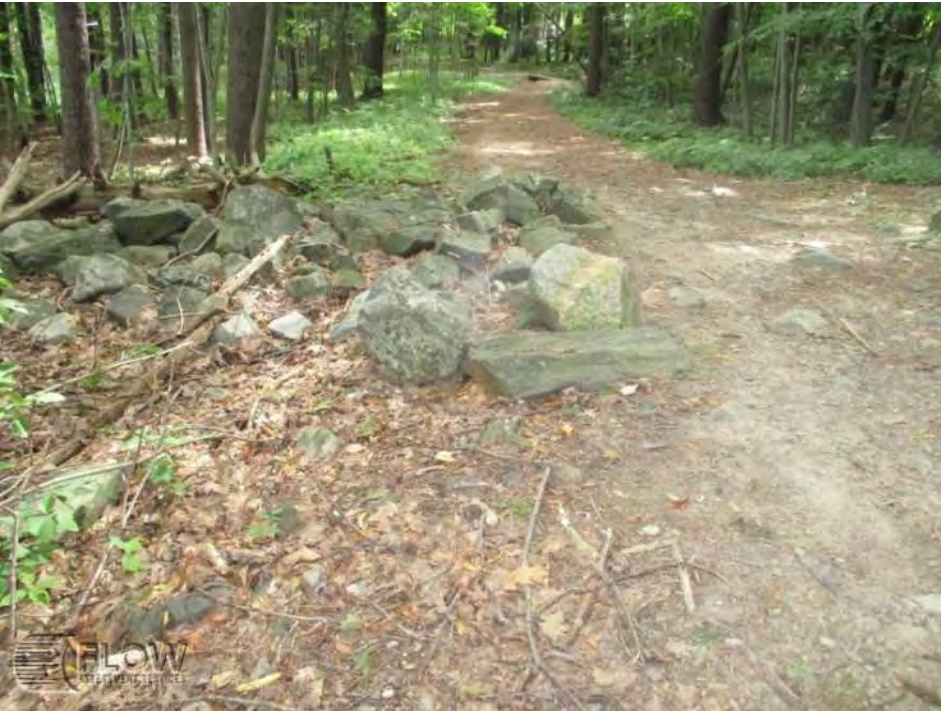
Image #: IMG\_0134.JPG

Findings:	Drainage Area SqFt	Runoff Coeff
Smoke from rockpile near MH 338 - direct connection	150	0.3

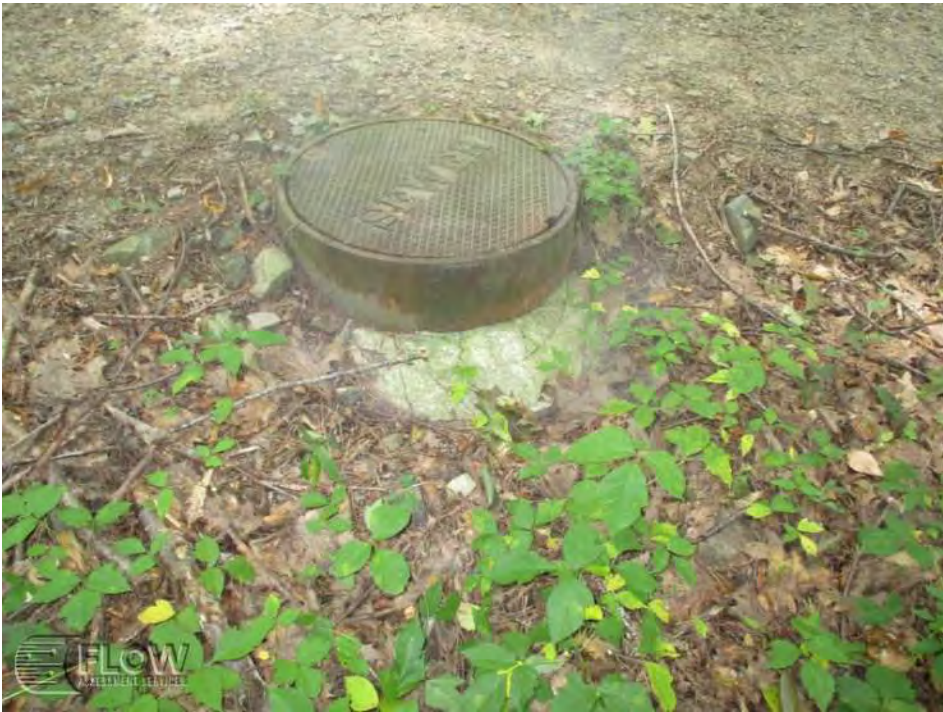
Image #: IMG\_0133.JPG

Findings:	Drainage Area SqFt	Runoff Coeff
Smoke from corbel of MH 338 - direct connection	9	0.3

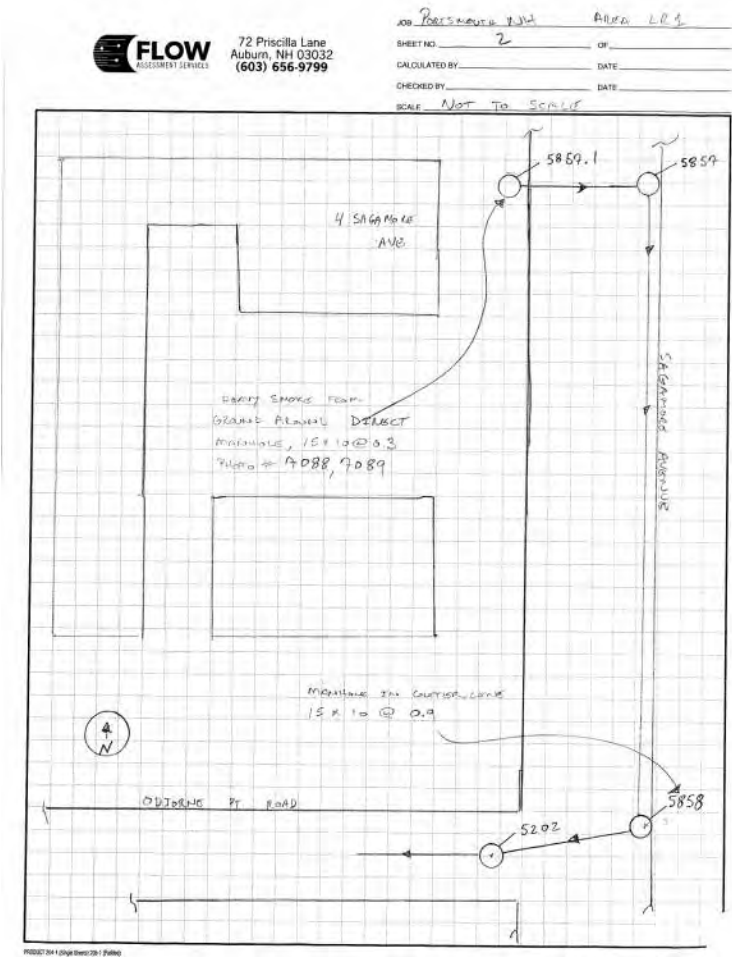
Sketch #: Subarea LR1 Sketch#2.tif

Findings:	Drainage Area SqFt	Runoff Coeff
MH 5858 is in gutterline	150	0.9

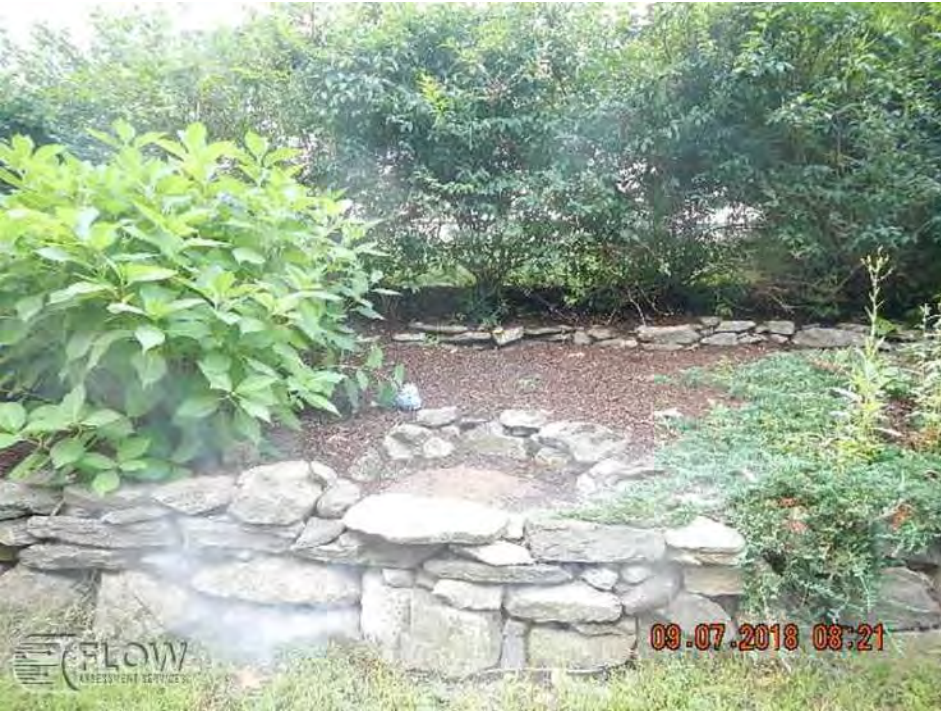
Image #: DSCN7089.JPG

Findings:	Drainage Area SqFt	Runoff Coeff
Heavy smoke from ground around MH 5857.1	0	0

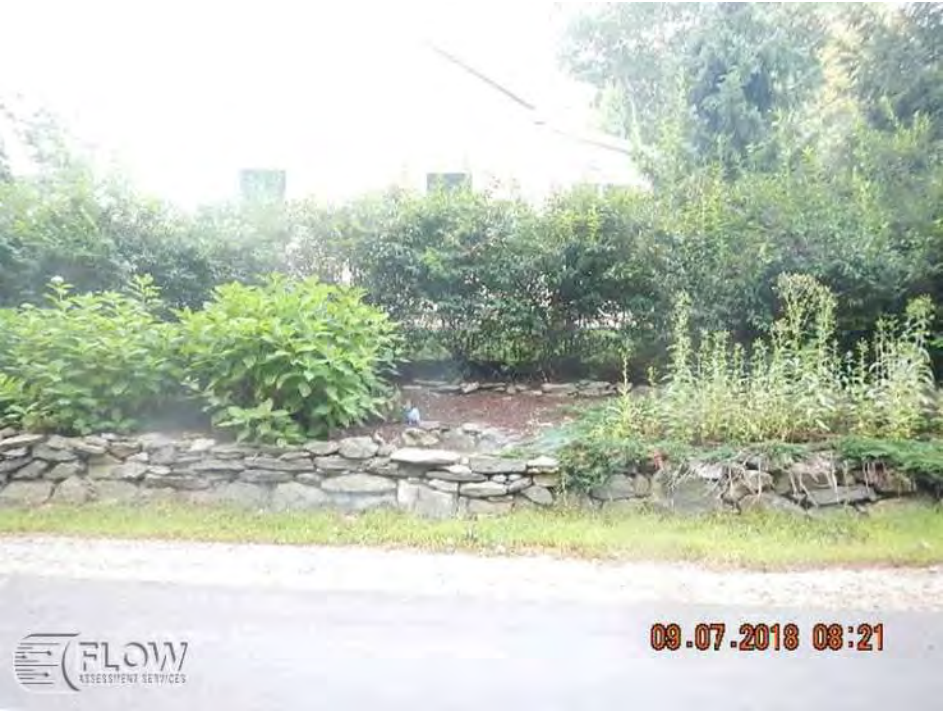
Image #: DSCN7088.JPG

Findings:	Drainage Area SqFt	Runoff Coeff
Heavy smoke from ground around MH 5857.1 - direct connection. MH 5857.1 unnamed on map - see revised map.	150	0.3

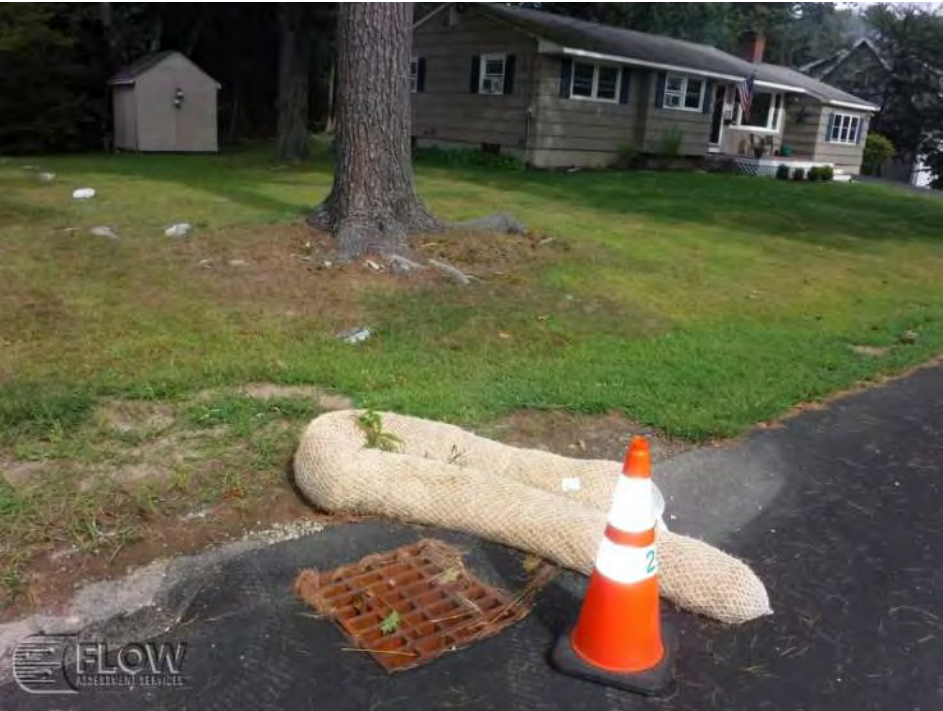
Image #: 0251.JPG

Findings:	Drainage Area SqFt	Runoff Coeff
Light smoke from catch basin#1847 - indirect connection	0	0

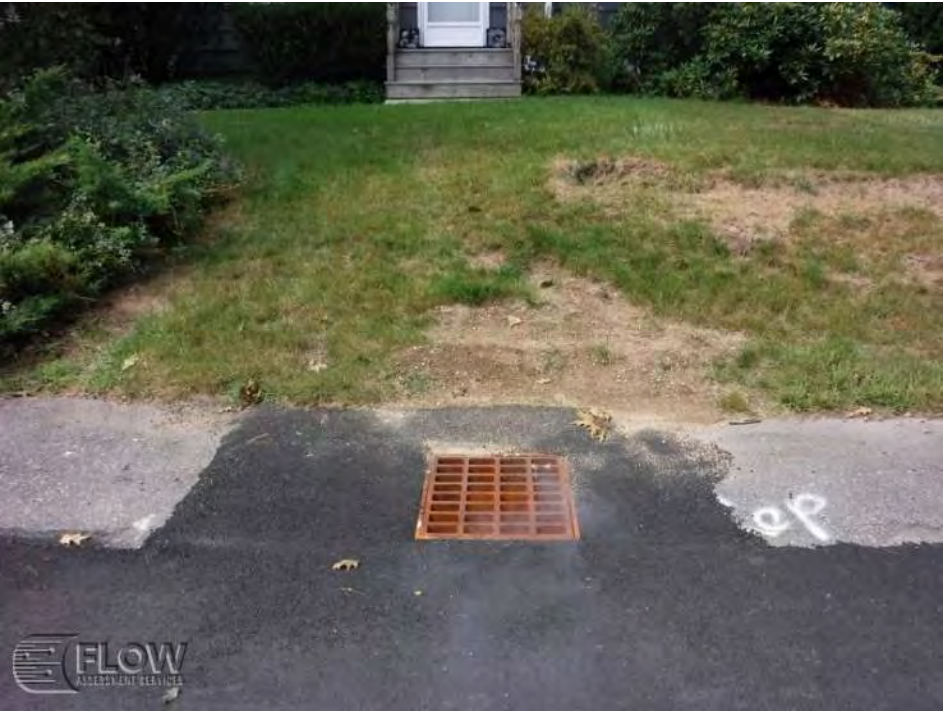
Image #: 0258.JPG

Findings:	Drainage Area SqFt	Runoff Coeff
Smoke from catch basin#1507 - direct connection	4950	0.9

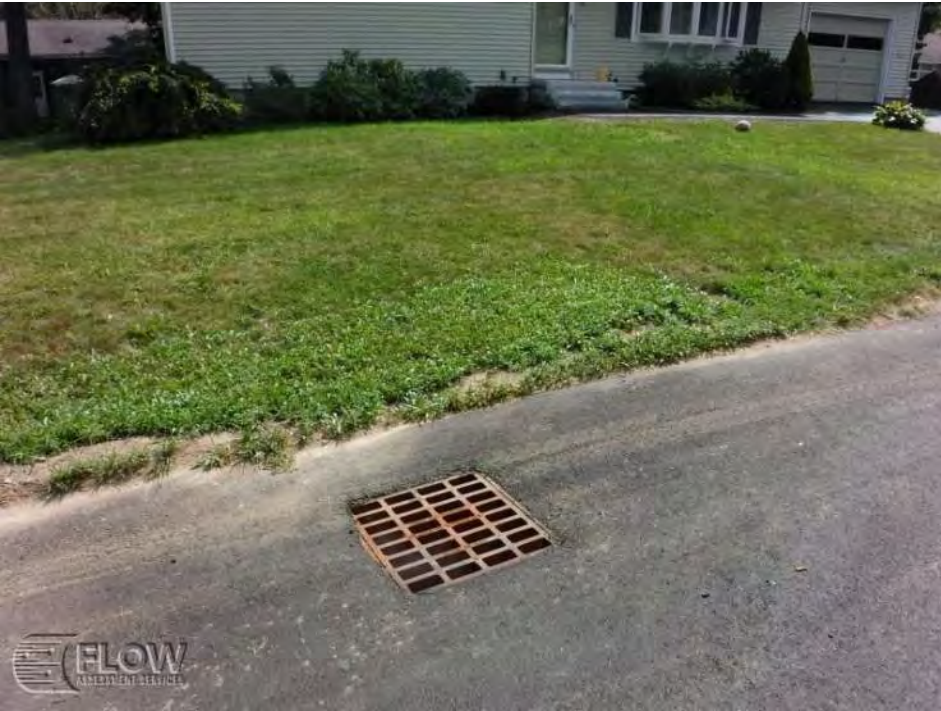
Image #: 0250.JPG

Findings:	Drainage Area SqFt	Runoff Coeff
Light smoke from catch basin#1573 - indirect connection	0	0

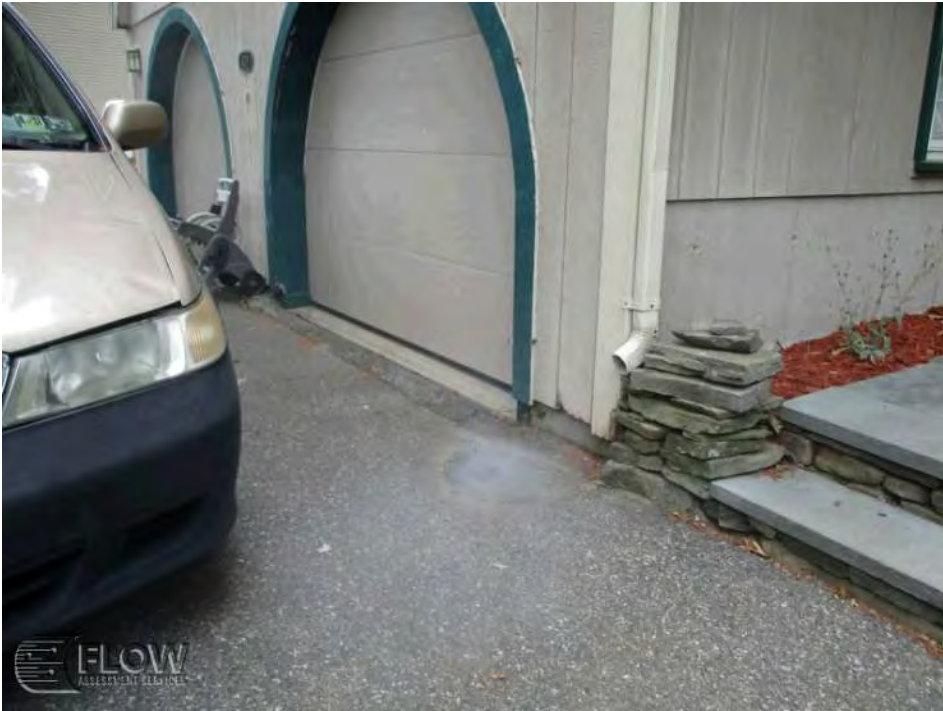
Image #: IMG\_0138.JPG

Findings:	Drainage Area SqFt	Runoff Coeff
Smoke from cleanout missing cap, at grade - direct connection	15	0.9

Findings Address	Findings	Drainage Area SqFt	Runoff Coeff	Photo No.	Sketch No.	Insp. Date
420 Grant Drive	Smoke from cleanout missing cap, at grade - direct connection	15	0.9	0138	1	09/12/18
2021 Lafayette Road	Light smoke from catch basin - indirect connection	0	0	0261	2	09/12/18

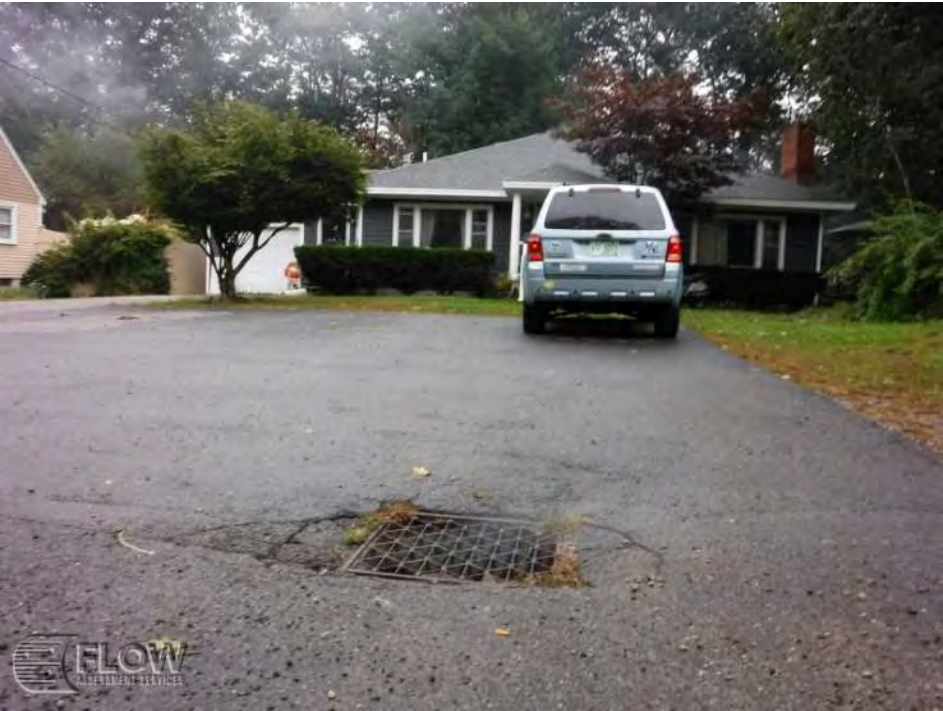
Image #: 0261.JPG

Findings:	Drainage Area SqFt	Runoff Coeff
Light smoke from catch basin - indirect connection	0	0

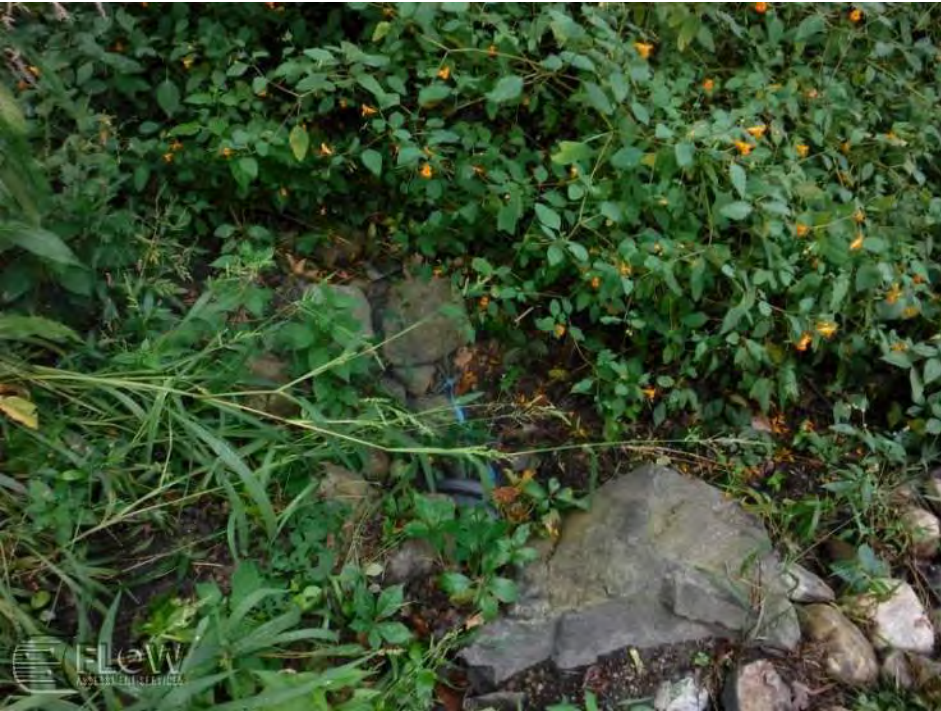
Image #: 0271.JPG

Findings:	Drainage Area SqFt	Runoff Coeff
Light smoke from drain pipe - direct connection	0	0

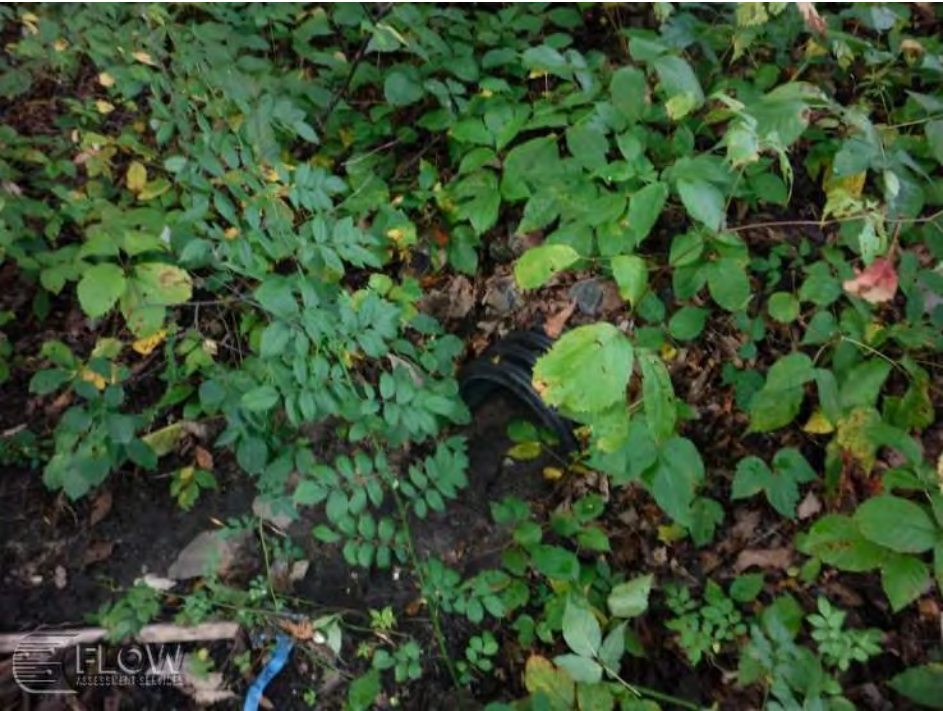
Image #: 0270.JPG

Findings:	Drainage Area SqFt	Runoff Coeff
Light smoke from drain pipe - indirect connection	0	0

Findings Address	Findings	Drainage Area SqFt	Runoff Coeff	Photo No.	Sketch No.	Insp. Date
380 Greenleaf Avenue	Light smoke from drain pipe - indirect connection	0	0	0270	2	09/20/18
Hillside Drive	Light smoke from catch basin#4071 - direct connection	1650	0.9	0272	3	09/20/18
Leavitt Avenue	3 GPM leak from above outgoing line in MH 543	0	0	0268		09/20/18
10 McClintock Avenue	Smoke from ground - direct connection	150	0.3	0269	1	09/20/18

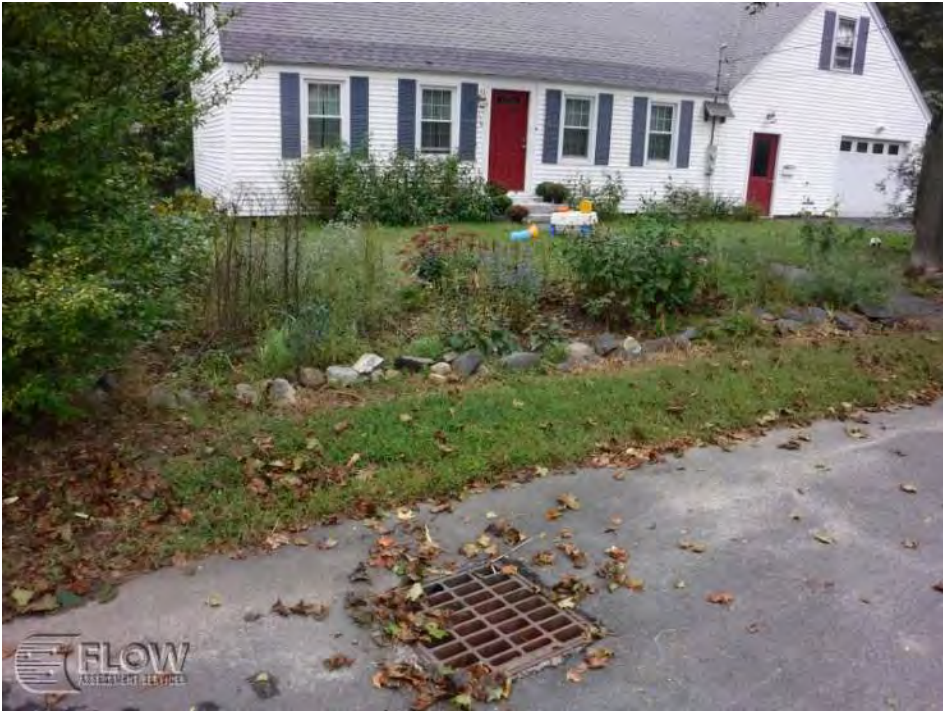
Image #: 0272.JPG

Findings:	Drainage Area SqFt	Runoff Coeff
Light smoke from catch basin#4071 - direct connection	1650	0.9

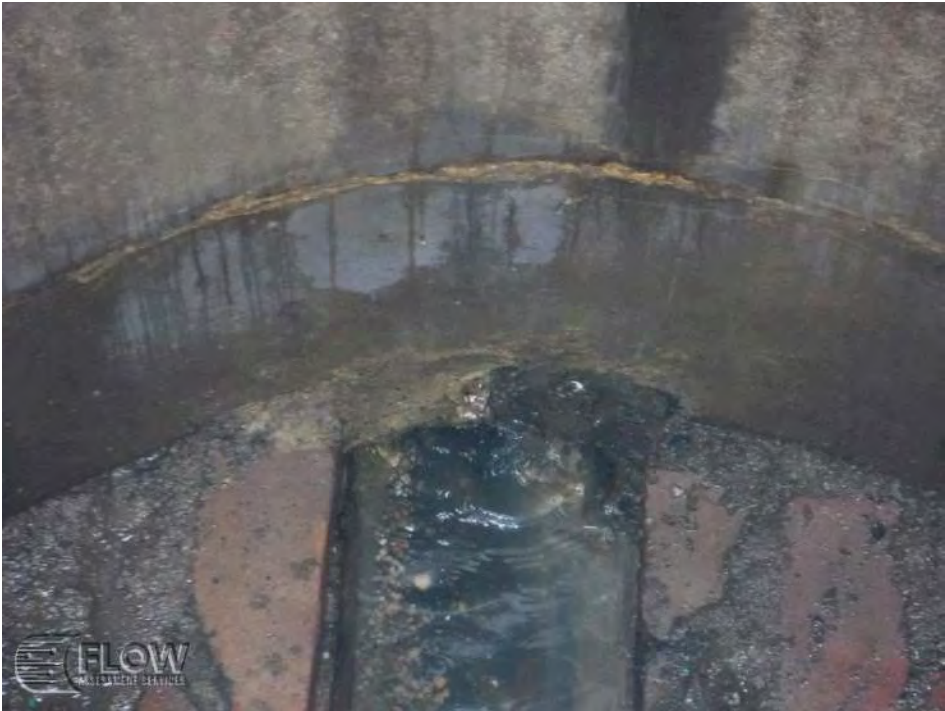
Image #: 0268.JPG

Findings:	Drainage Area SqFt	Runoff Coeff
3 GPM leak from above outgoing line in MH 543	0	0

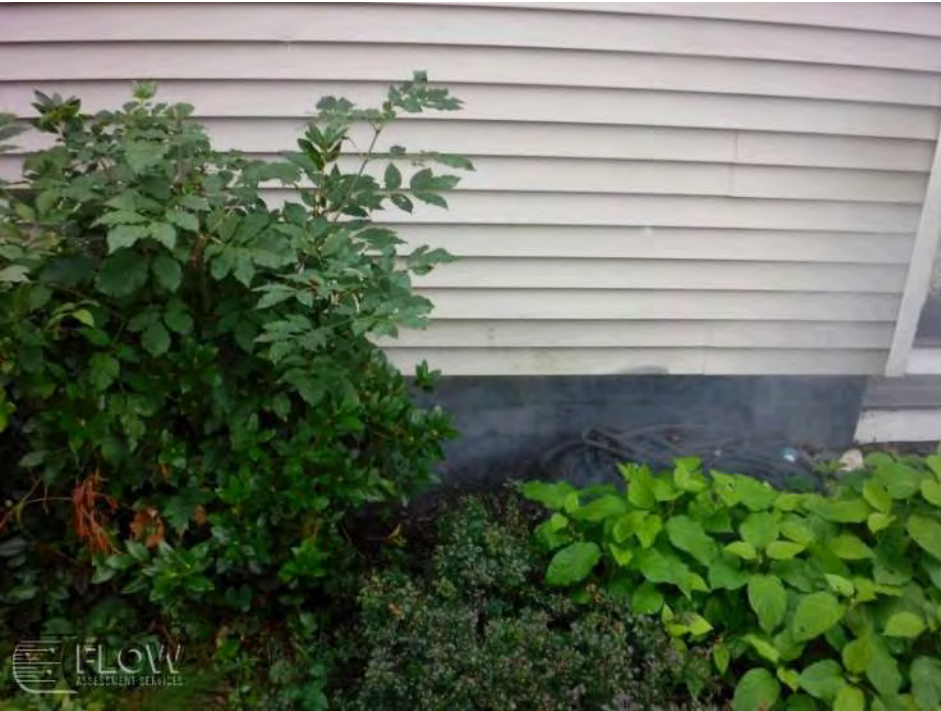
Image #: 0269.JPG

Findings:	Drainage Area SqFt	Runoff Coeff
Smoke from ground - direct connection	150	0.3

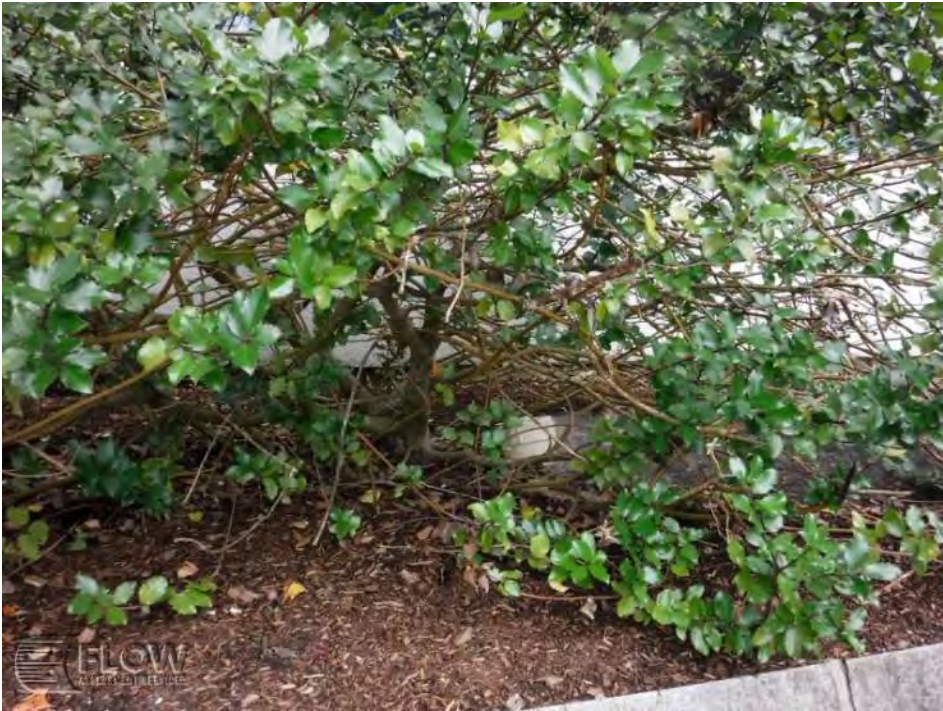
Image #: 0262.JPG

Findings:	Drainage Area SqFt	Runoff Coeff
Smoke from loose cleanout cover 6" above grade - direct connection	0	0

Findings Address	Findings	Drainage Area SqFt	Runoff Coeff	Photo No.	Sketch No.	Insp. Date
275 Constitution Avenue	Smoke from loose cleanout cover 6" above grade - direct connection	0	0	0262		09/14/18
225 Heritage Avenue	Smoke from cleanout missing cover, 3" above grade - direct connection	0	0	0265	2	09/14/18
225 Heritage Avenue	Smoke from cleanout missing cover, at grade - direct connection	160	0.3	0264	2	09/14/18
Lafayette Road	MH 2479 is buried - footages combined. Smoke from ground near approximate location of MH 2479 - direct connection	30	0.3	0267	3	09/14/18
2468 Lafayette Road	Smoke from metal plates and cracks - direct connection	800	0.9	0263	1	09/14/18

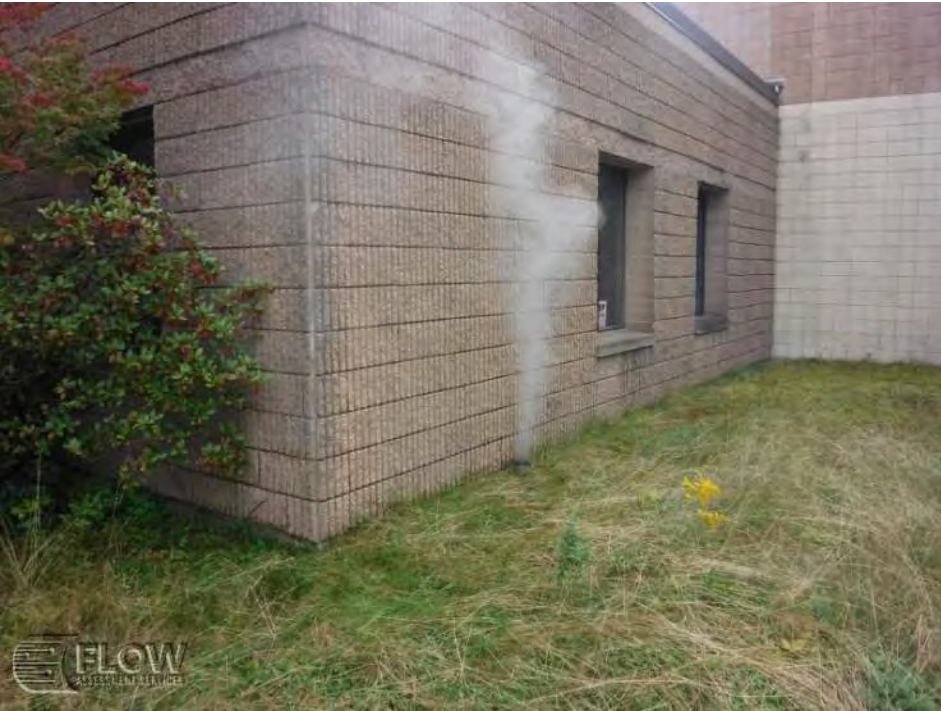
Image #: 0265.JPG

Findings:	Drainage Area SqFt	Runoff Coeff
Smoke from cleanout missing cover, 3" above grade - direct connection	0	0
