# Sewer System Evaluation Survey (SSES) Infiltration Study

227950.01  
City of Portsmouth, NH  
July 2020

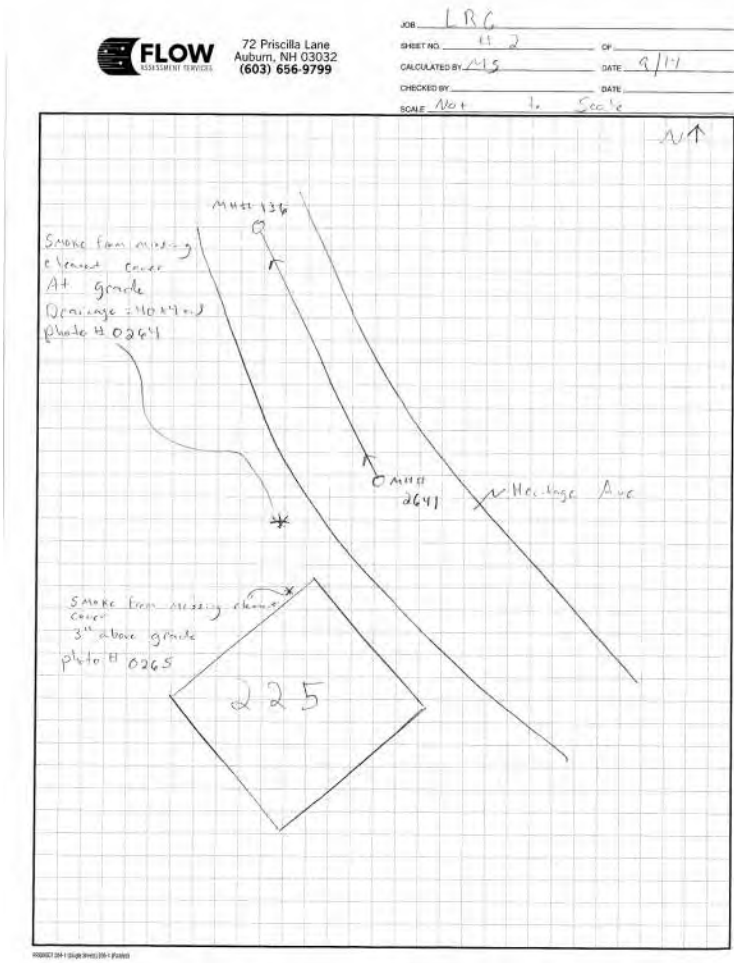
Sketch #: Subarea LR6 Sketch#2.tif

Findings:	Drainage Area SqFt	Runoff Coeff
Smoke from cleanout missing cover, 3" above grade - direct connection	0	0

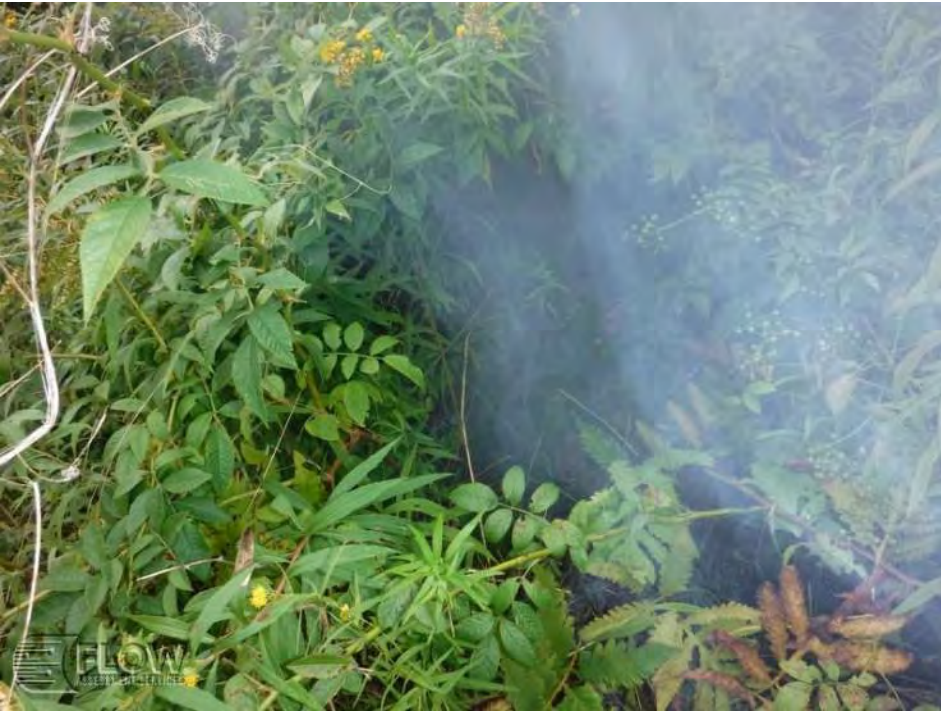
Image #: 0264.JPG

Findings:	Drainage Area SqFt	Runoff Coeff
Smoke from cleanout missing cover, at grade - direct connection	160	0.3

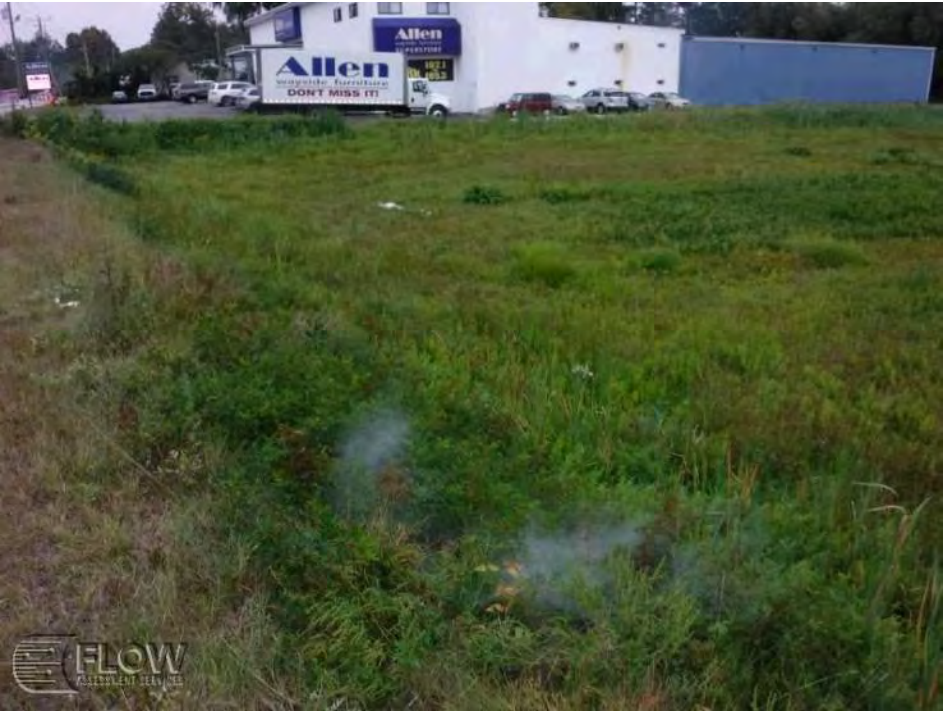
Image #: 0267.JPG

Findings:	Drainage Area SqFt	Runoff Coeff
MH 2479 is buried - footages combined. Smoke from ground near approximate location of MH 2479 - direct connection	30	0.3

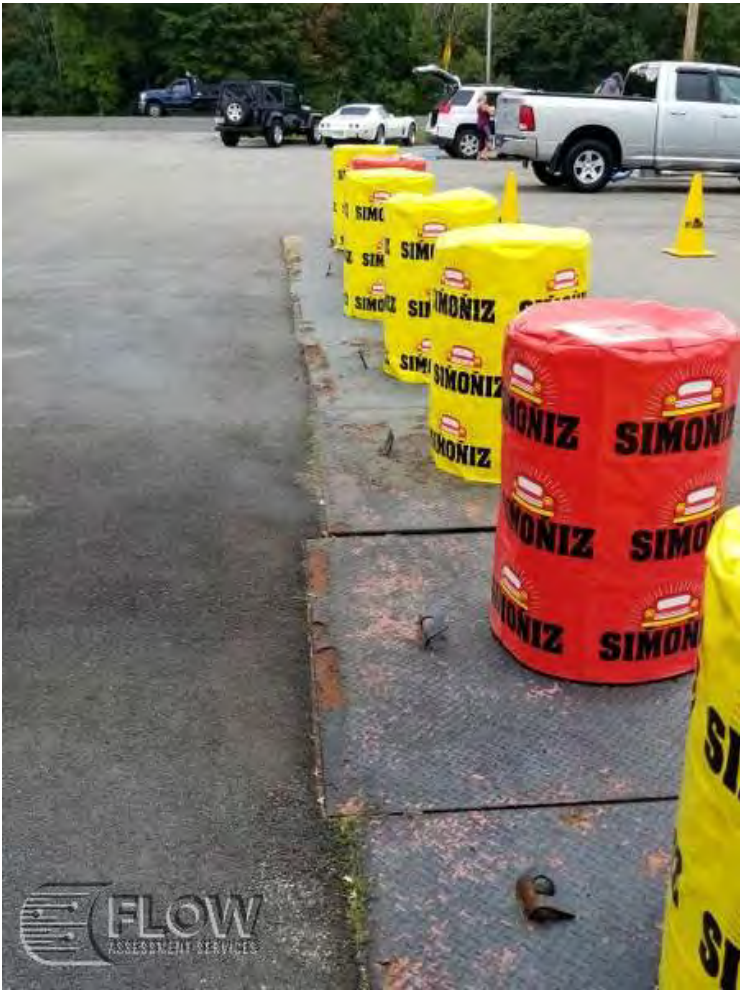
Image #: 20180913\_105548.jpg

Findings:	Drainage Area SqFt	Runoff Coeff
Smoke from metal plates and cracks - direct connection	0	0

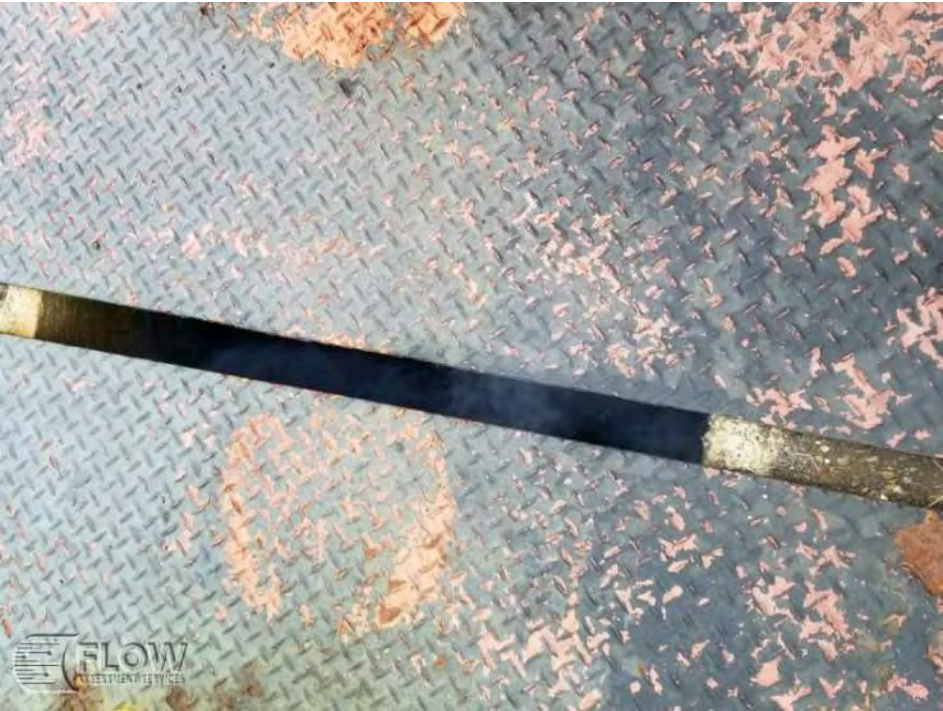
Image #: 20180913\_105604.jpg

Findings:	Drainage Area SqFt	Runoff Coeff
Smoke from metal plates and cracks - direct connection	0	0

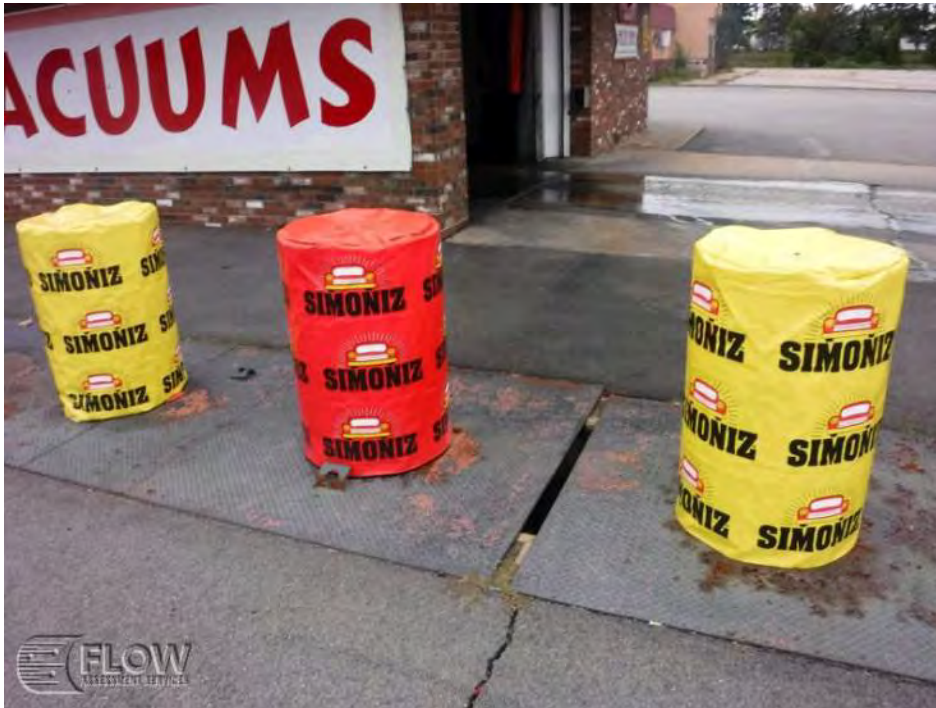
**Image #:** 0263.JPG

Smoke from metal plates and cracks - direct connection

Findings Address	Findings	Drainage Area SqFt	Runoff Coeff	Photo No.	Sketch No.	Insp. Date
275 Constitution Avenue	Smoke from loose cleanout cover 6" above grade - direct connection	0	0	0262		09/14/18
225 Heritage Avenue	Smoke from cleanout missing cover, 3" above grade - direct connection	0	0	0265	2	09/14/18
225 Heritage Avenue	Smoke from cleanout missing cover, at grade - direct connection	160	0.3	0264	2	09/14/18
Lafayette Road	MH 2479 is buried - footages combined. Smoke from ground near approximate location of MH 2479 - direct connection	30	0.3	0267	3	09/14/18
2468 Lafayette Road	Smoke from metal plates and cracks - direct connection	800	0.9	0263	1	09/14/18
