76 Congress St.
Portsmouth, NH 03801

Renovations
to Existing
Tenant Space

2019-3-6 HDC submission

1st floor tenant
space renovations

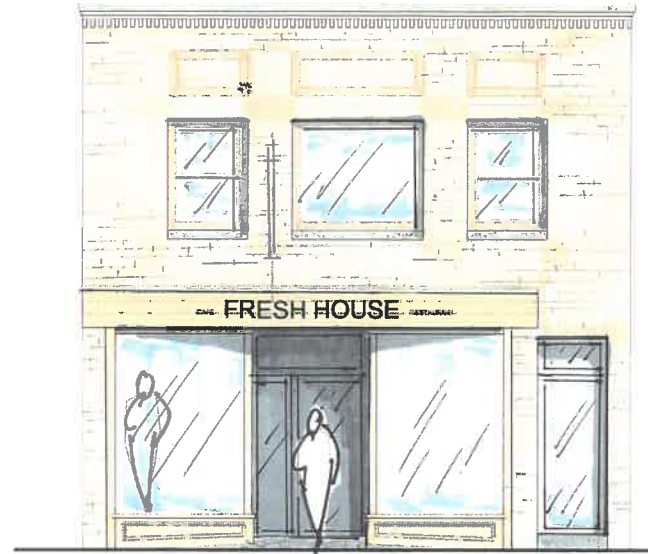
Elevation Option 3

Existing "approved" elevation w/ recessed panels below windows & existing sign board above - boards to be replaced

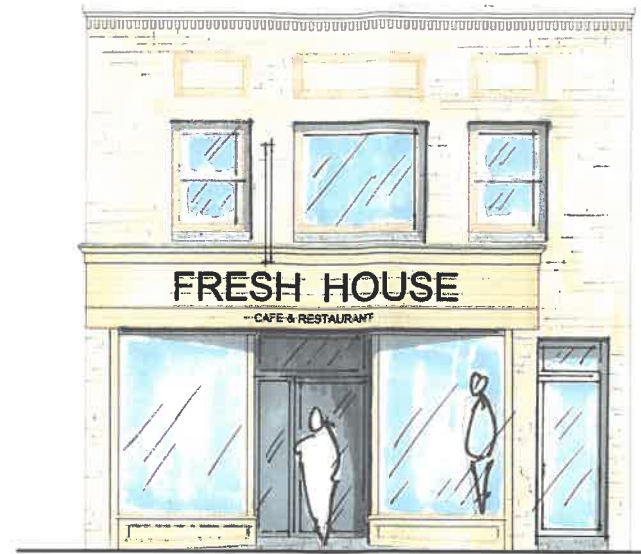
Elevation Option 2

More traditional look w/ heavy entablature/signboard centered over windows below extending up to the bottom of window sills at second floor above, recessed panels below windows

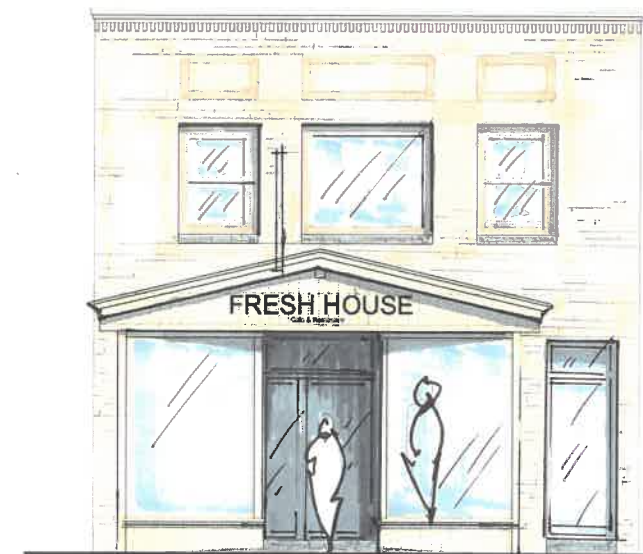
Elevation Option 1

Renovated storefront w/ open pediment & traditional moulding detailing @ rake w/ vertical boards in the pediment and below the storefront windows - stained natural wood or painted
Natural wood blends w/ yellow brick, paint alternative would be a cream color similar to the previous storefront

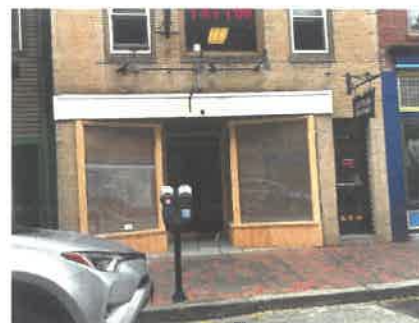
2 - 2018 facade w/ vertical panels below new storefront windows & previous sign board above

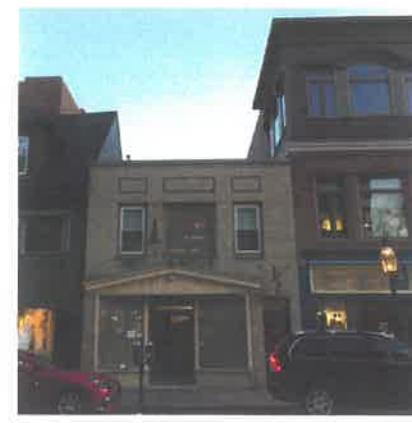
3 - 2018 facade w/ new pediment & signboard above storefront

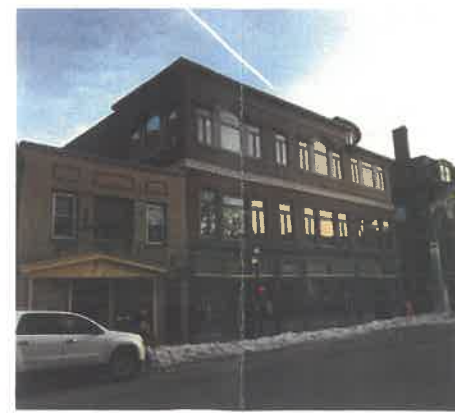
5 - 2018 view down Congress St. w/ facade modifications
