# appendix a

EXISTING INFRASTRUCTURE REPORTS AND MAPPING

Re: Prescott Park Master Plan

Subject: Summary of Subsurface Utility Conditions  
Prescott Park  
Portsmouth, New Hampshire

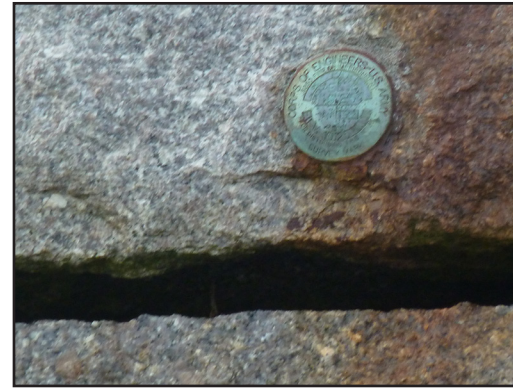
2. Quaywall  
Survey marker

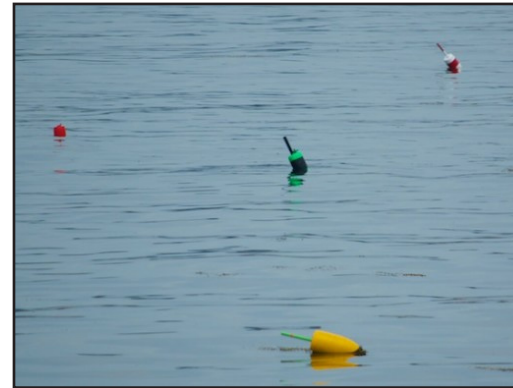
4. Harbor  
- Lobster Pots  
- Floats  $\pm 2$  feet with 2-3 traps each

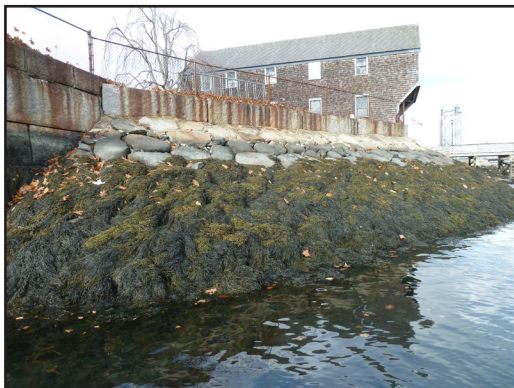
5.  
Top course to be mortared.  
(Sheafe warehouse in background)

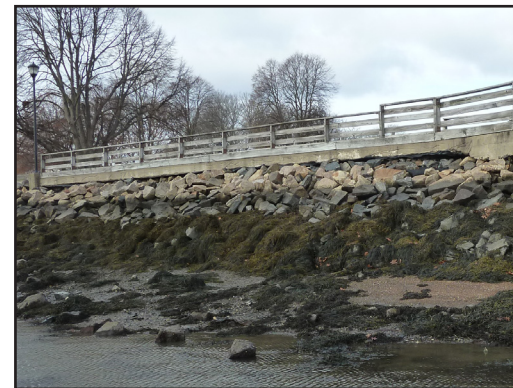
6. South pier  
Undermining of concrete

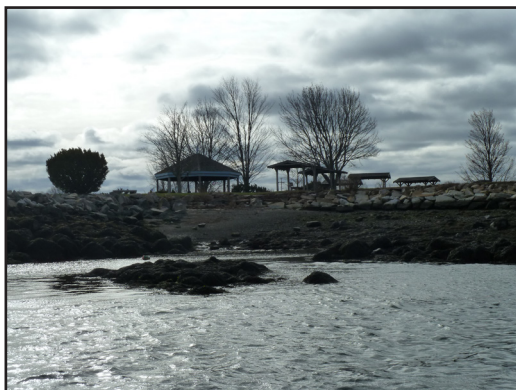
23. Four Tree Island  
Beach at northeast end of island

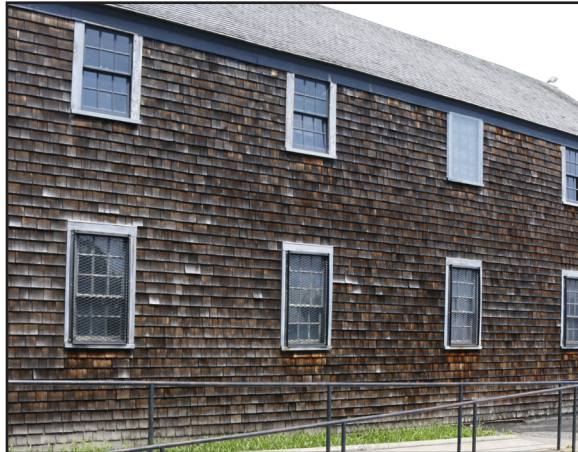
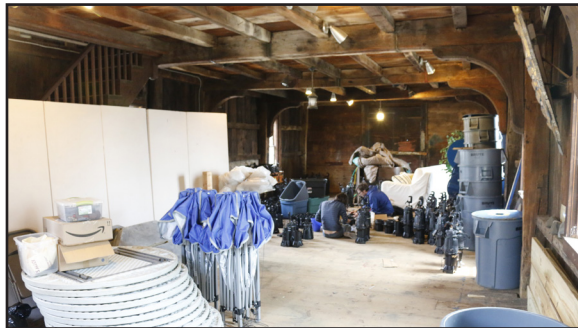
Doors: Painted wood, in generally good but weathered condition. These include the main access double doors as well as river-side and upper-level loading doors.

Windows: Painted wood, in generally good but weathered condition. Some windows have with applied expanded-metal security grilles. In some places the casing nails have worked out by an inch or more, probably due to extreme wet/dry cycling.

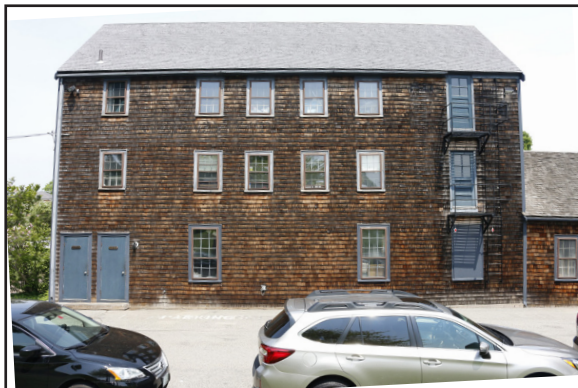
Roof: Simple longitudinal gables, with the three Sections at different heights; wood roof shingles on Sections 2 and 3, in generally good but weathered condition, asphalt shingles on Section 1. Wood gutters and downspouts are present; some gutters are loose and deflected. Downspouts (rain leaders) are missing at the rear (North) side of Section 3. There is a brick chimney at the East end of Section 2.

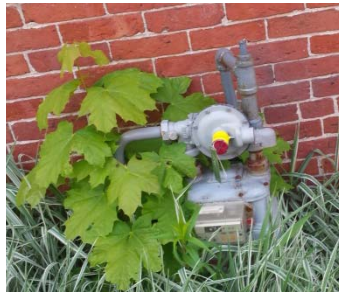
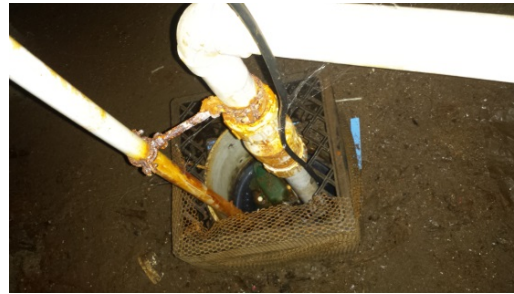
both hard and flexible duct. The ductwork is in poor condition overall and the installation does not meet current SMACNA standards. Air registers are impromptu. Mechanical ventilation consists of two exhaust fans of unknown size. Some of the exhaust has been connected to what appears to be an old cast iron abandoned plumbing vents. One of the exhaust fans exits the side of the building. One of the office spaces on the upper floor has a floor mounted, portable air conditioning with the condenser heat rejection ducted to an adjacent window. There is a small, abandoned, approximately 50 gallon, stand mounted, fuel oil tank in the basement that is about half full. It is in a very poor condition and is in danger of failure.

- **Plumbing.** The building is served by a 1-inch natural gas service. Domestic hot water is served by a small electric water heater located in the basement. There is a pit mounted submersible sump pump.

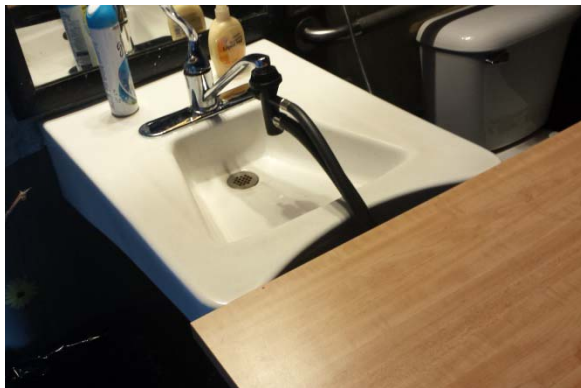
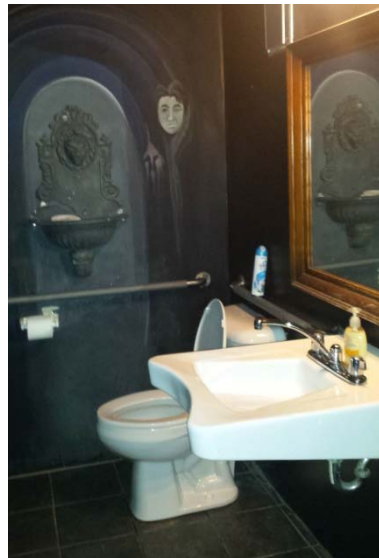
There are two handicapped accessible restrooms on the first floor that are located in the office area of the Players Ring theater with a residential tank type toilet and lavatory each. One of the lavatories has a portable dishwasher connected to it.

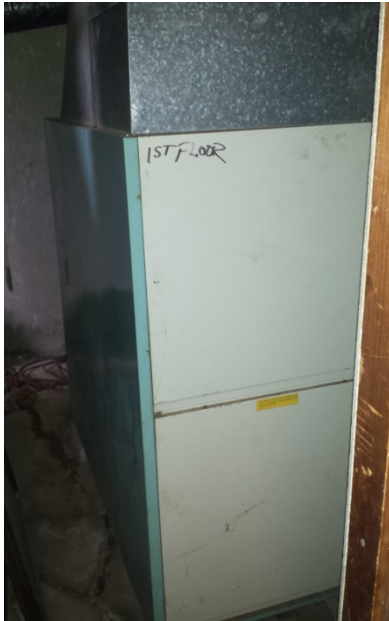
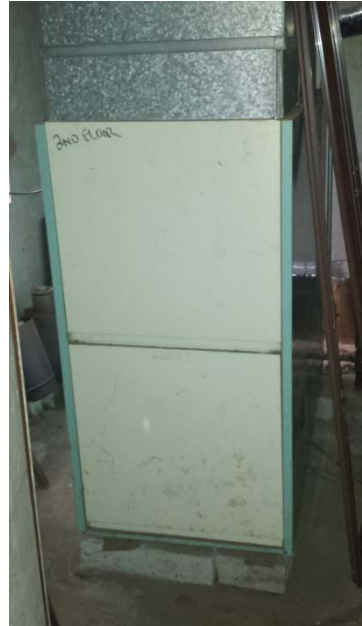
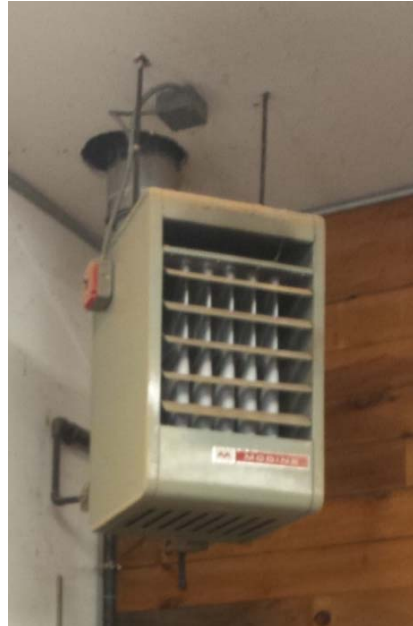
**HVAC.** The HVAC system in the Shaw Warehouse includes two (2) ducted, gas fired Williamson Temp-O-Matic furnaces, one serving each floor. The units provide recirculated, heated air to each floor by ceiling mounted galvanized ductwork. There is a gas fired, ceiling hung, Modine unit heater serving the back single story shop area.

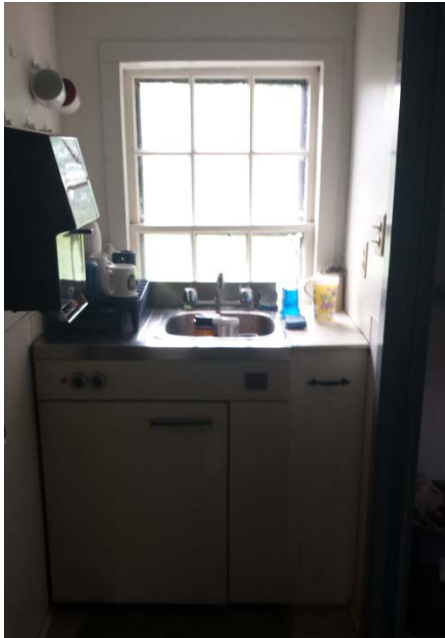
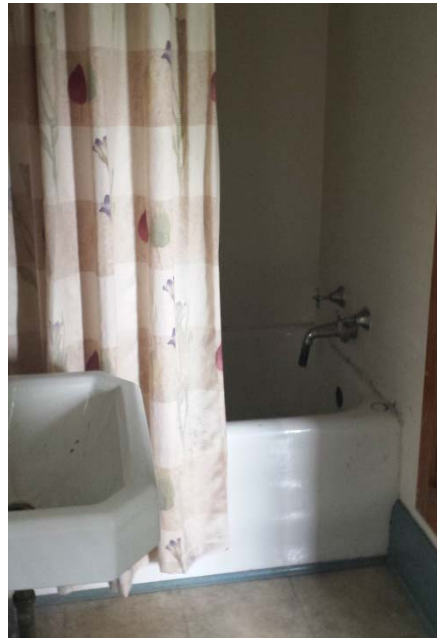
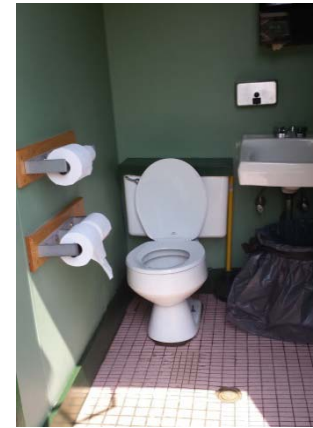
- **Plumbing.** There are two (2) non-handicapped accessible restrooms that are public access from the outside of the building. The restrooms are equipped with floor mounted, residential tank style, toilets, non-accessible lavatories and floor drains. The men's room has a wall hung, urinal with a low flow flushometer. Domestic hot water for these restrooms is provided by an approximately 40-gallon Rheem electric hot water heater. There is a water fountain and a plastic deep sink located next to the water heater.

There is a residential style kitchen sink and bathroom on the second floor. The bathroom has a standard tub, a non-accessible lavatory and a floor mounted, residential tank style toilet.
