# 179 PLEASANT STREET

HDC WORK SESSION #4 APPLICATION TO AMEND PREVIOUS APPROVAL: AUGUST 3, 2022

Structural Condition Assessment Connector, Barn and Carriage House Captain Thomas Thompson House 179 Pleasant Street Portsmouth, New Hampshire

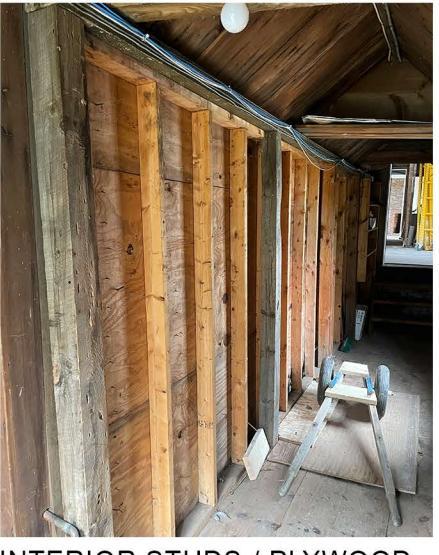
INTERIOR STUDS / PLYWOOD

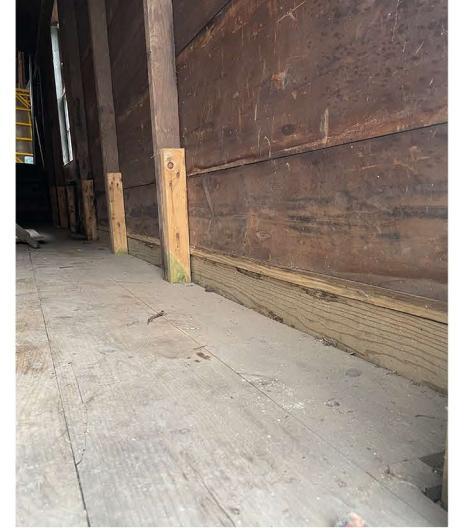
PRESSURE TREATED SILL REPAIR

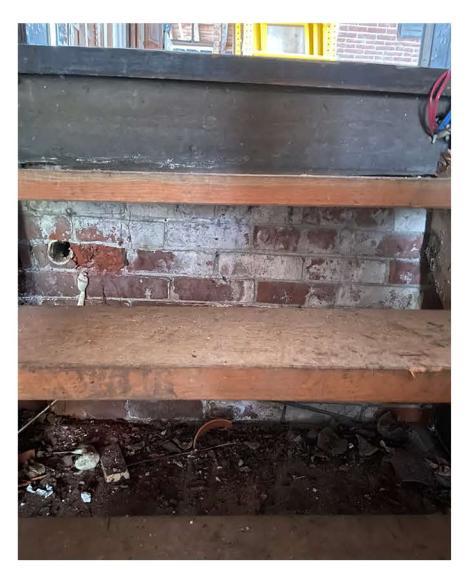
BRICK FOUNDATION

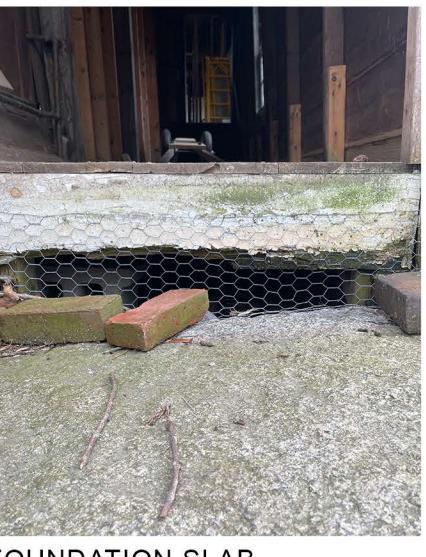
FOUNDATION SLAB

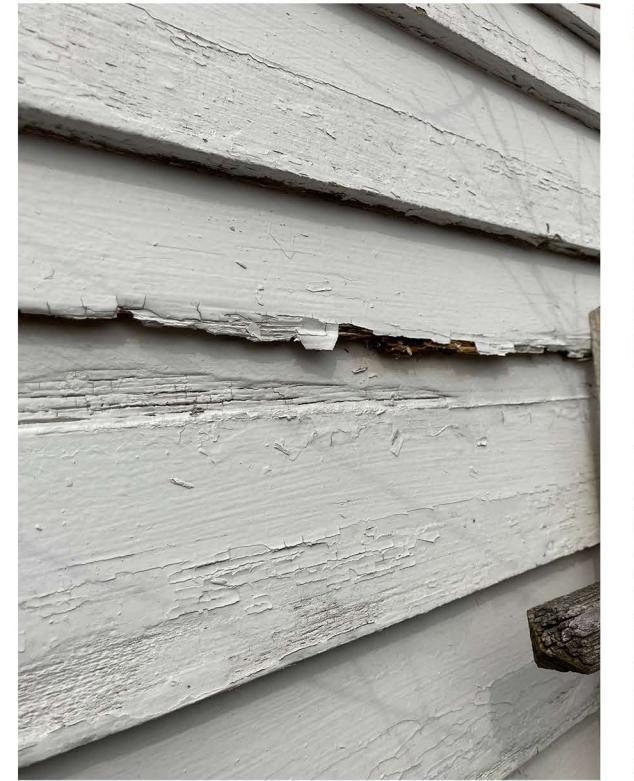
TYPICAL SIDING ROT

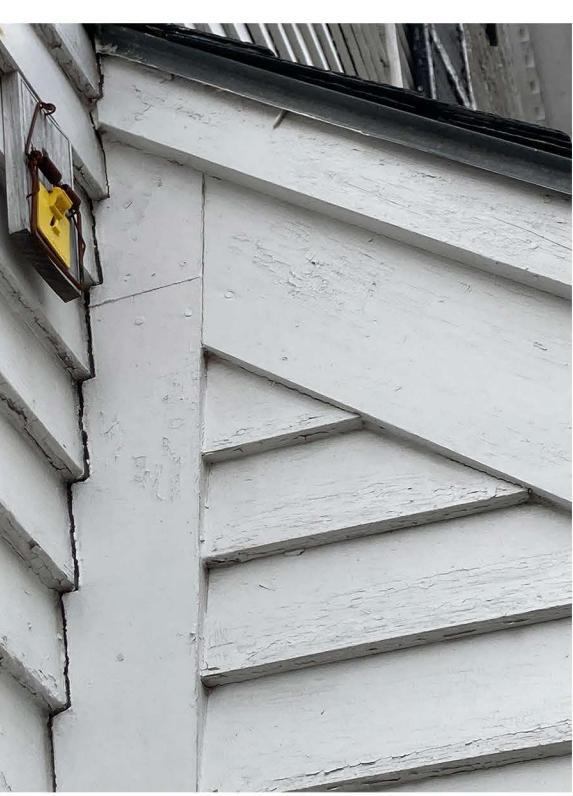
CORNER BOARD NOTCHED AGAINST ANNEX SIDING

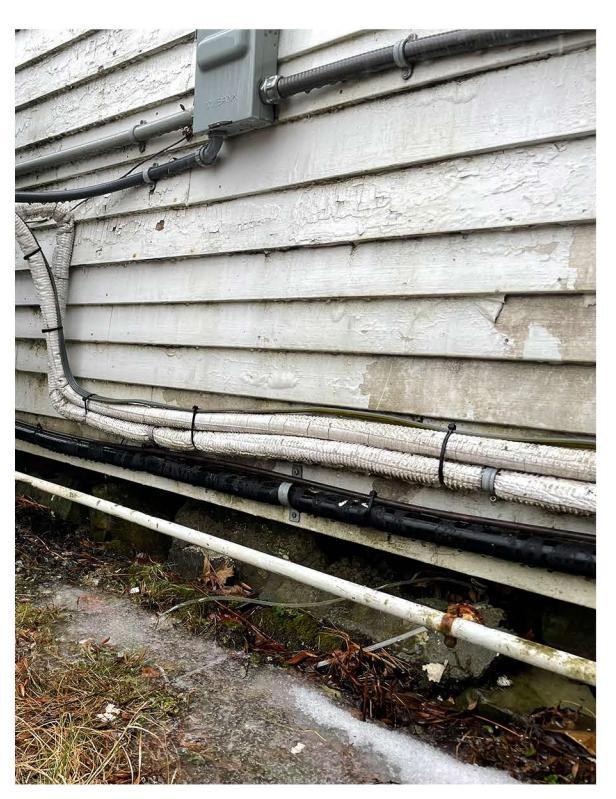
STONE RUBBLE FOUNDATION

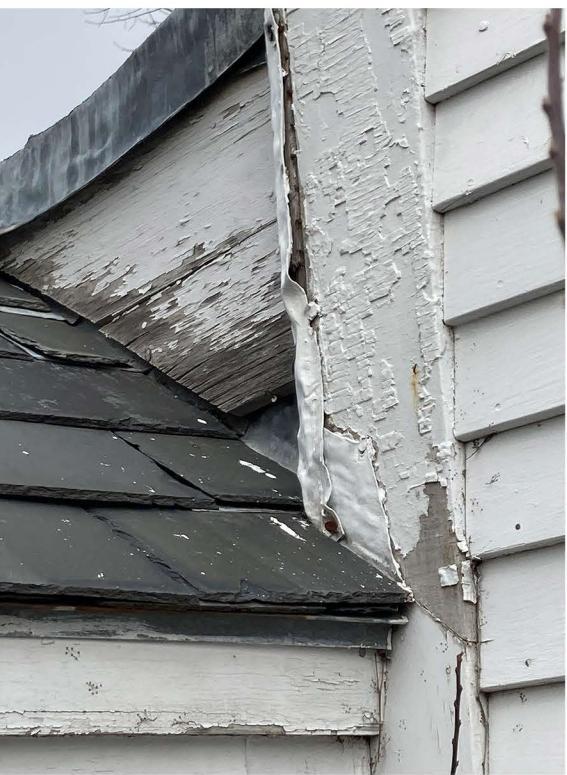
INTERSECTION WITH CONNECTOR AT ROOF

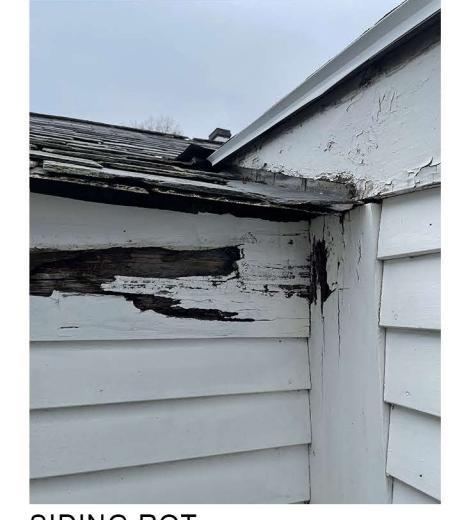
SIDING ROT

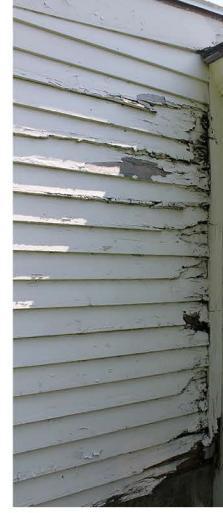
SIDING ROT

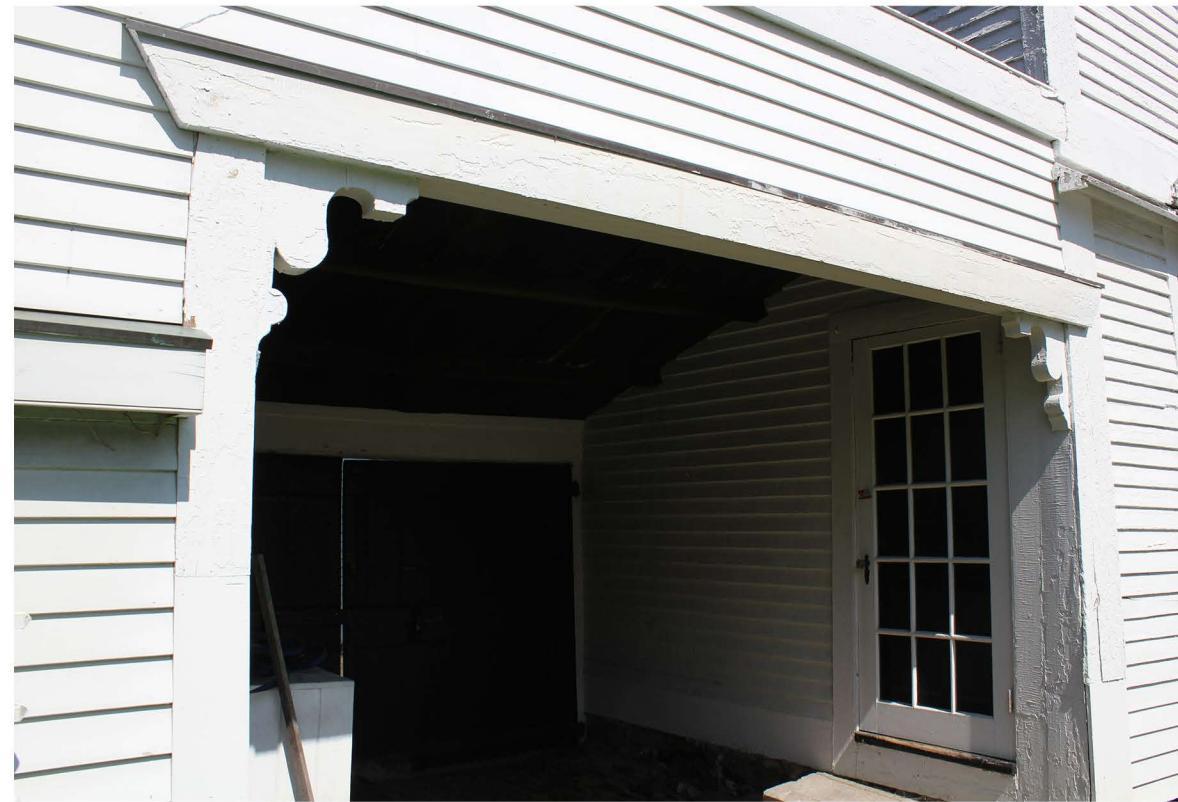
POSSIBLE HISTORIC CORBEL

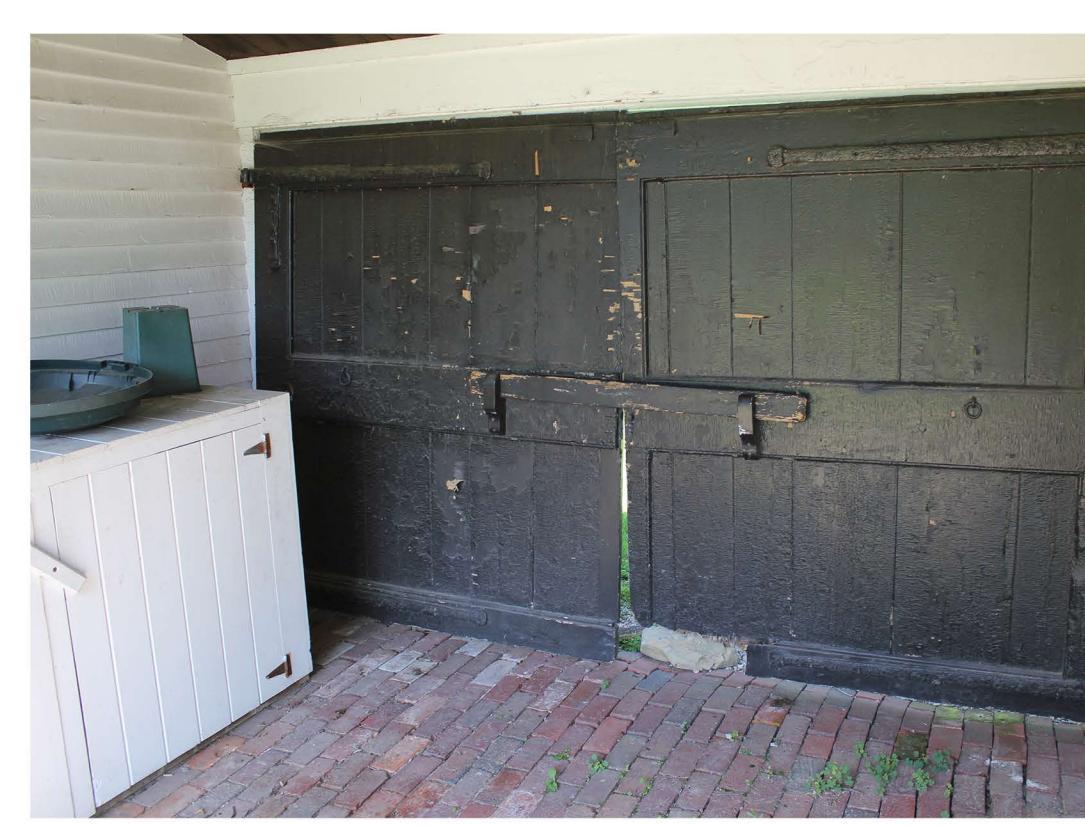
POSSIBLE HISTORIC DOOR WITH HISTORIC HINGES

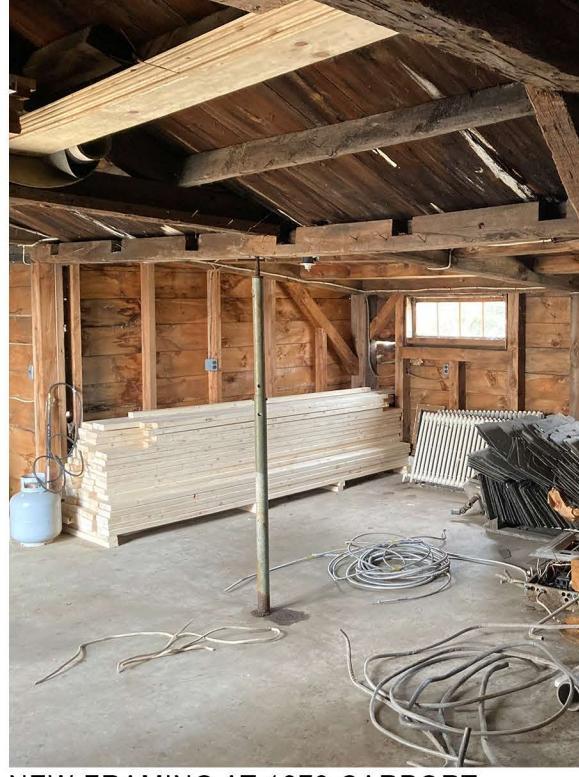
NEW FRAMING AT 1979 CARPORT

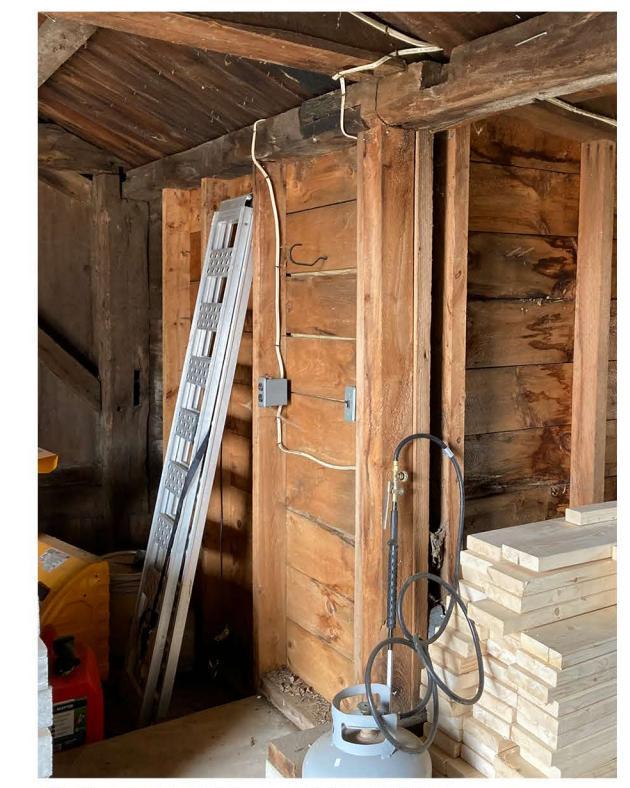
NEW FRAMING AT REAR WALL

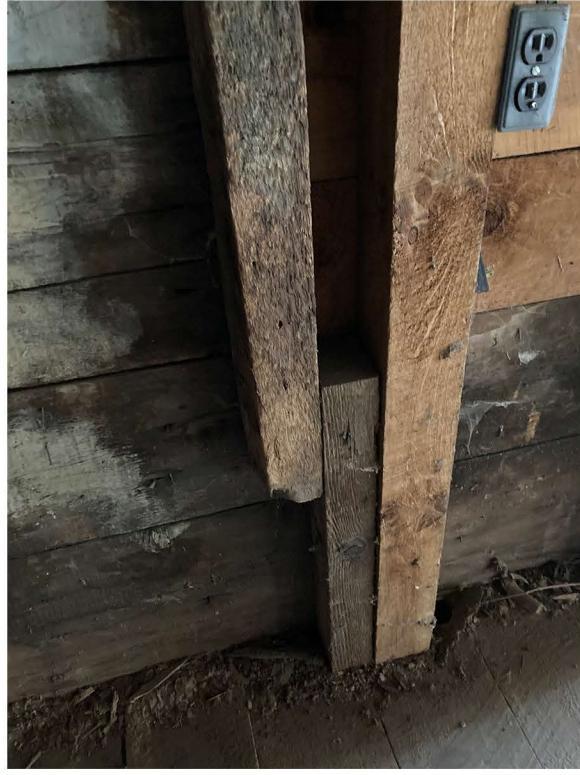
TYPICAL FRAMING AT FRONT WALL

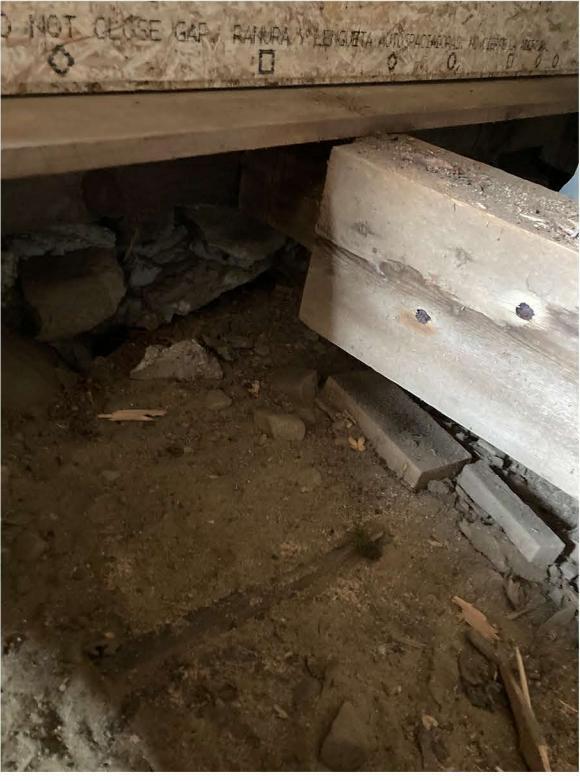
TYPICAL FLOOR FRAMING MADE UP OF REPURPOSED BEAMS

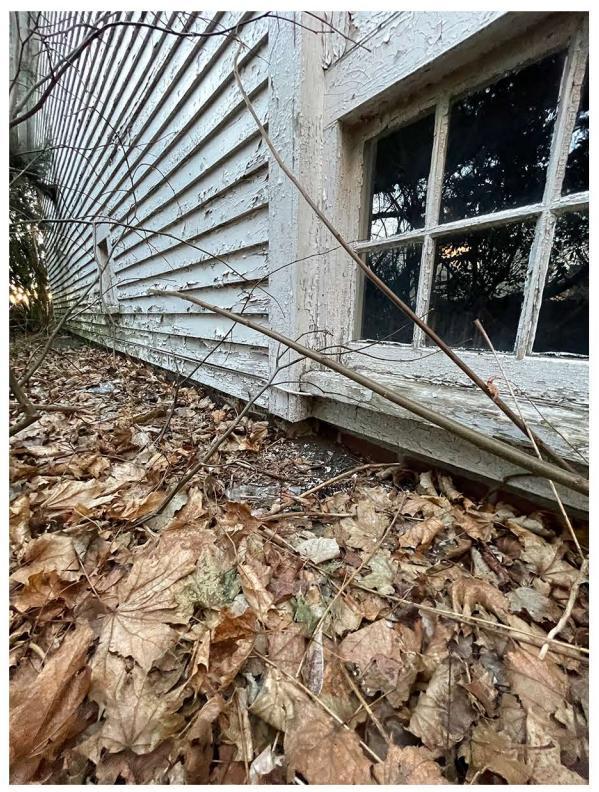
NEW WINDOW REPAIR

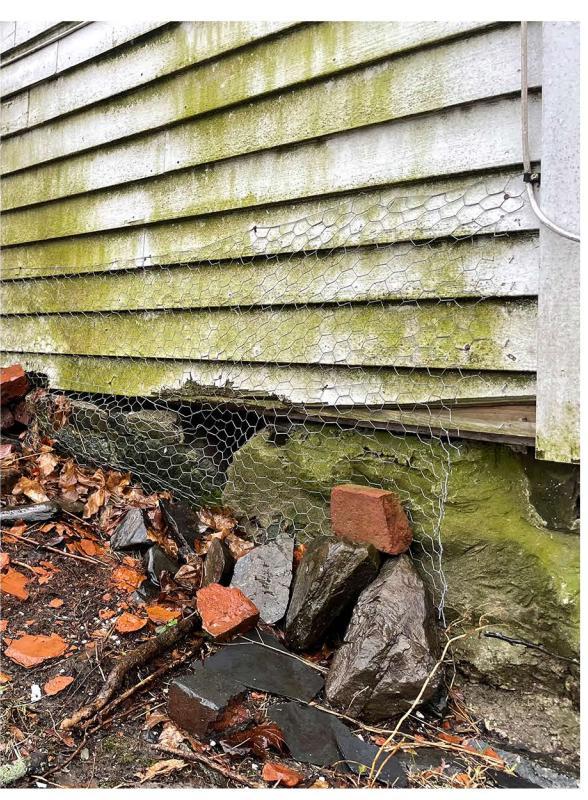
STONE RUBBLE FOUNDATION AND NEW SIDING REPAIR

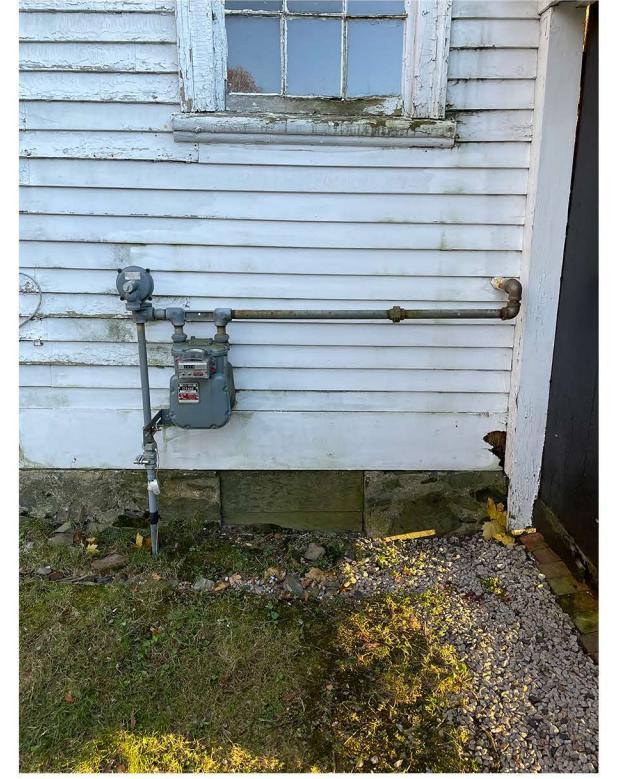
NEW SIDING REPAIR

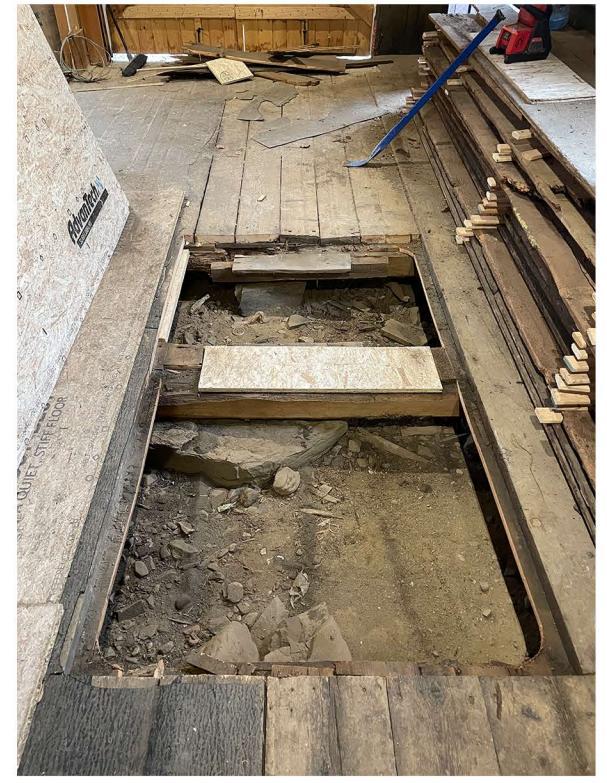
TYPICAL BEAMS IN DIRECT CONTACT WITH GROUND

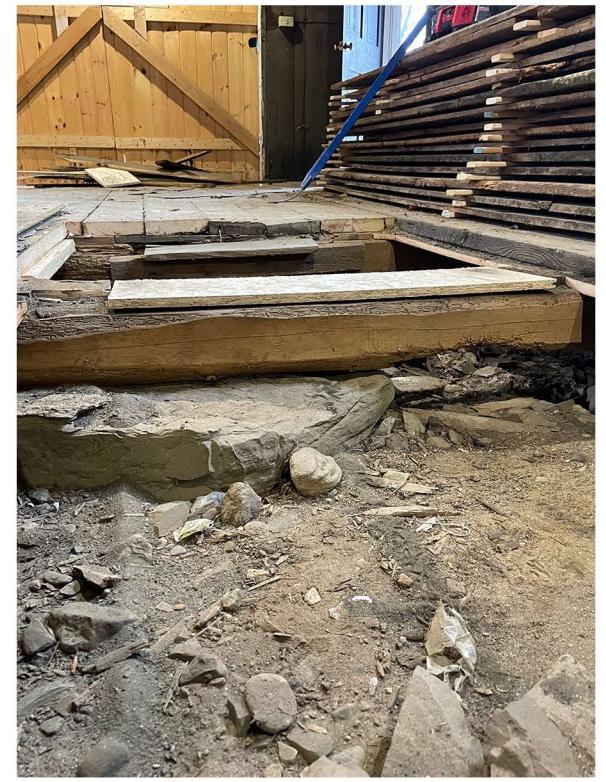
TYPICAL BEAMS IN DIRECT CONTACT WITH GROUND

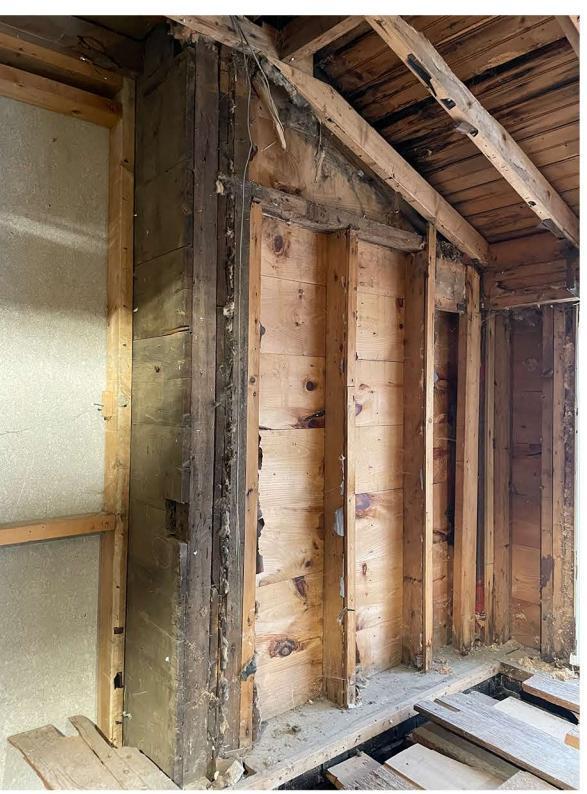
TYPICAL NEW FRAMING

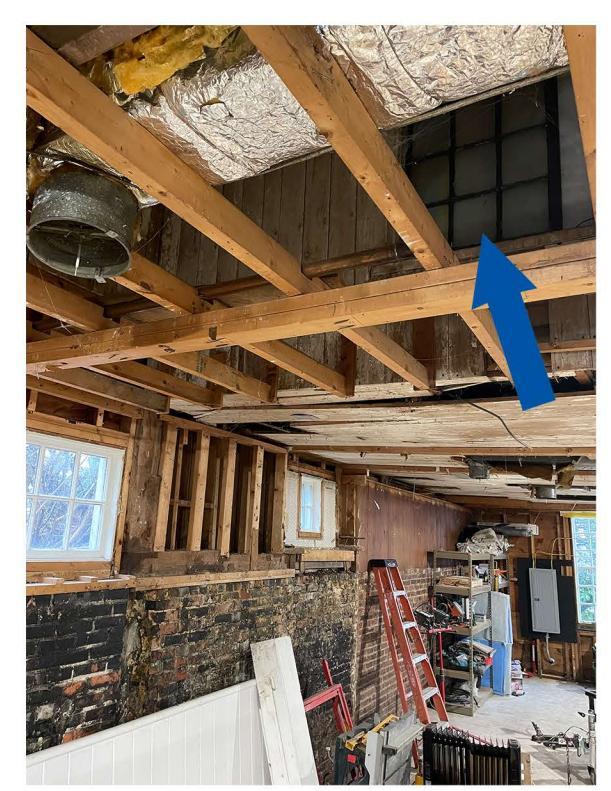
EXISTING WINDOW LOCATED AT REAR OF ORIGINAL CARRIAGE HOUSE BLOCK

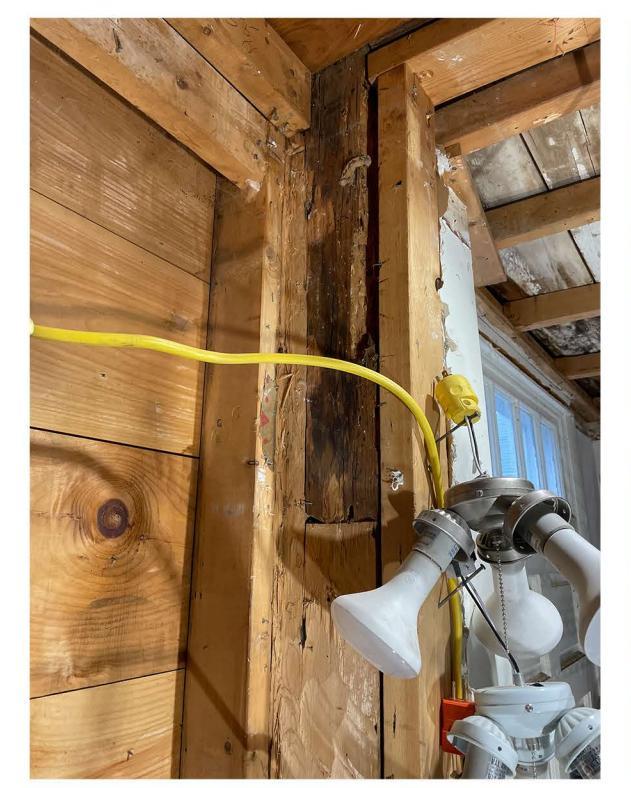
TYPICAL NEW FRAMING COMBINED WITH OLDER MODIFIED FRAMING

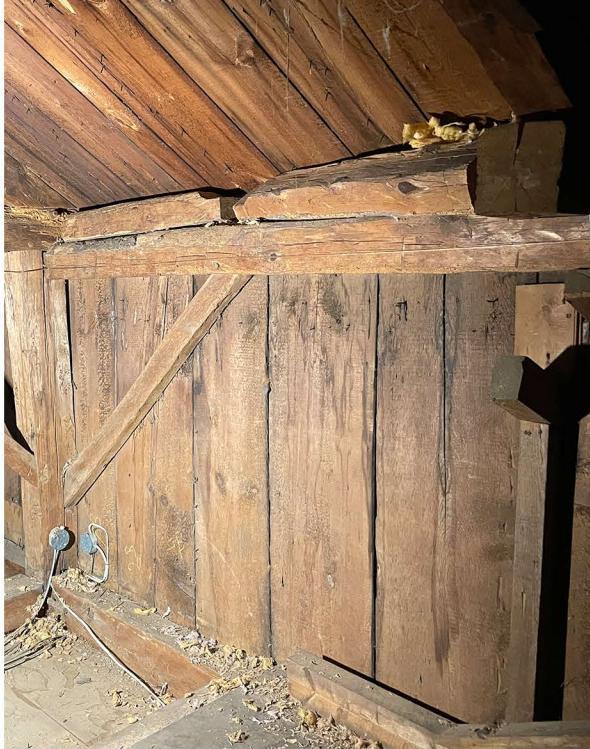
OLDER FRAMING MEMBERS HAVE BEEN MODIFIED, REMOVED, OR RELOCATED. (SECOND FLOOR OF CARRIAGE HOUSE)

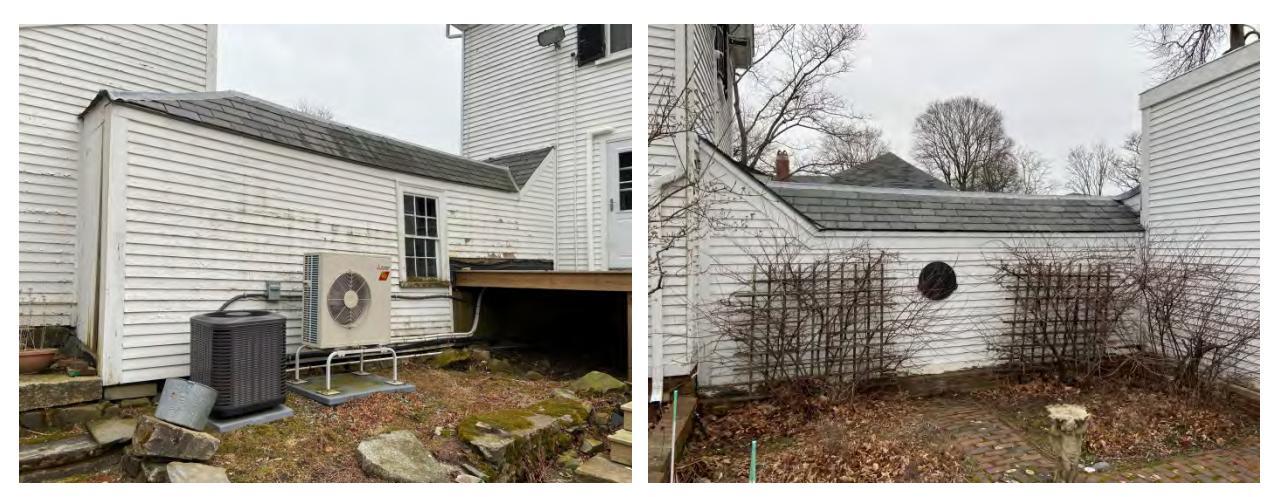
1-Connector north elevation

The connector foundation is made of loosely spaced stone supporting a timber plate. The exterior grade along the north side is about 1-foot below the top of the foundation wall. The exterior grade along the south side is approximately at the same elevation as the interior wood floor. Brick masonry cladding has been added along the outside face of the south wall in an attempt to provide some decay protection to the wall and timber sill. The top of this brick cladding is about 1-foot above the exterior grade and interior floor and covers decaying wall sheathing. (Images 1 - 5)

The connector construction is haphazard, with a sloping floor, walls out of plumb, and techniques that would be considered unconventional for any time period. The brick masonry cladding wall does not provide sufficient or appropriate decay protection for the wood framing materials.

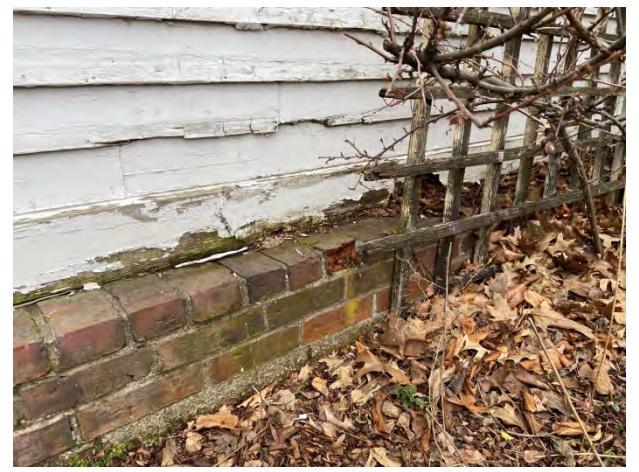
3-Connector brick cladding on south side

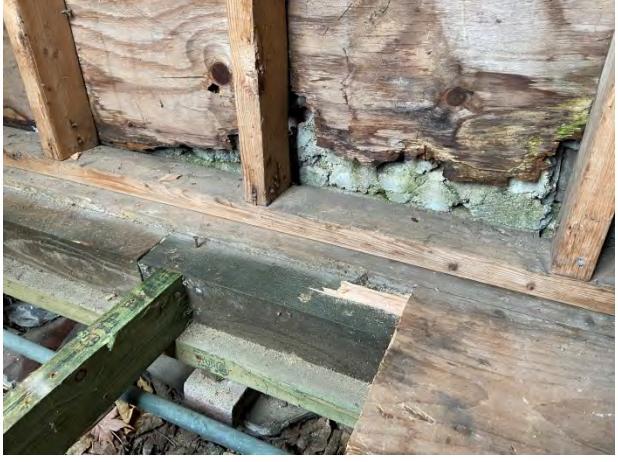
4-Connector inside face of brick cladding

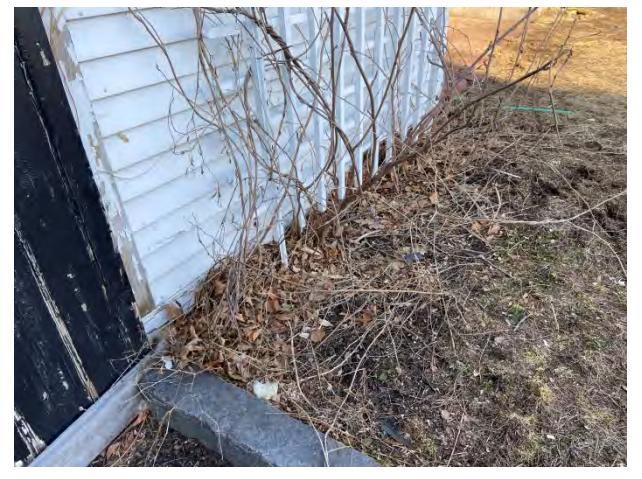
9-Siding extending below grade

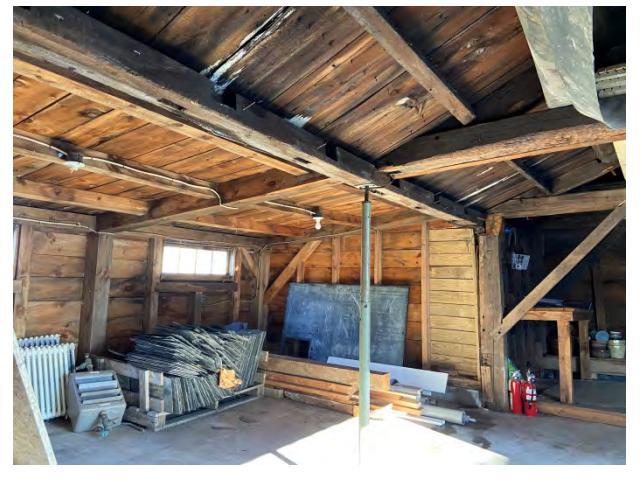
11-Inside looking north

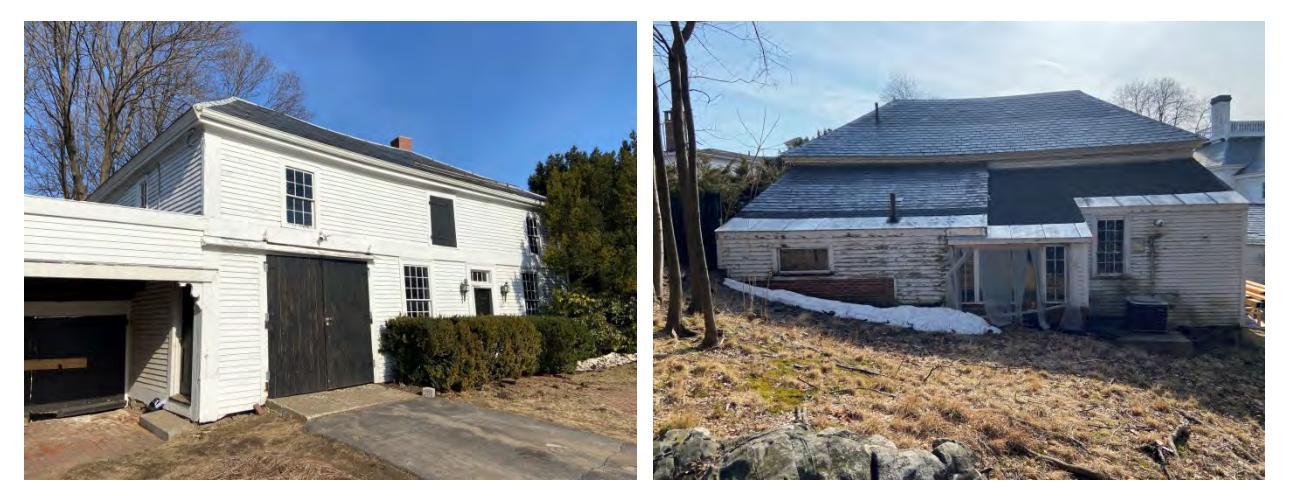
The carriage house was originally constructed as a 26'-3"x40'-6" story and a half timber frame hiproofed structure. A subsequent renovation added a one story shed extension along the entire back of the building. (See image 17 and 18)

17-Carriage house east elevation

18-Carriage house northeast elevation

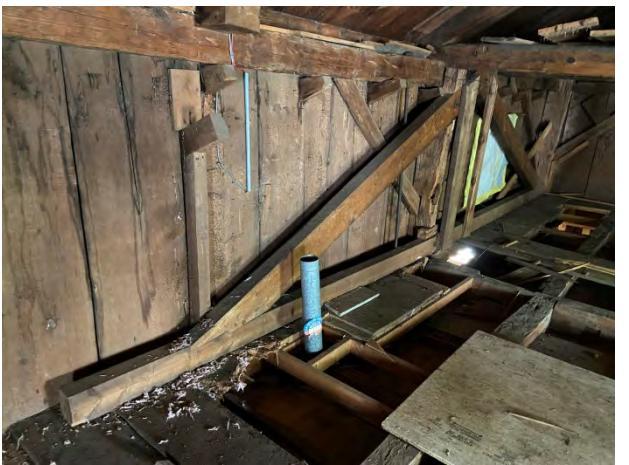
23-Modified framing to bridge over the removed post and wall at lower level

At the intersection of grid lines 8 and C, (SK-A) the balloon post was cut and removed at the first floor level. In an effort to compensate, truss-like diagonal framing was installed at the second floor wall along line C, to bridge over the removed post. (See image 23 and 3/SK-E)

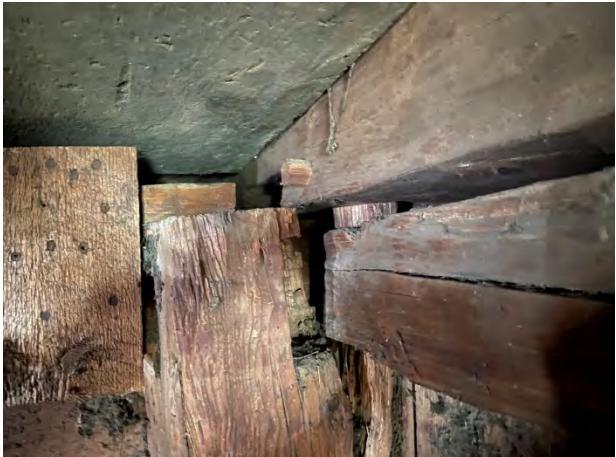
24-Vertical split at corner post

Looking at the building from outside, it can be observed that there is significant distortion, or deflection, along the ridge, the hips and in the plane of the roof itself. Looking inside the building at the top of the corner post, we can observe the vertical split in the post where the hip rafter is being pushed outward. (See image 24)

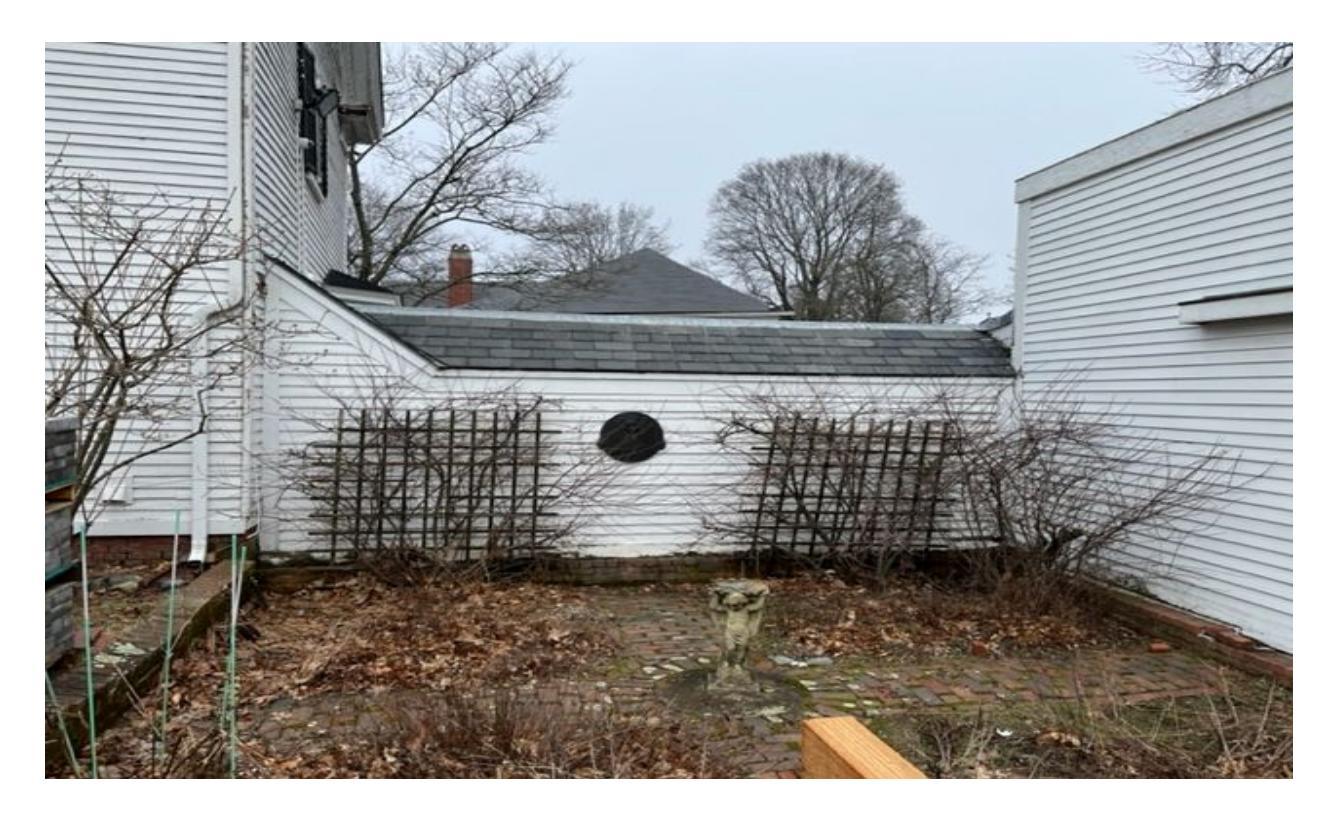
### **Dog Leg Connector:**

The front elevation exterior trim and clapboards have all been replaced and have no signs of original materials. The back elevation has older clapboards installed on a portion of the wall system. The clapboards have a very steep lap joint that overlaps by roughly 2". This indicates older siding practice and thus older material. The nails used to secure the siding and the steep lap joints however, do not match the siding details on the mansion. This suggests a different period for the installation of the siding on the dog leg connector.

Another key detail is how the dog leg connector buts into the annex and barn/connector. The corner boards and fascia are cut into the other structures and in some points scribed around the other structures. Again, this suggests that this building postdates the annex and even the barn/connector.

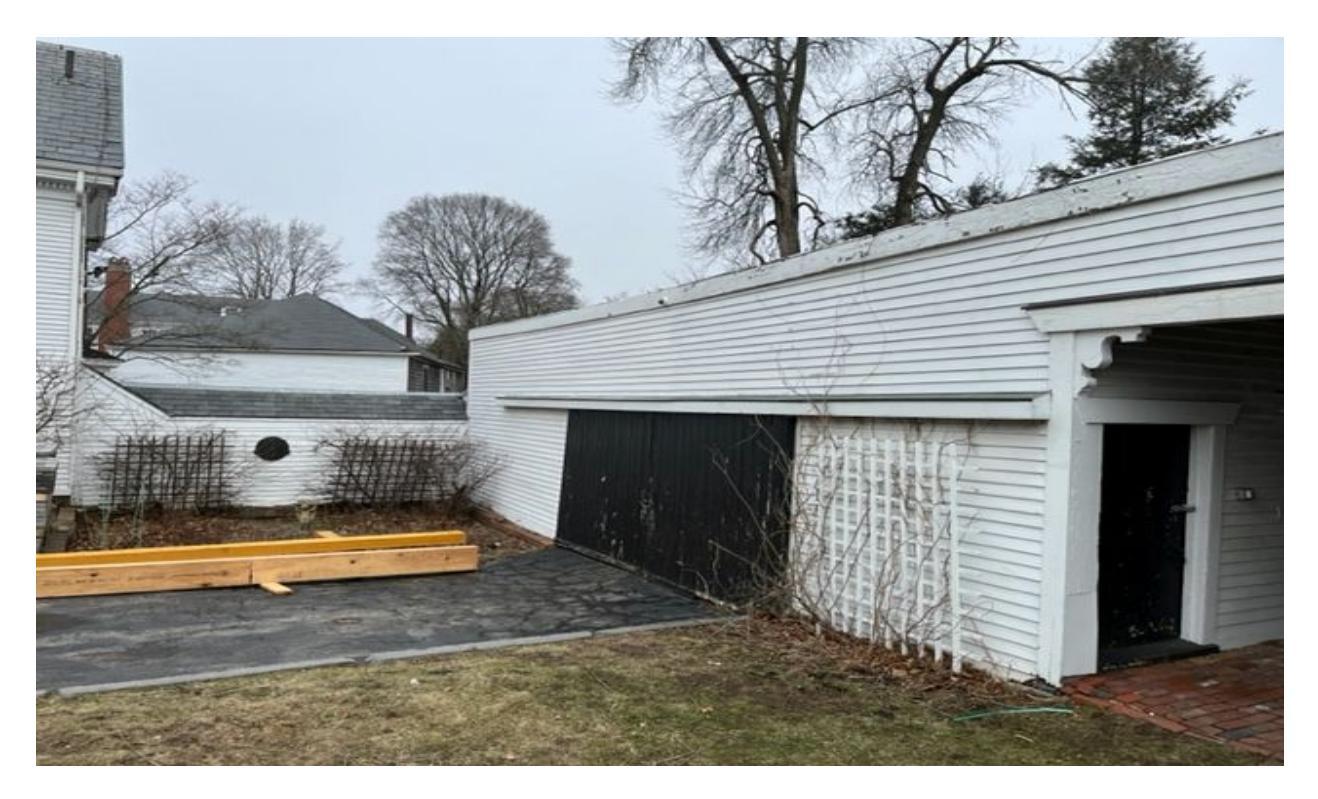
## **Barn/Connector:**

The barn/main connecting structure also exhibits signs of significant renovation work over the years. Through our research we know that the front wall was reframed to accommodate a larger sliding door in 2018. A 10' x 16' "carport" was added to the back side of the structure in 1979. In reviewing the framing most of the front wall has been removed and replaced with rough sawn material to accommodate the door renovation in 2018. Additionally, most of the roof framing was cut and altered to accommodate the carport addition in 1979.

There is little to extract from the exterior details on this structure. Most of the siding and exterior trim has been replaced or is rotted beyond any repair. The exterior wall facing the carriage house located under the open roof system is however intact. The siding on this wall has a but joints and no noticeable nail heads like the mansion.

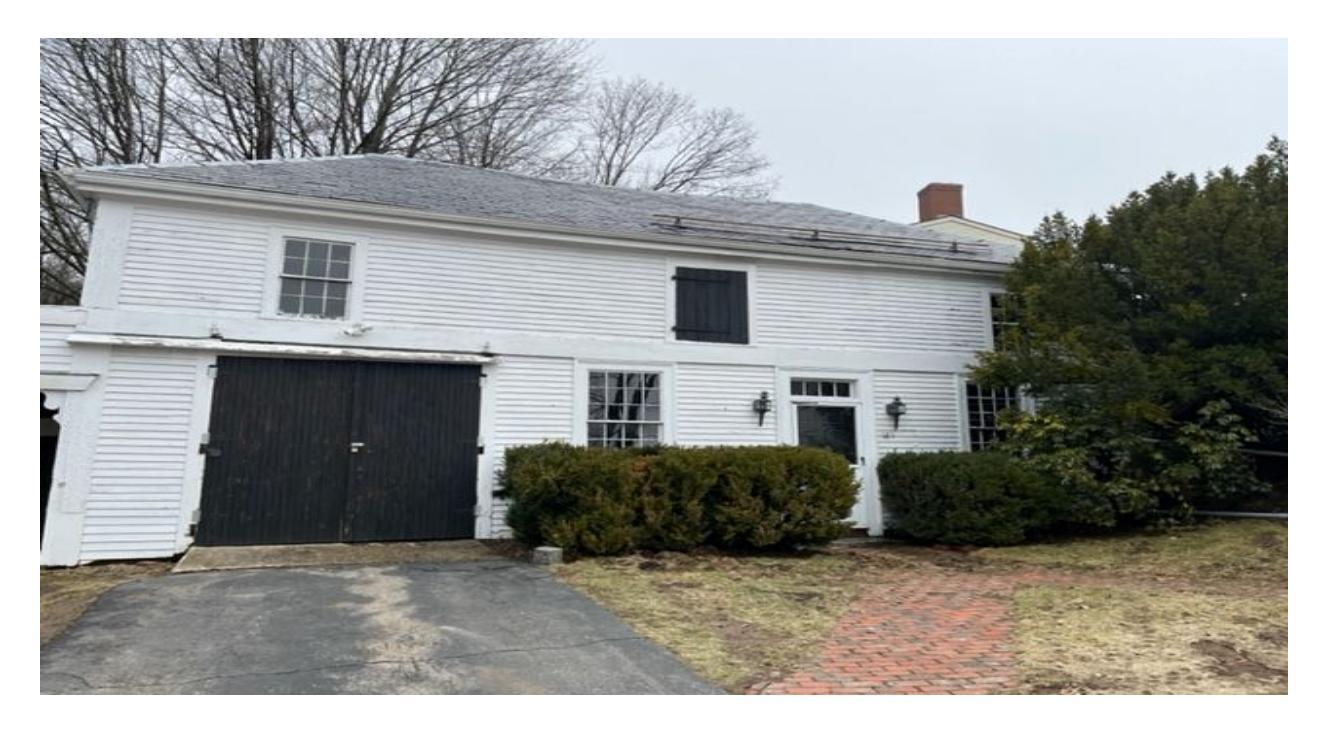
### **Carriage House:**

In 1962 the carriage house underwent an extensive renovation to accommodate a dentist office. The renovation basically removed the entire first floor walls and floor systems. There are almost no original materials left on the first floor of the carriage house to include, wall studs, sheathing, windows, doors, siding, trim, foundation. I believe they systematically removed sections of the walls while they reframed and eventually poured a concrete slab throughout most of the carriage house.

The second floor and roof system however have remained mostly intact and original to the 1784 period. The massing of the beams, the joinery methods, and the framing layouts all match the mansion framing. Some of the beams have been cut or notched over the years but for the most part the framing is intact.
