179 PLEASANT STREET
PORTSMOUTH, NEW HAMPSHIRE

HDC WORK SESSION #3 APPLICATION TO AMEND PREVIOUS APPROVAL: JULY 6, 2022

Structural Condition Assessment
Connector, Barn and Carriage House
Captain Thomas Thompson House
179 Pleasant Street
Portsmouth, New Hampshire

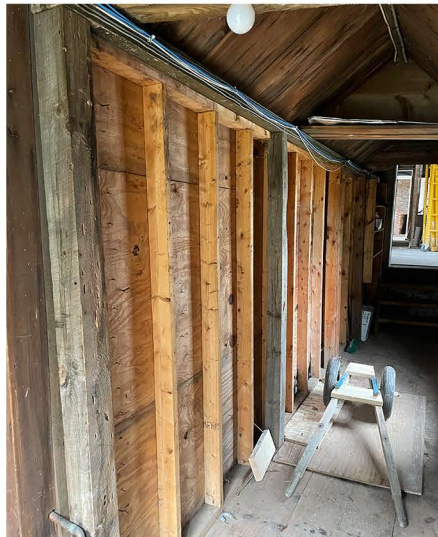
INTERIOR STUDS / PLYWOOD

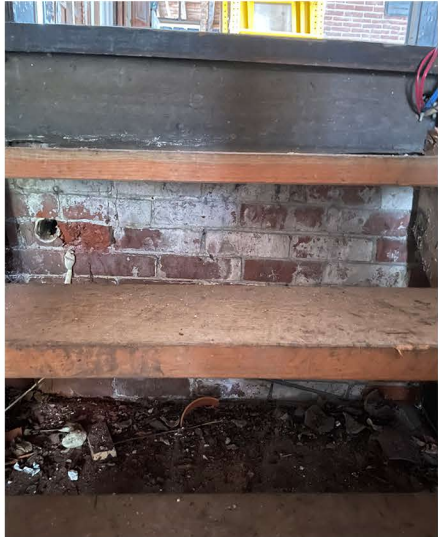
BRICK FOUNDATION

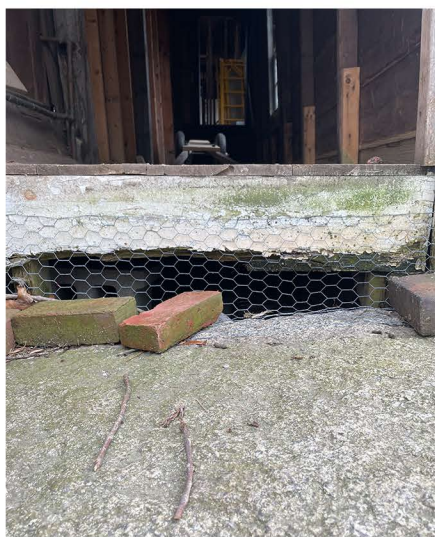
FOUNDATION SLAB

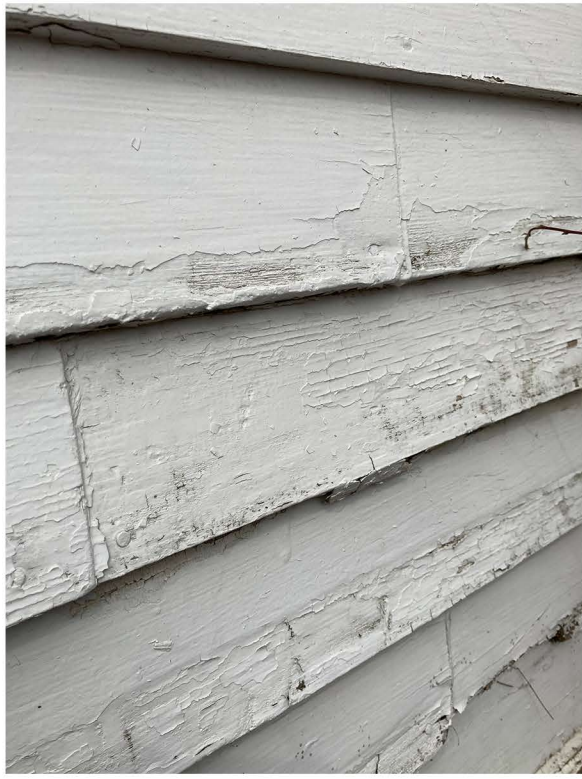
TYPICAL SIDING BUTT JOINT

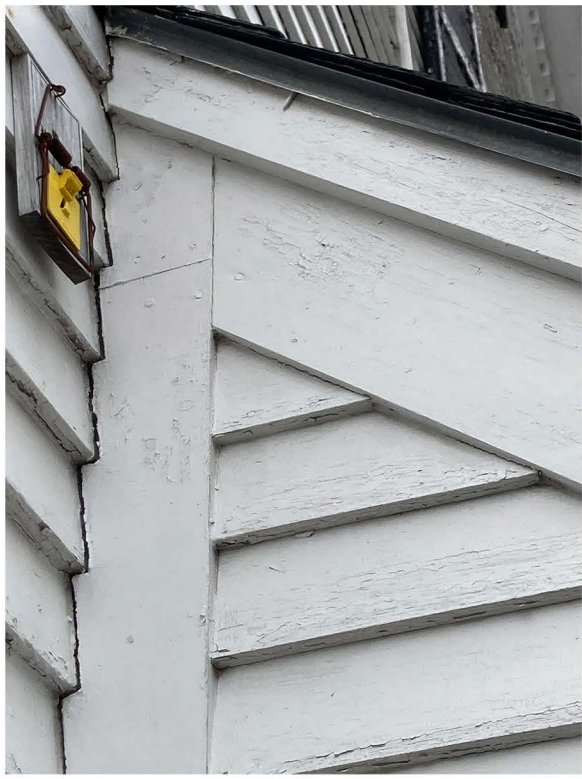
CORNER BOARD NOTCHED AGAINST ANNEX SIDING

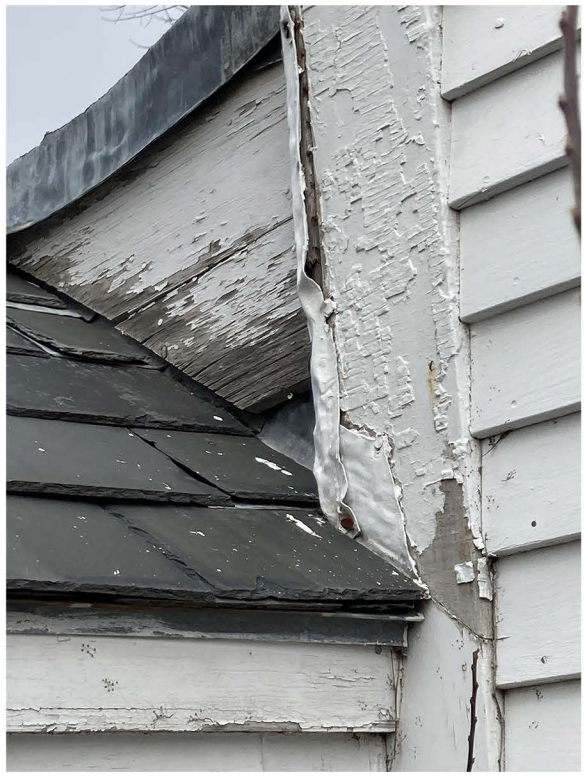
INTERSECTION WITH CONNECTOR AT ROOF

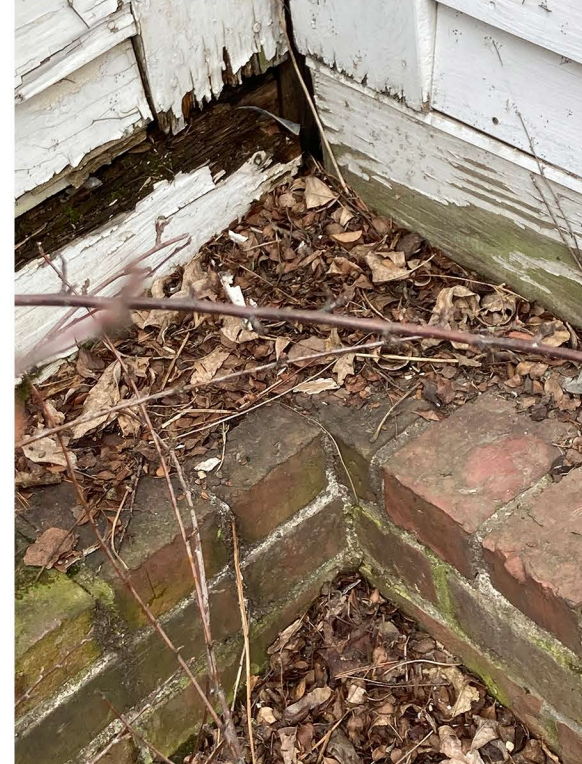
INTERSECTION WITH CONNECTOR AT FOUNDATION

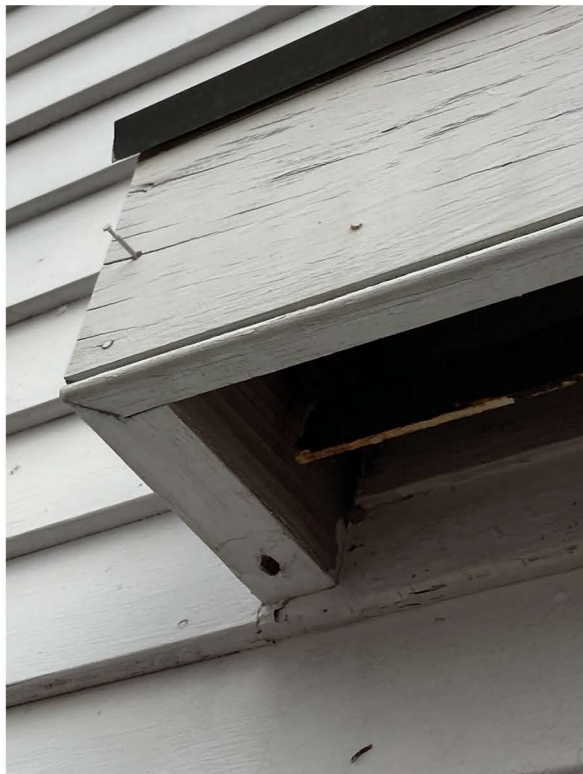
NEW BARN DOOR TRIM COVER

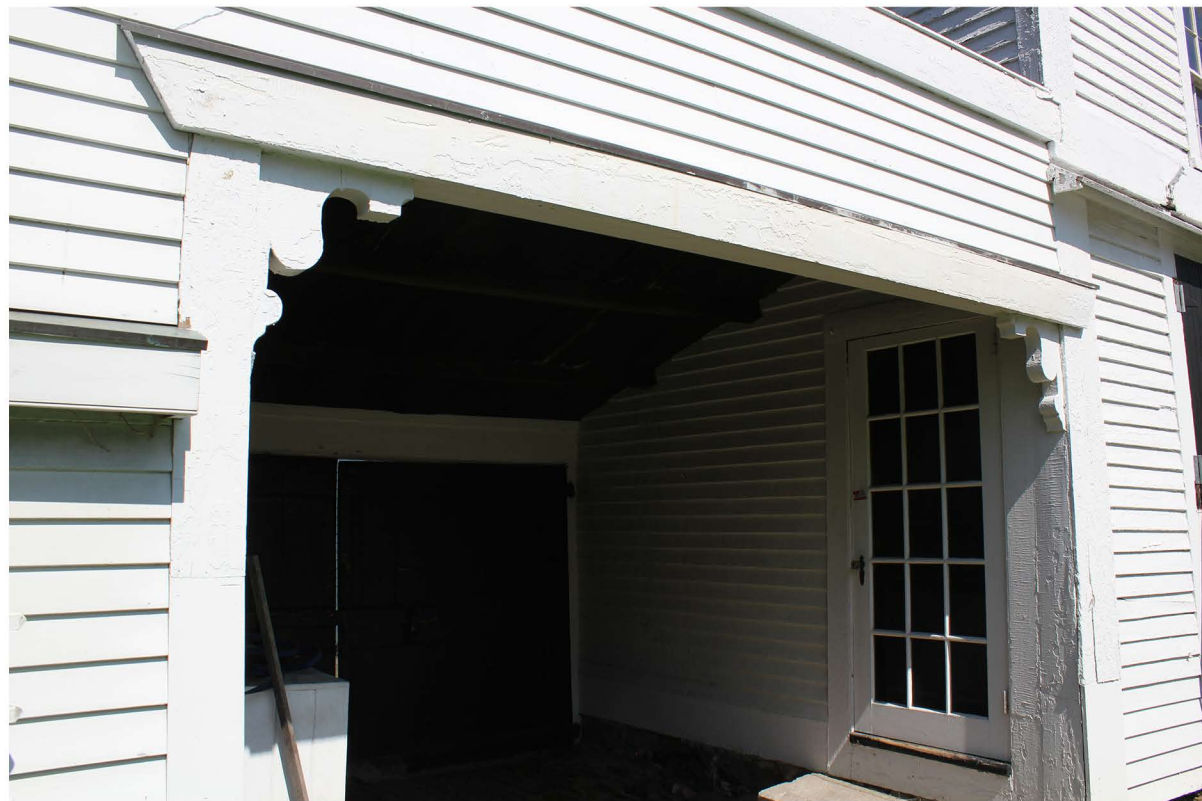
POSSIBLE HISTORIC CORBEL

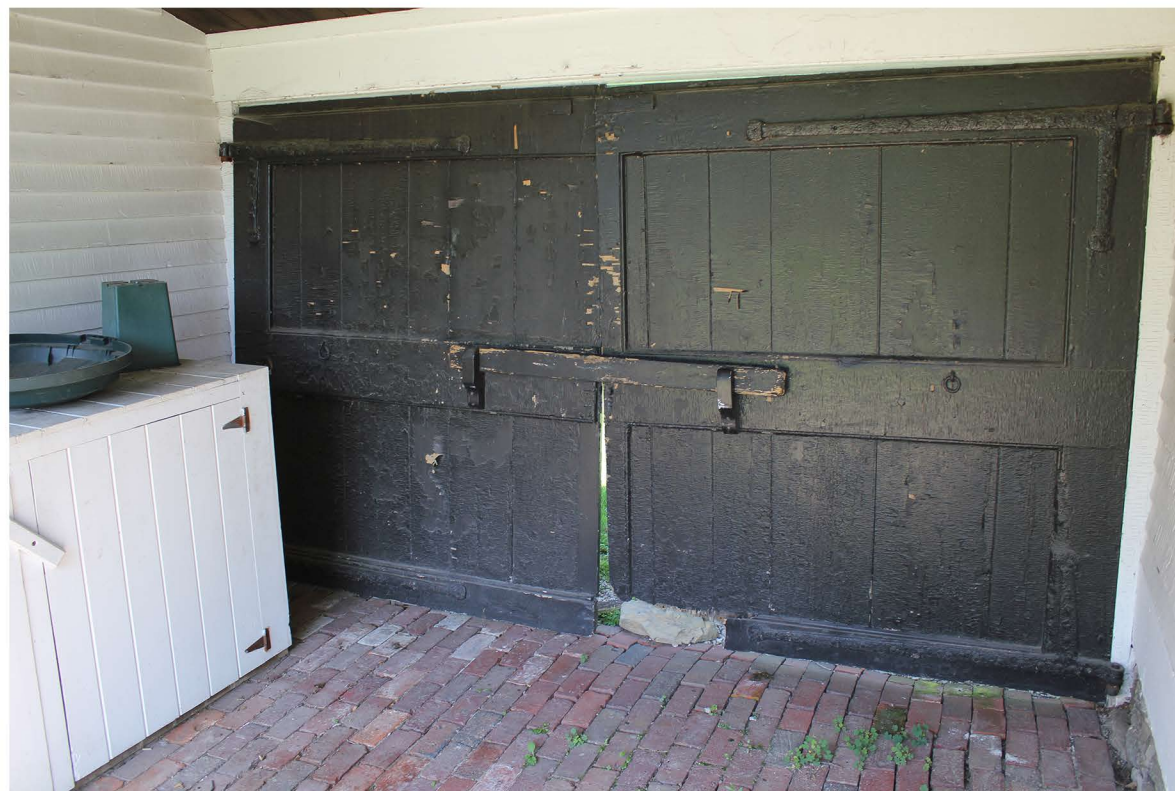
POSSIBLE HISTORIC DOOR WITH HISTORIC HINGES

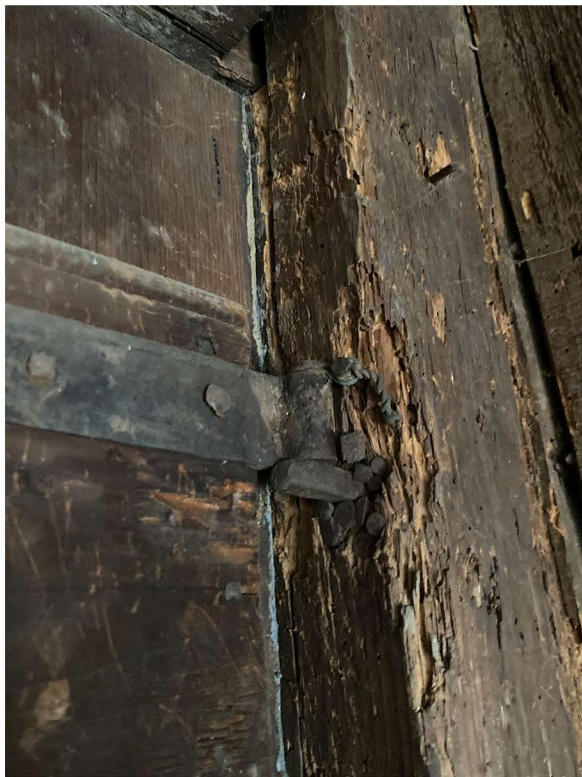
ORIGINAL HINGE (1) ON SMALL DOOR OF CONNECTOR

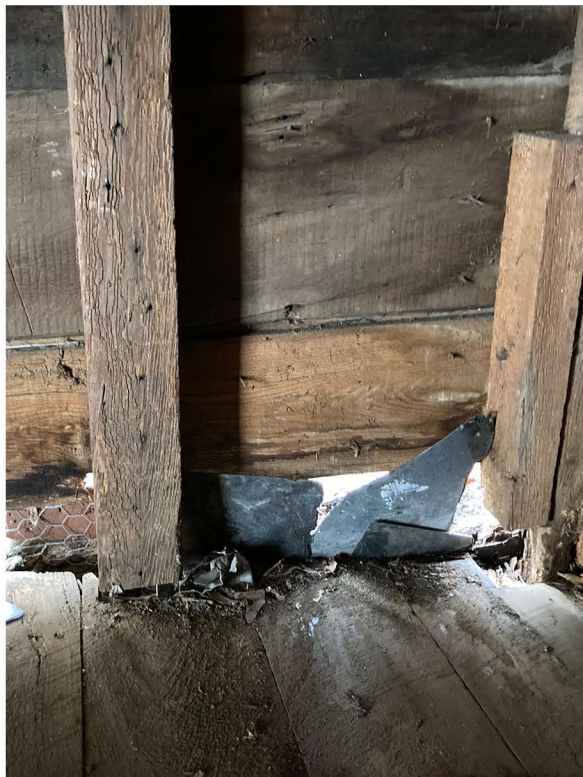
COMPROMISED STRUCTURE AT BASE

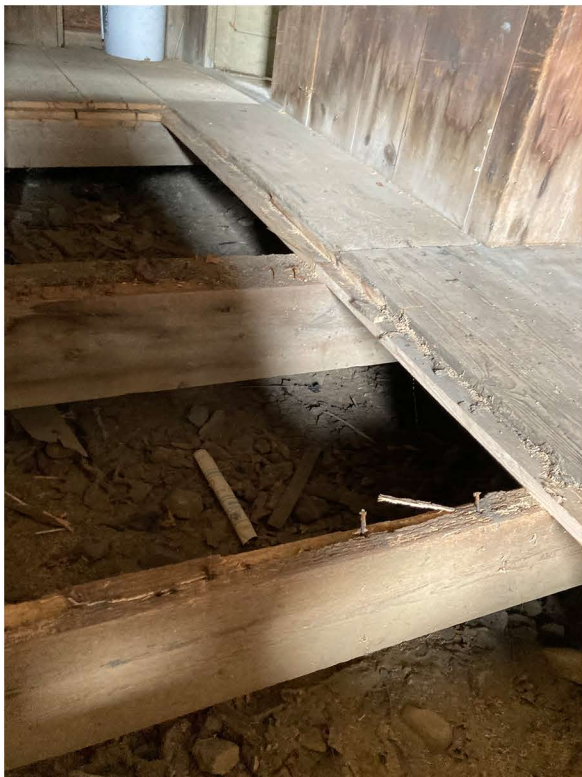
TYPICAL FLOOR FRAMING MADE UP OF REPURPOSED BEAMS

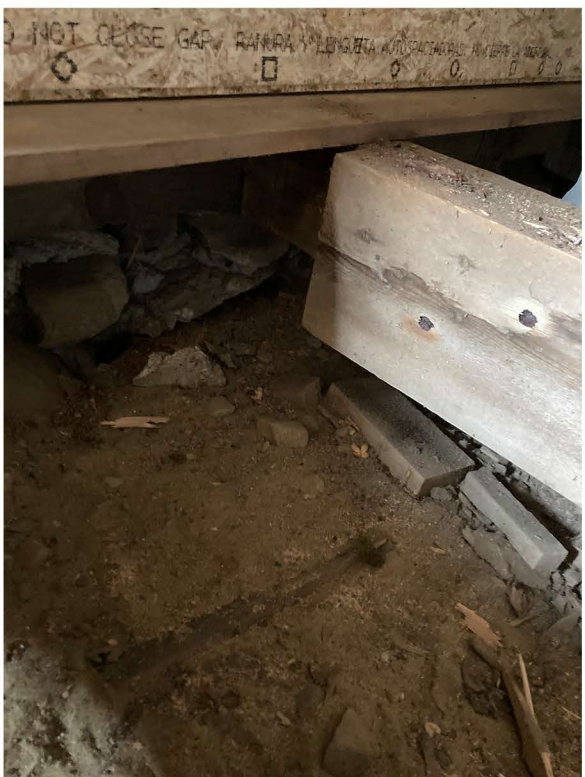
TYPICAL FLOOR FRAMING MADE UP OF REPURPOSED BEAMS

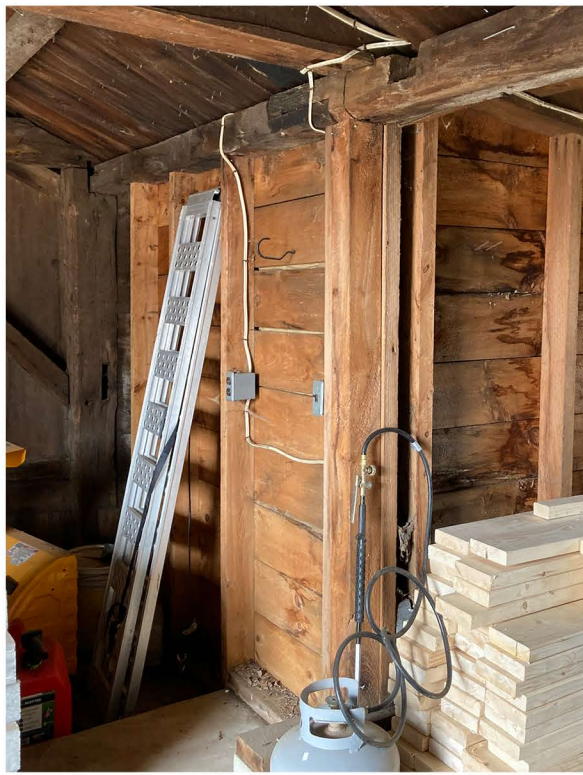
NEW FRAMING AT REAR WALL

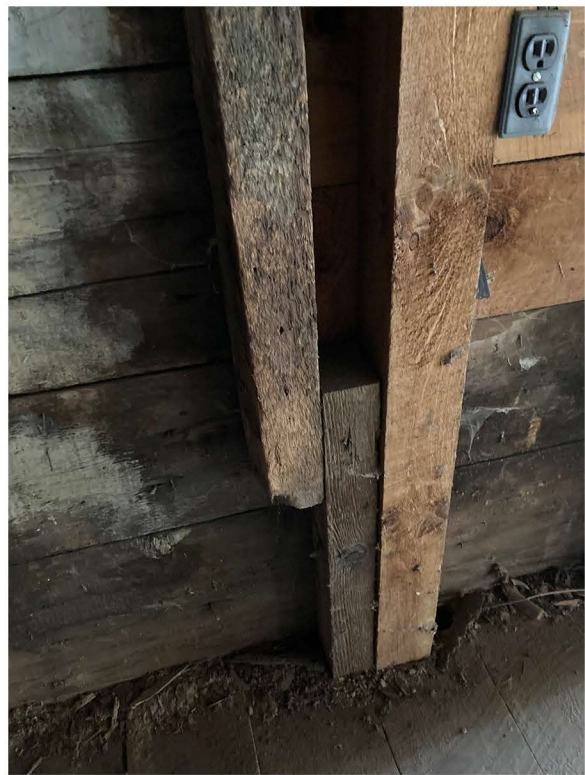
TYPICAL FRAMING AT FRONT WALL

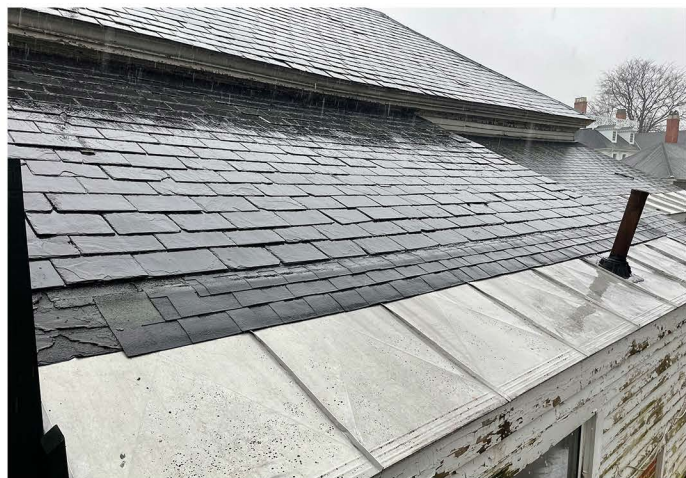
SLATE, ASPHALT AND, METAL ROOFING

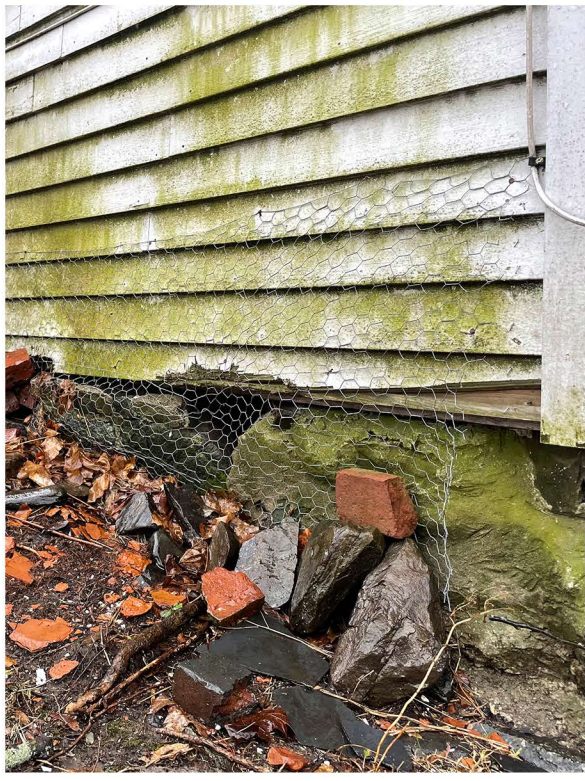
STONE RUBBLE FOUNDATION AND NEW SIDING REPAIR

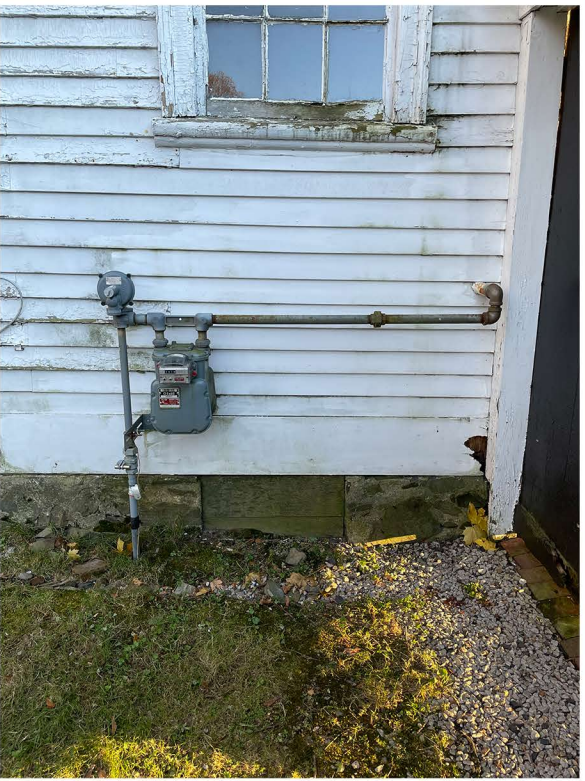
NEW SIDING REPAIR

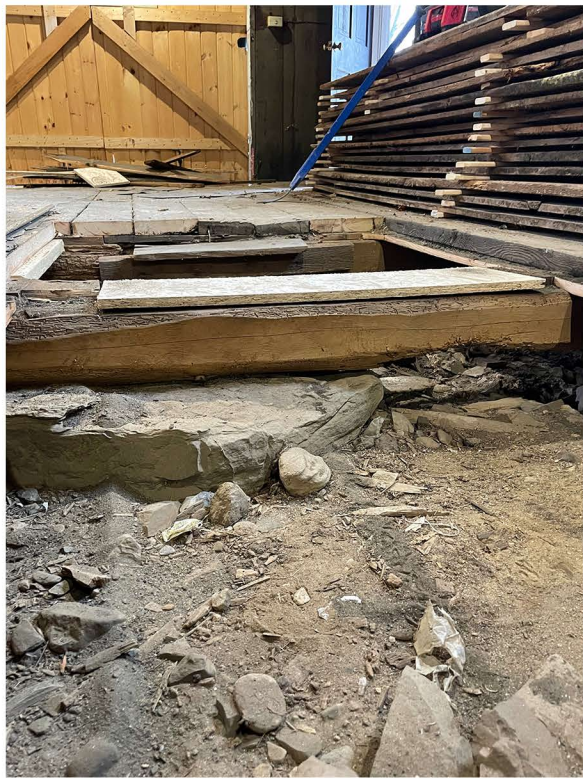
TYPICAL BEAMS IN DIRECT CONTACT WITH GROUND

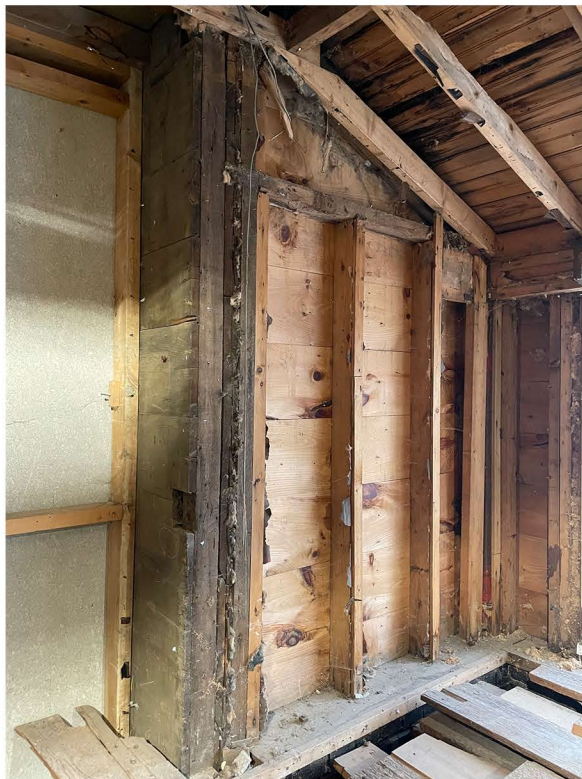
TYPICAL NEW FRAMING

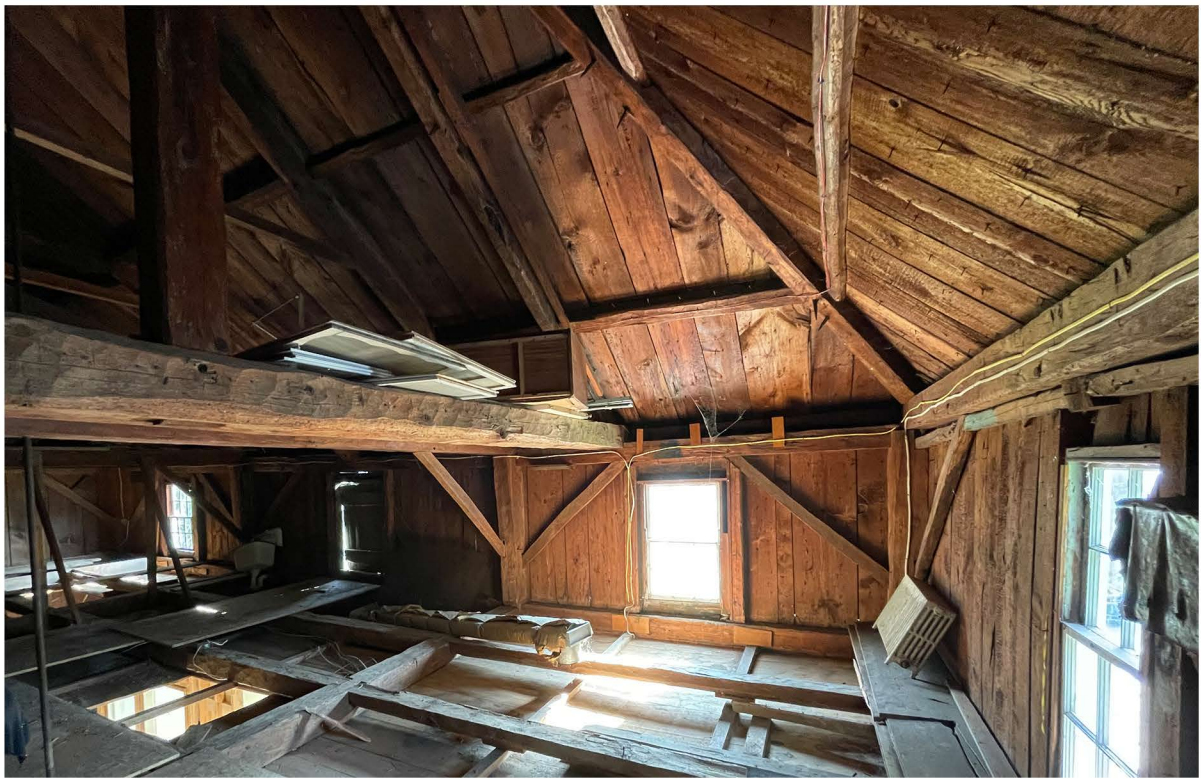
TYPICAL HISTORIC FRAMING

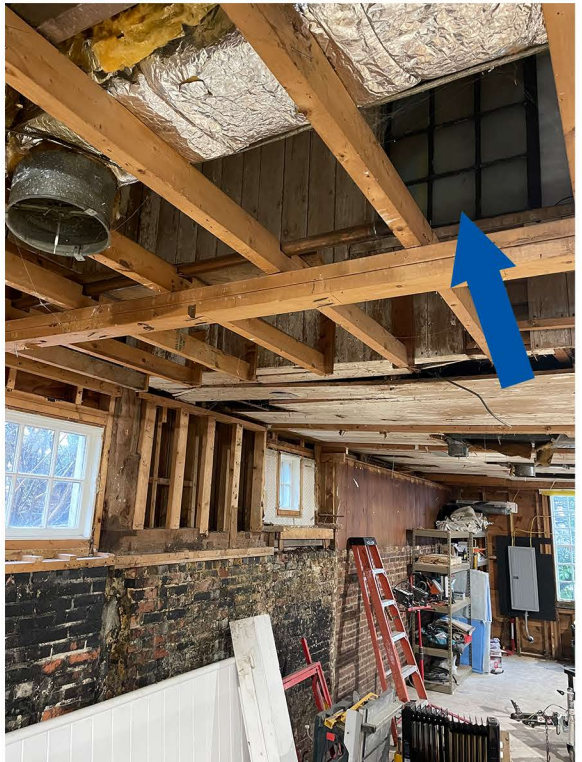
EXISTING WINDOW LOCATED AT REAR OF ORIGINAL CARRIAGE HOUSE BLOCK

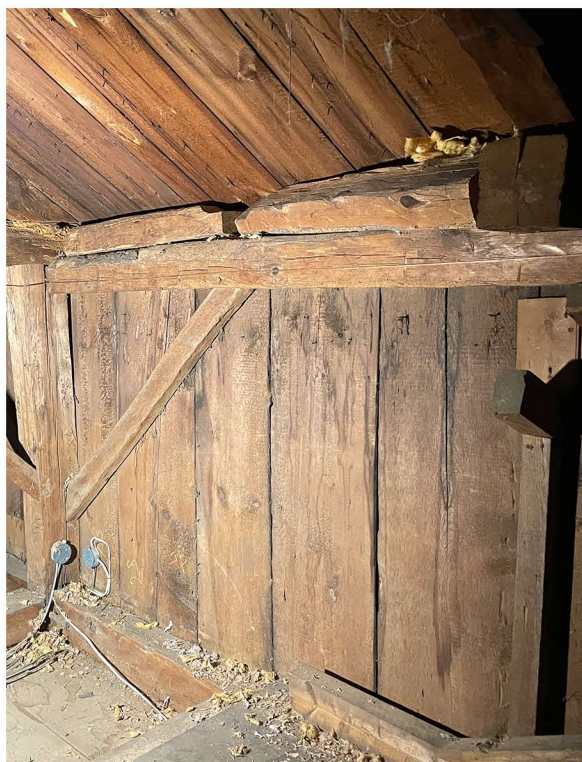
OLDER FRAMING MEMBERS HAVE BEEN MODIFIED, REMOVED, OR RELOCATED. (SECOND FLOOR OF CARRIAGE HOUSE)

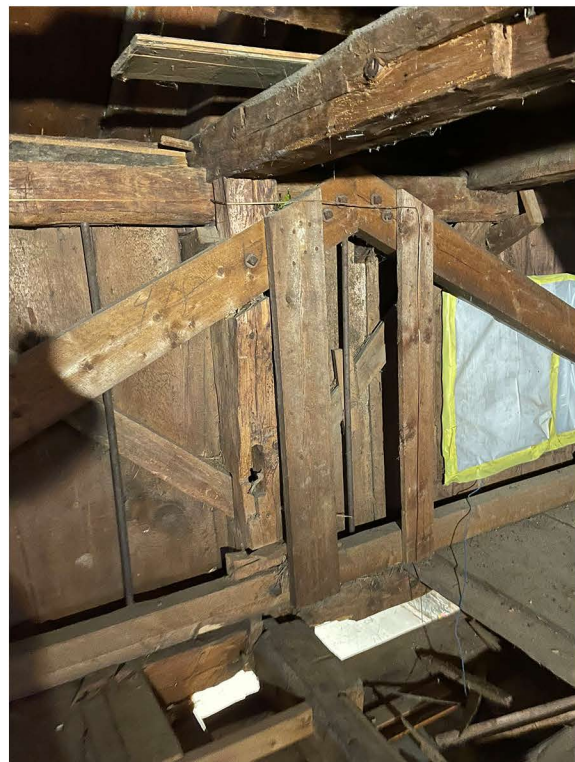
OLDER FRAMING MEMBERS HAVE BEEN MODIFIED, REMOVED, OR RELOCATED. (SECOND FLOOR OF CARRIAGE HOUSE)

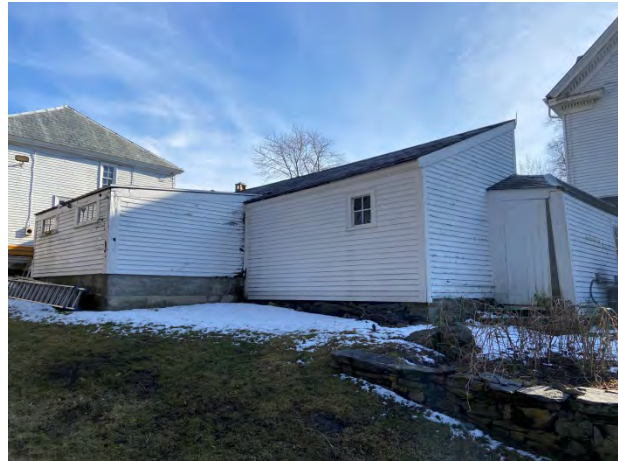
8-Barn north elevation

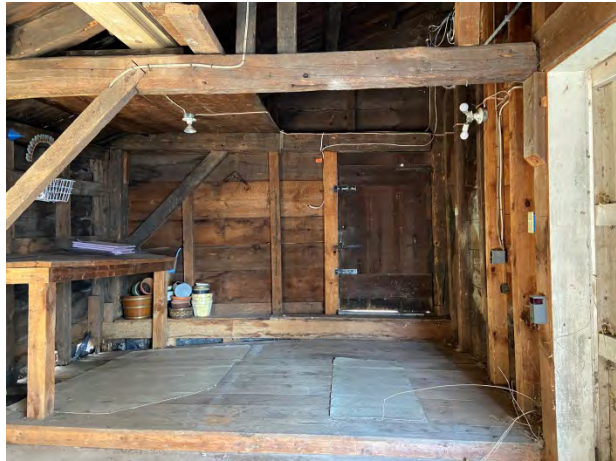
12-Inside looking south

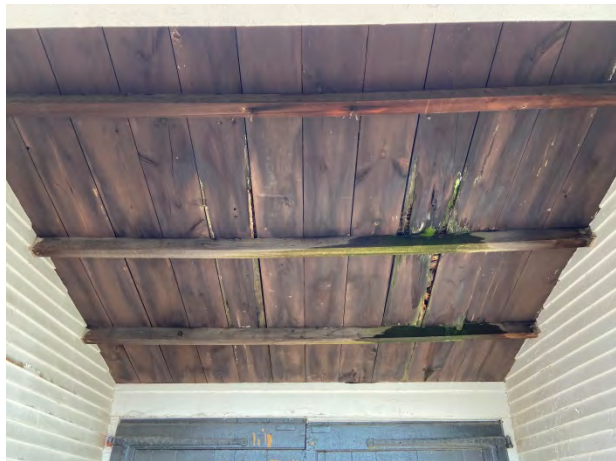
14-Connector roof sheathing and purlins

The original barn timber frame was constructed using reasonably sized members and techniques. The renovation that added the shed extension, and the wide sliding doors along the front of the building, damaged and structurally degraded the original framing system. Much of the original front wall framing, including a frame supporting post on line-3, was removed to create the current door opening. (SK-A and SK-D) The original front wall frame posts on lines 2 and 4 have also been removed and replaced. Where the back wall of the original barn was removed, the existing and added framing has been supported by a heavily notched 5x5 timber and a screw jack. (Image 13) The purlins spanning from the barn to the carriage house are grossly undersized. (Image 14)

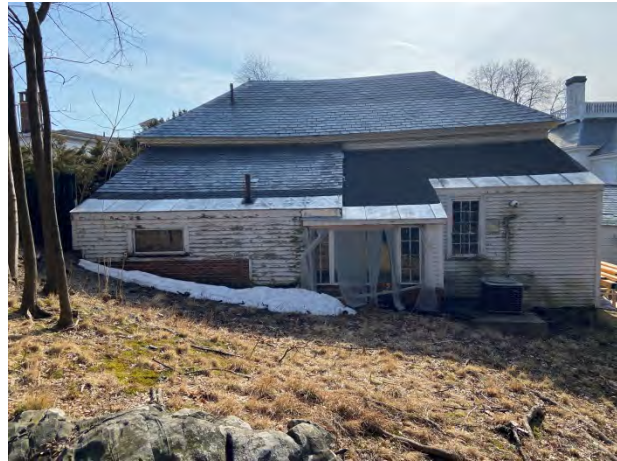
The carriage house was originally constructed as a 26'-3"x40'-6" story and a half timber frame hip-roofed structure. A subsequent renovation added a one story shed extension along the entire back of the building. (See image 17 and 18)

18-Carriage house northeast elevation

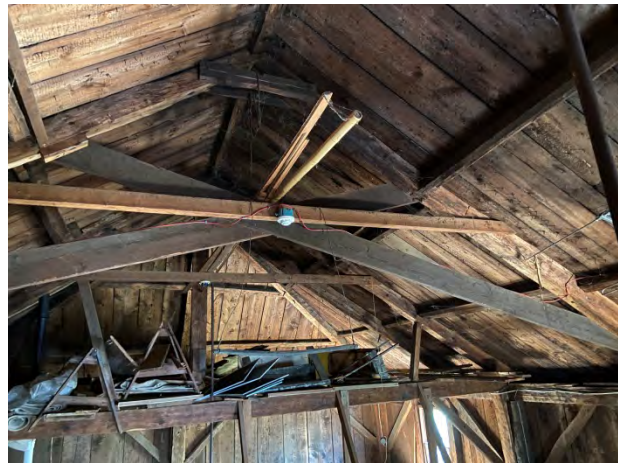
The structure has two major frames along lines 7 and 8 with steel hanger rods that extend from the second floor 8x8 carrying timber to the rafter peak. (See SK-B and SK-C) This system provides support to the second floor and relies on diagonal bracing at the second floor level and balloon posts that are continuous from the foundation to the roof truss. (See 1/SK-E) At the frame on line 7.5, the timber bottom chord was cut and removed. In an effort to compensate, 2x8 diagonal chords were installed in an attempt to create a scissor truss. (See images 21 & 22, and 2/SK-E)

22-Modified roof framing at line 7.5

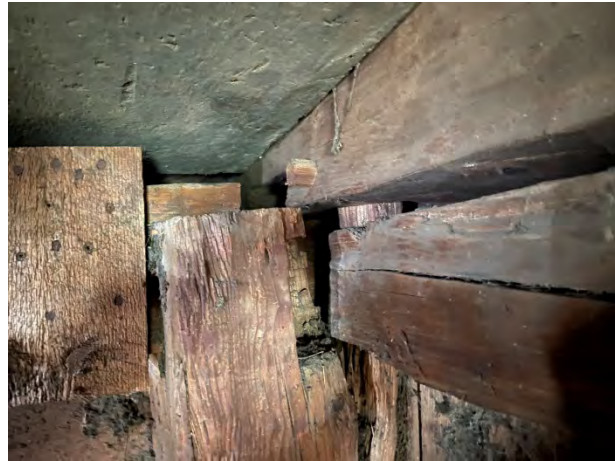
24-Vertical split at corner post

Looking at the building from outside, it can be observed that there is significant distortion, or deflection, along the ridge, the hips and in the plane of the roof itself. Looking inside the building at the top of the corner post, we can observe the vertical split in the post where the hip rafter is being pushed outward. (See image 24)

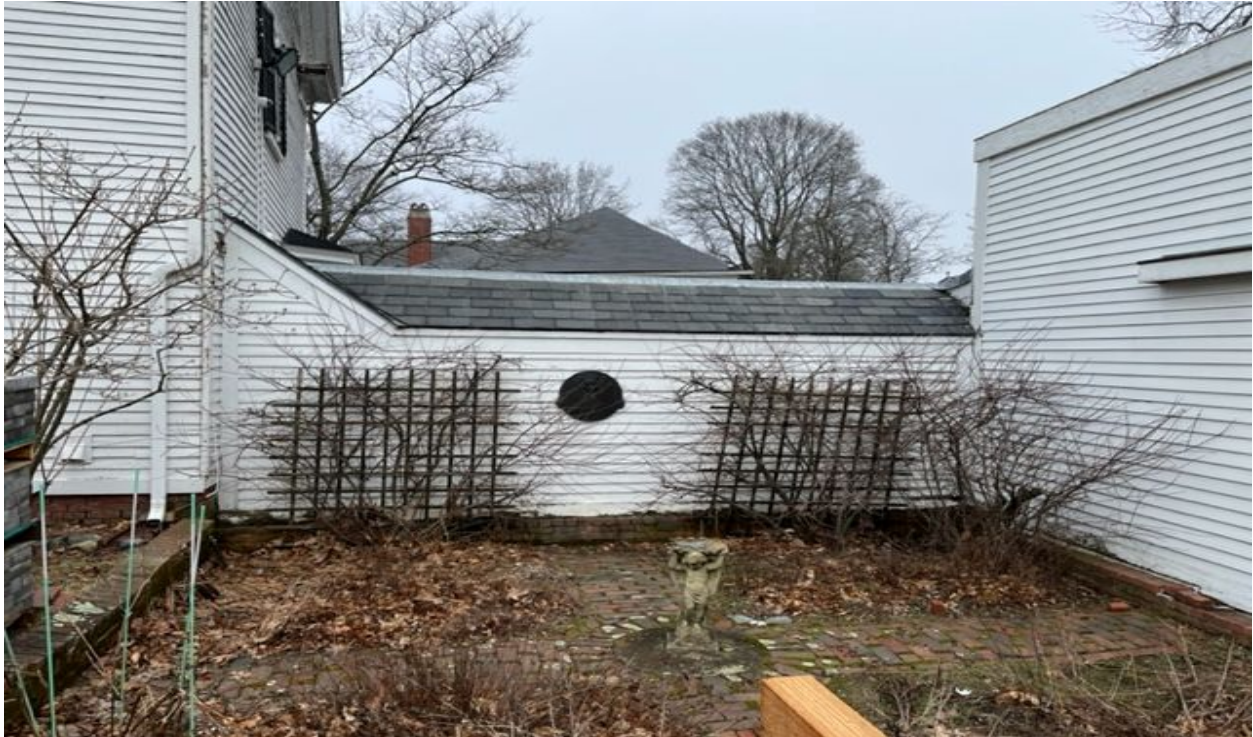
Dog Leg Connector:

The front elevation exterior trim and clapboards have all been replaced and have no signs of original materials. The back elevation has older clapboards installed on a portion of the wall system. The clapboards have a very steep lap joint that overlaps by roughly 2". This indicates older siding practice and thus older material. The nails used to secure the siding and the steep lap joints however, do not match the siding details on the mansion. This suggests a different period for the installation of the siding on the dog leg connector.

Another key detail is how the dog leg connector butts into the annex and barn/connector. The corner boards and fascia are cut into the other structures and in some points scribed around the other structures. Again, this suggests that this building postdates the annex and even the barn/connector.

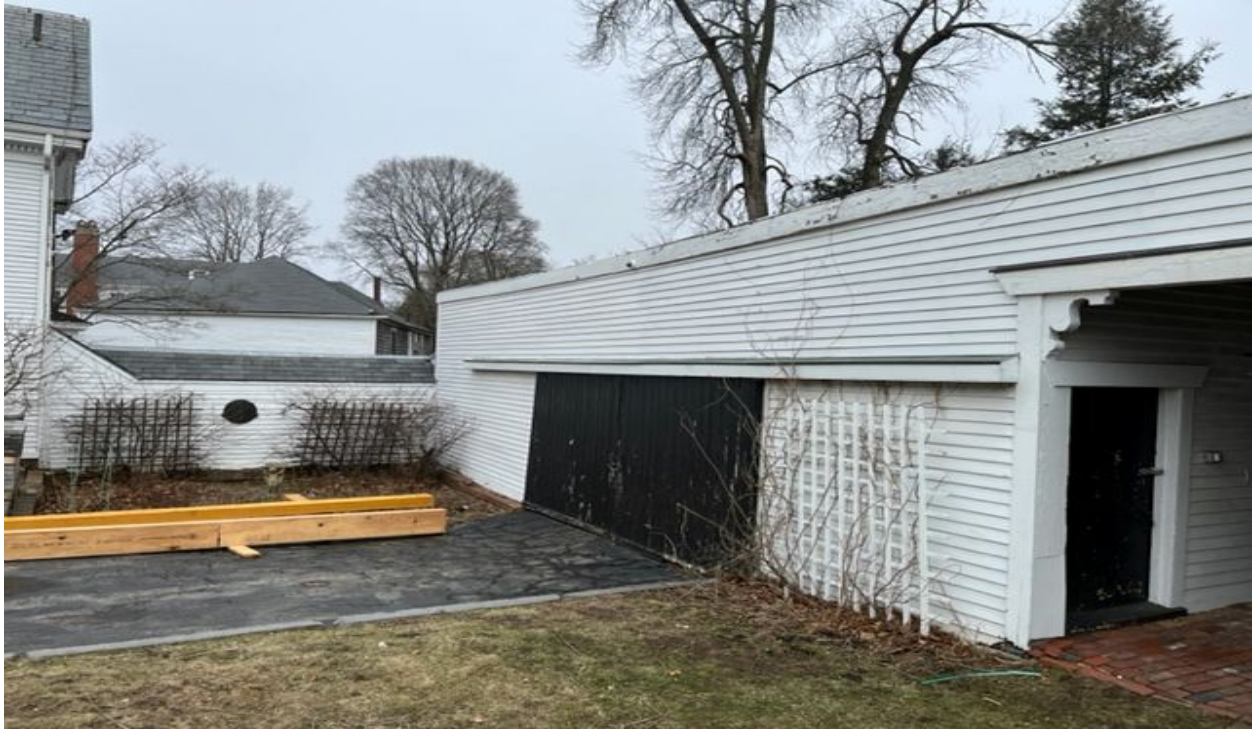
Barn/Connector:

The barn/main connecting structure also exhibits signs of significant renovation work over the years. Through our research we know that the front wall was reframed to accommodate a larger sliding door in 2018. A 10' x 16' "carport" was added to the back side of the structure in 1979. In reviewing the framing most of the front wall has been removed and replaced with rough sawn material to accommodate the door renovation in 2018. Additionally, most of the roof framing was cut and altered to accommodate the carport addition in 1979.

There is little to extract from the exterior details on this structure. Most of the siding and exterior trim has been replaced or is rotted beyond any repair. The exterior wall facing the carriage house located under the open roof system is however intact. The siding on this wall has a but joints and no noticeable nail heads like the mansion.

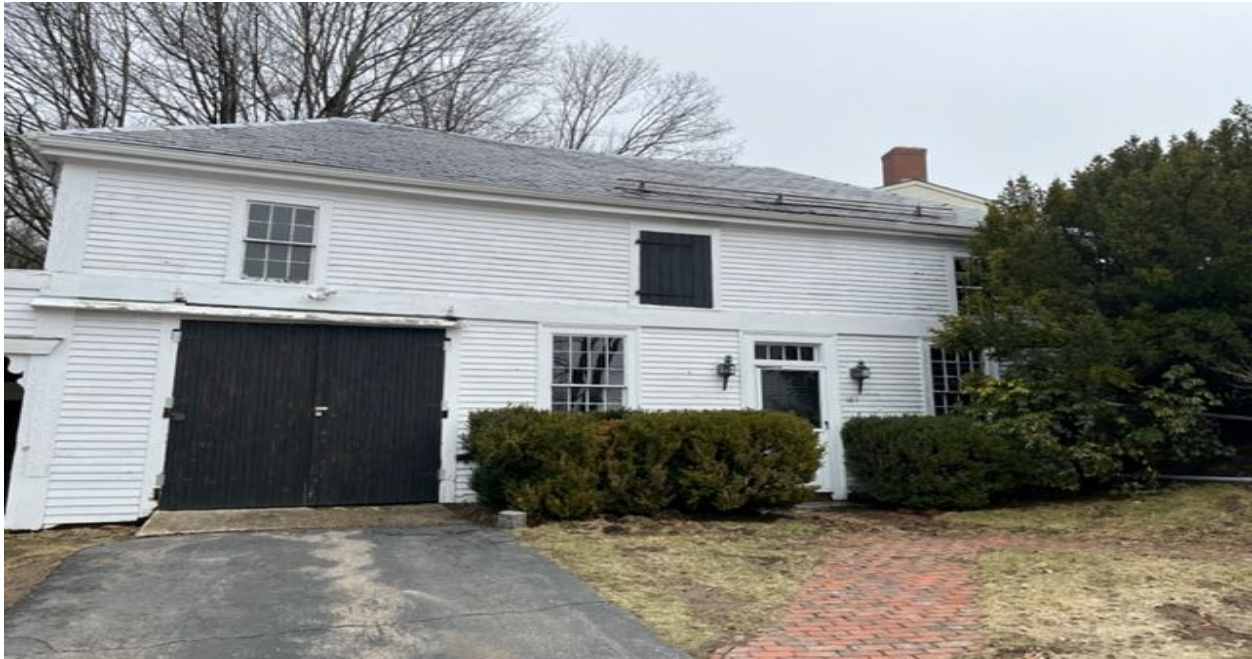
Carriage House:

In 1962 the carriage house underwent an extensive renovation to accommodate a dentist office. The renovation basically removed the entire first floor walls and floor systems. There are almost no original materials left on the first floor of the carriage house to include, wall studs, sheathing, windows, doors, siding, trim, foundation. I believe they systematically removed sections of the walls while they reframed and eventually poured a concrete slab throughout most of the carriage house.

The second floor and roof system however have remained mostly intact and original to the 1784 period. The massing of the beams, the joinery methods, and the framing layouts all match the mansion framing. Some of the beams have been cut or notched over the years but for the most part the framing is intact.

There are (2) single story additions off the back of the carriage house. These two structures are not original to the carriage house, and we believe were most likely added in the late 1800's or early 1900's with the barn/connector. The framing members used are machined and the framing practice mimics that of the annex and a balloon frame style. The roof rafters of these additions are also notched into the second-floor sheathing of the carriage house.
