179 PLEASANT STREET
PORTSMOUTH, NEW HAMPSHIRE

HDC WORK SESSION #2 APPLICATION TO AMEND PREVIOUS APPROVAL: JUNE 1, 2022

Structural Condition Assessment
Connector, Barn and Carriage House
Captain Thomas Thompson House
179 Pleasant Street
Portsmouth, New Hampshire

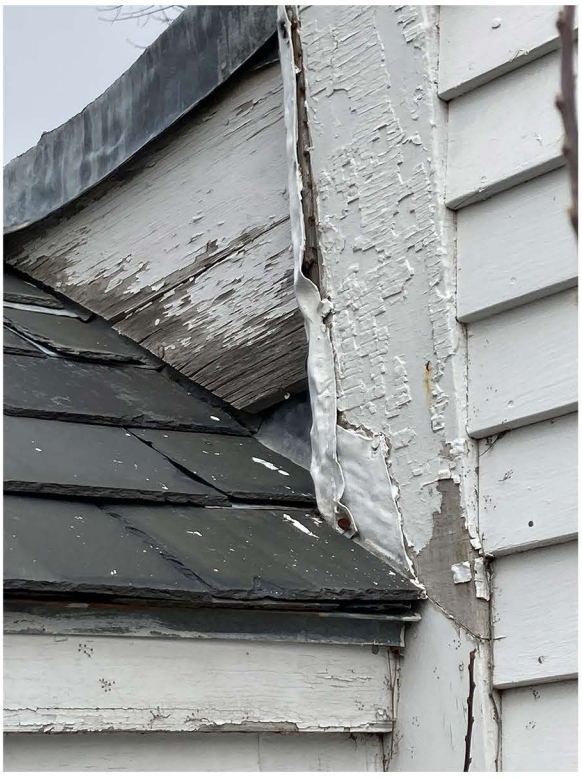
INTERSECTION WITH CONNECTOR AT ROOF

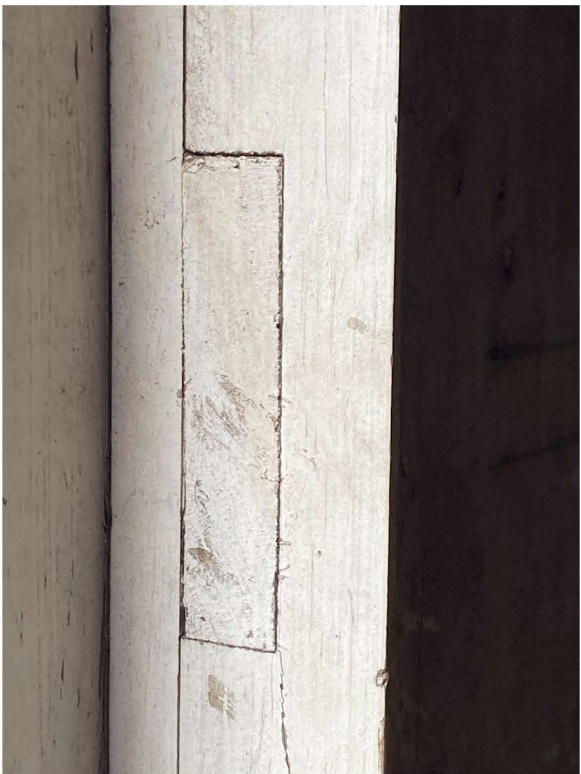
BARN DOOR MORTISE AND TENON

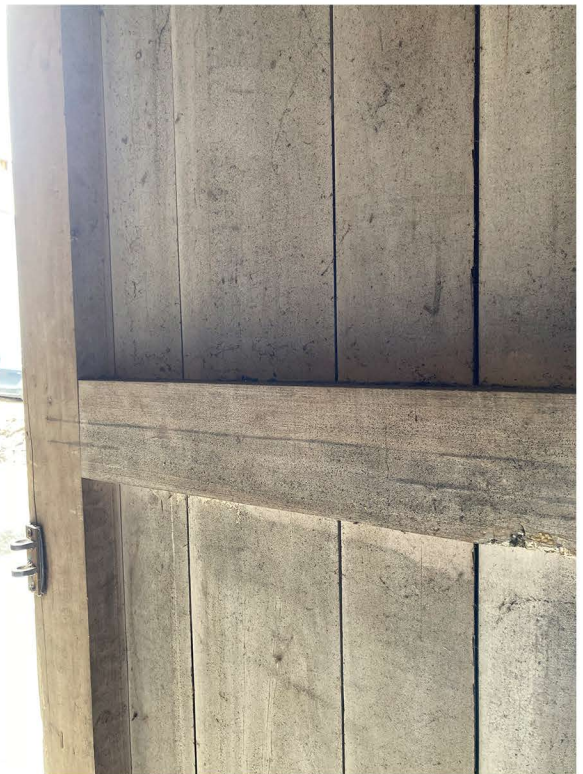
NEW BARN DOOR FRAMING

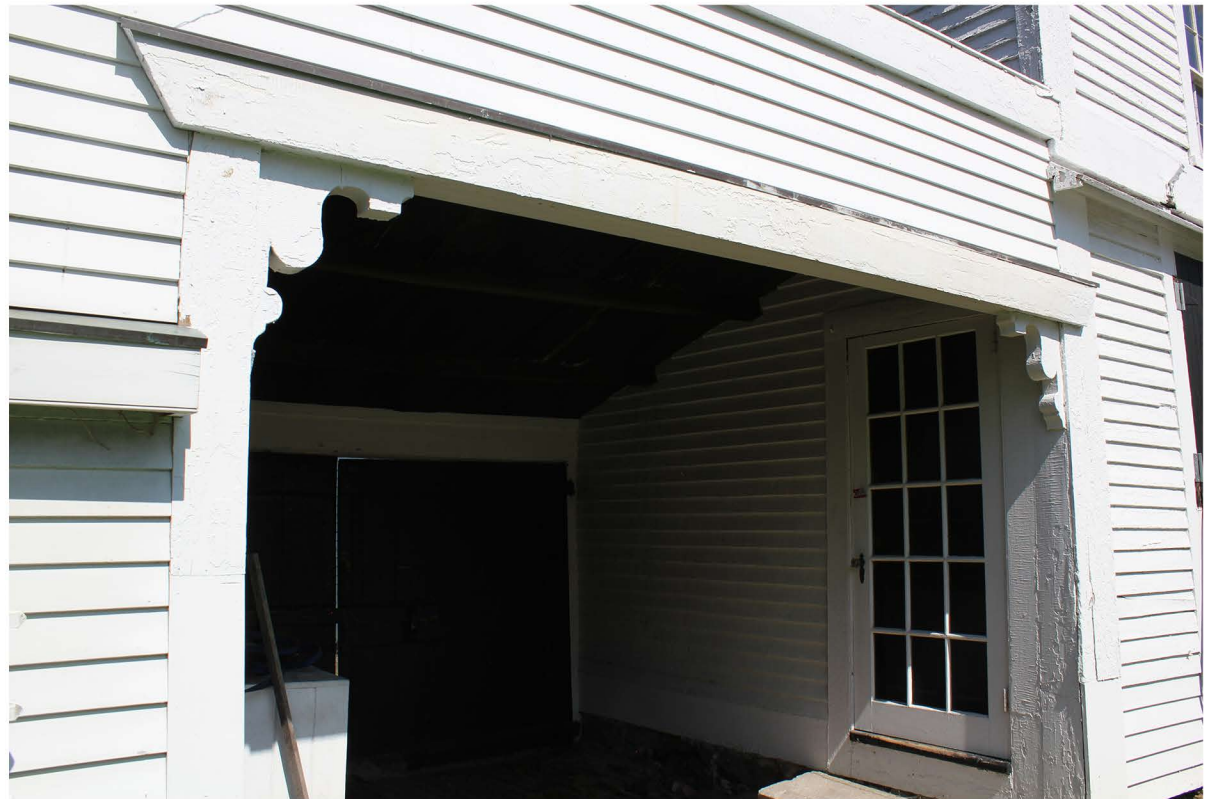
POSSIBLE HISTORIC CORBEL

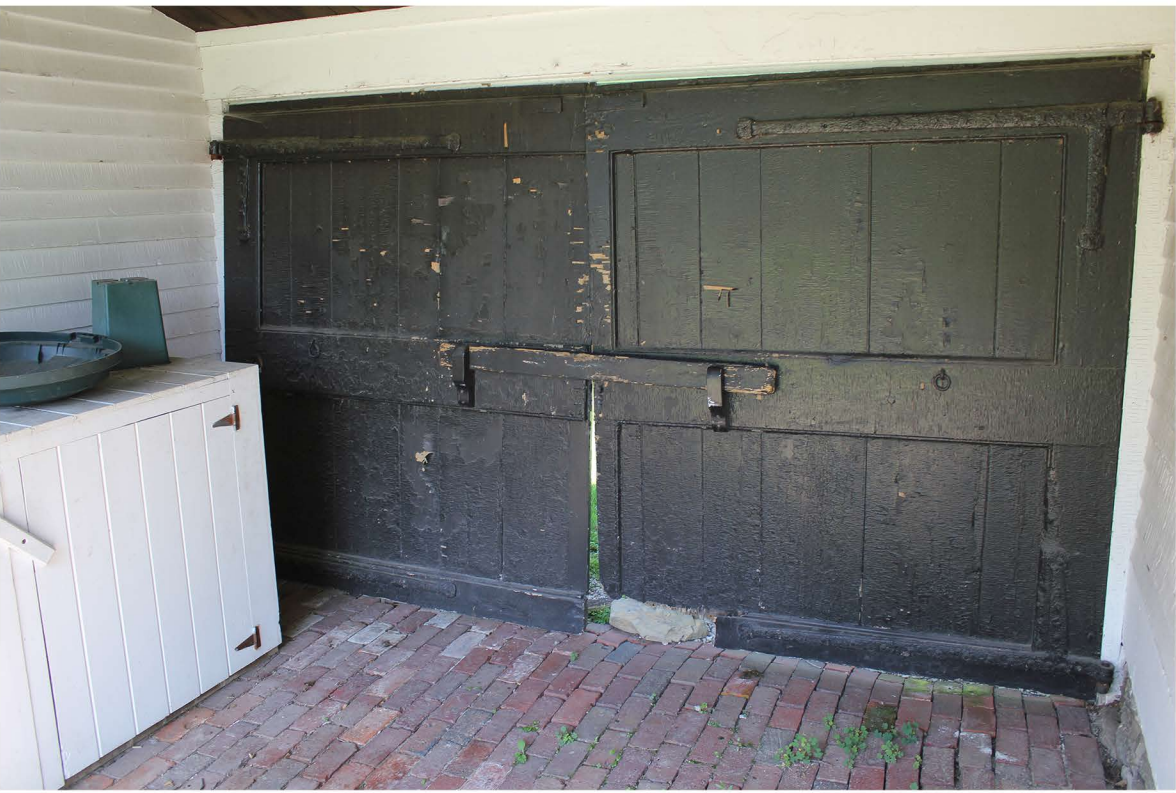
POSSIBLE HISTORIC DOOR WITH HISTORIC HINGES

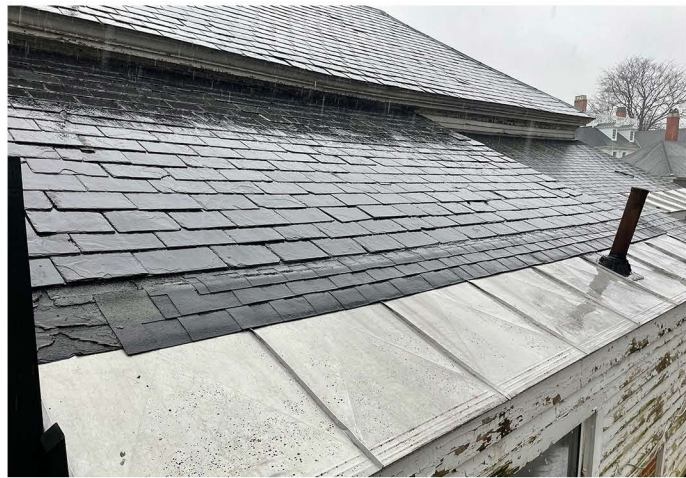
SLATE, ASPHALT AND, METAL ROOFING

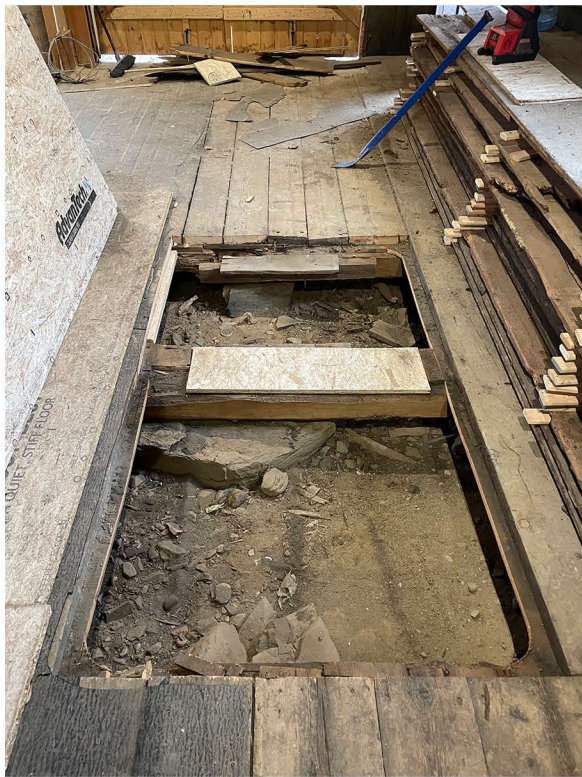
TYPICAL BEAMS IN DIRECT CONTACT WITH GROUND

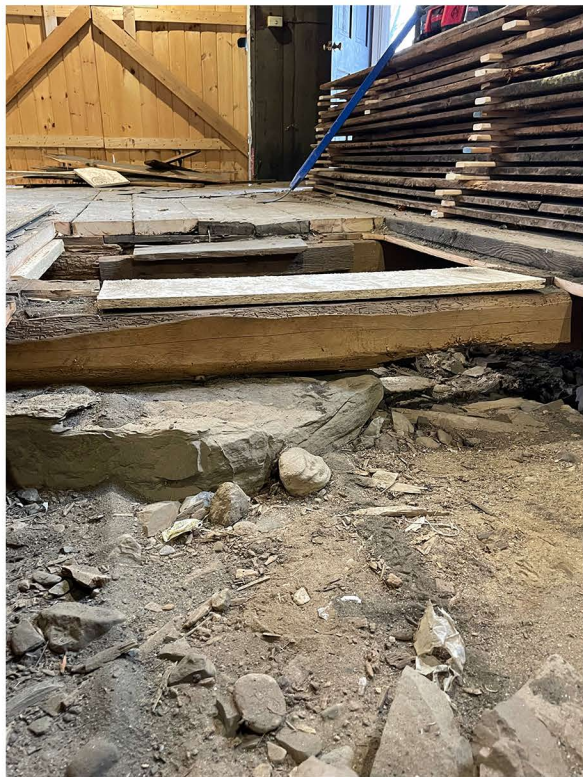
TYPICAL BEAMS IN DIRECT CONTACT WITH GROUND

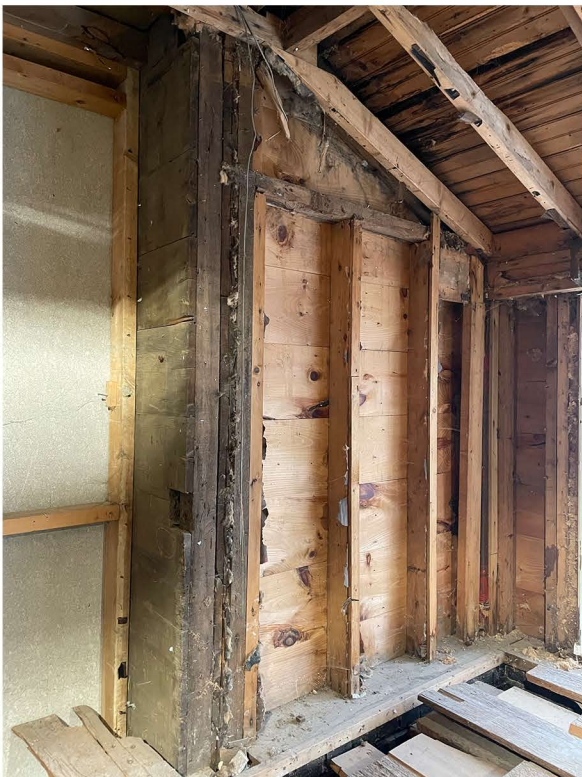
TYPICAL NEW FRAMING

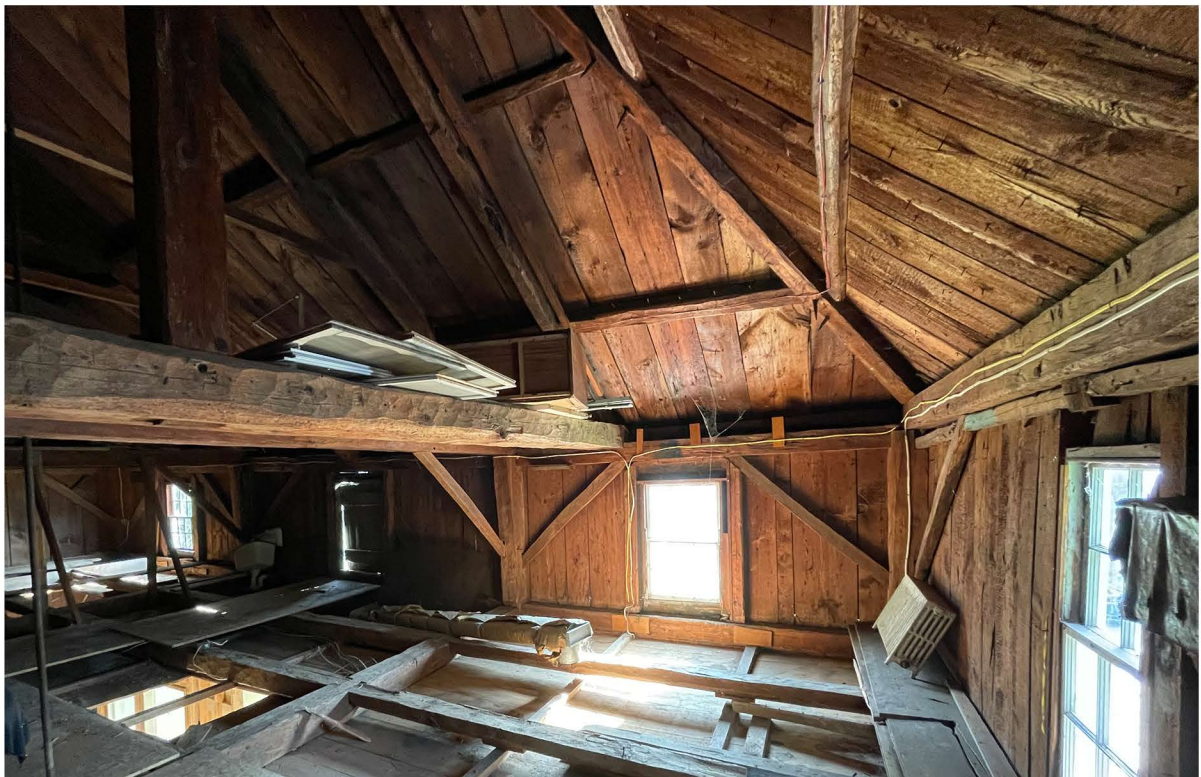
TYPICAL HISTORIC FRAMING

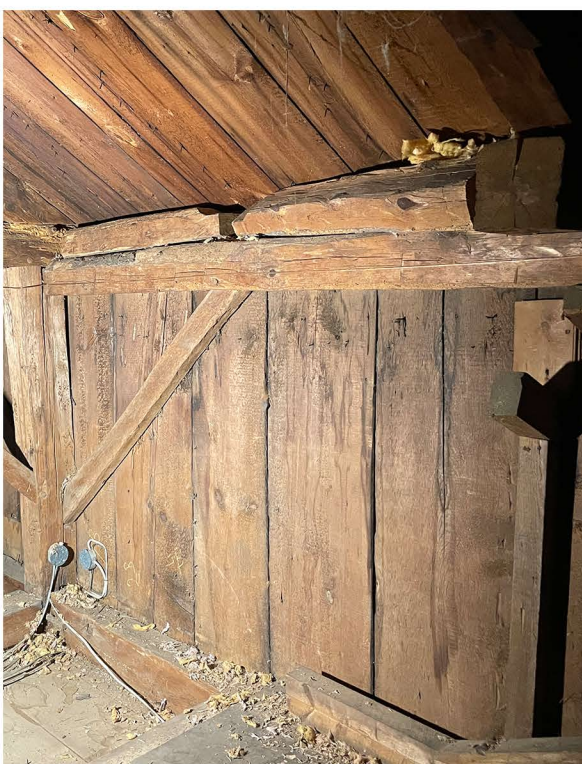
OLDER FRAMING MEMBERS HAVE BEEN MODIFIED, REMOVED, OR RELOCATED. (SECOND FLOOR OF CARRIAGE HOUSE)

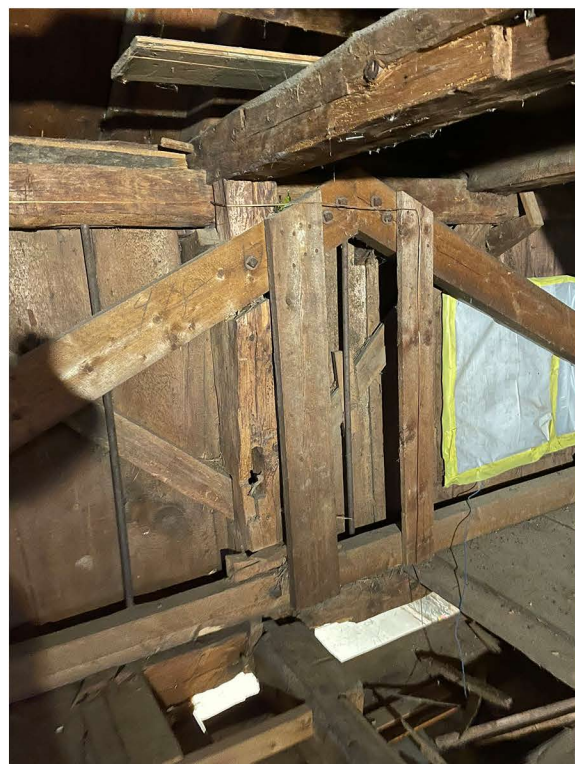
OLDER FRAMING MEMBERS HAVE BEEN MODIFIED, REMOVED, OR RELOCATED. (SECOND FLOOR OF CARRIAGE HOUSE)
