179 PLEASANT STREET
PORTSMOUTH, NEW HAMPSHIRE

HDC WORK SESSION #1 APPLICATION TO AMEND PREVIOUS APPROVAL: MAY 4, 2022

DOG LEG CONNECTOR - EXISTING CONDITIONS

Structural Condition Assessment
Connector, Barn and Carriage House
Captain Thomas Thompson House
179 Pleasant Street
Portsmouth, New Hampshire

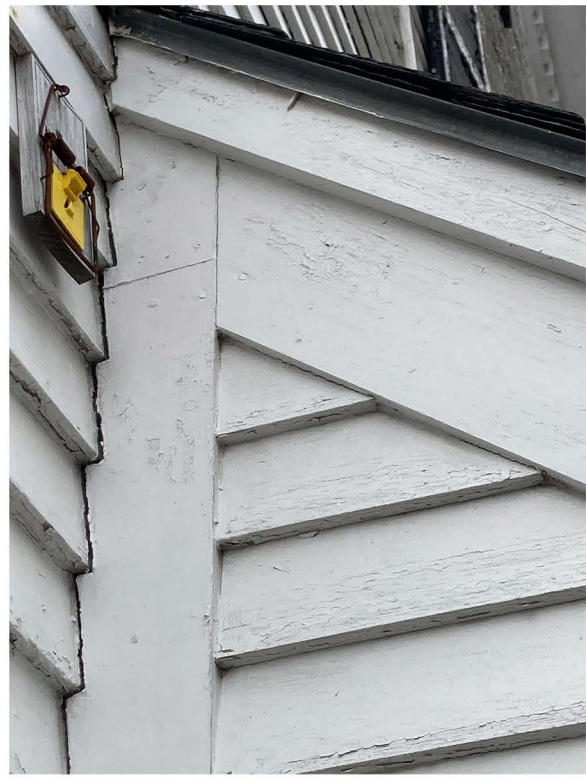
CORNER BOARD NOTCHED AGAINST ANNEX SIDING

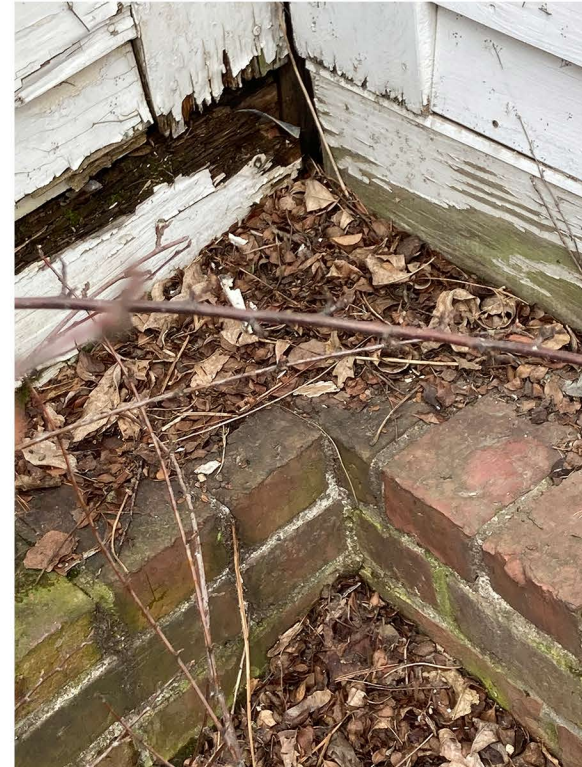
INTERSECTION WITH CONNECTOR AT FOUNDATION

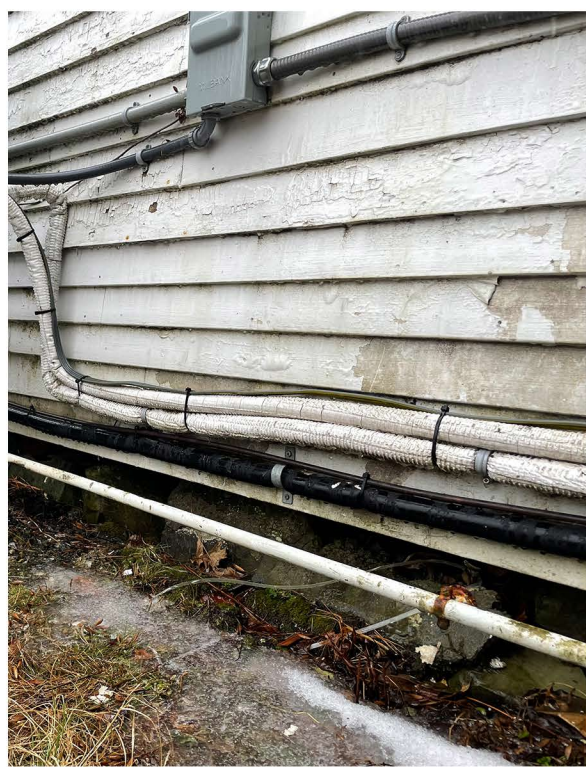
STONE RUBBLE FOUNDATION

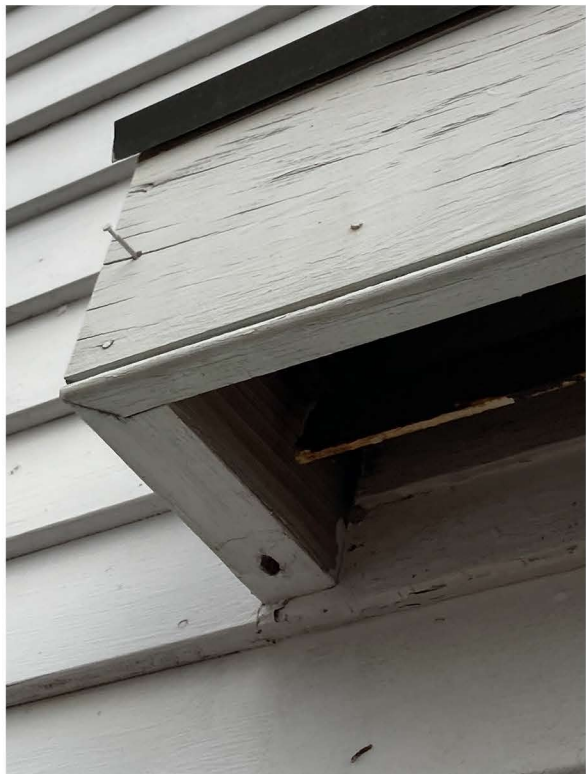
NEW BARN DOOR TRIM COVER

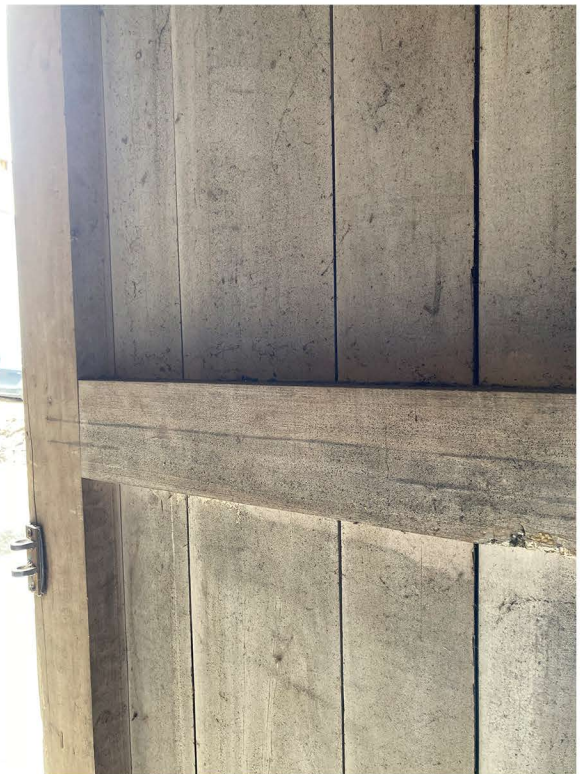
NEW BARN DOOR FRAMING

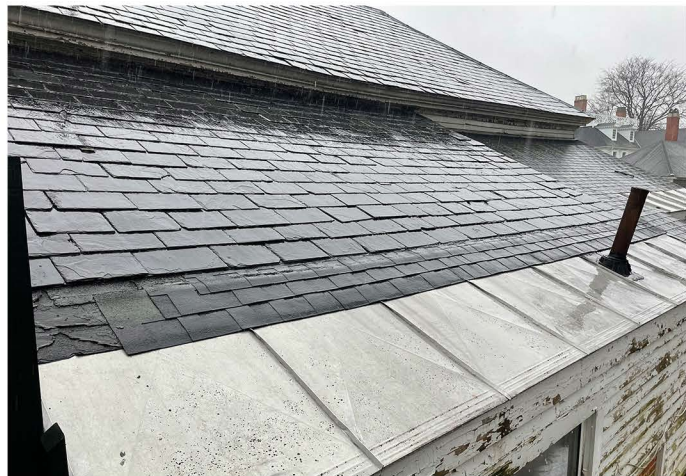
SLATE, ASPHALT AND, METAL ROOFING

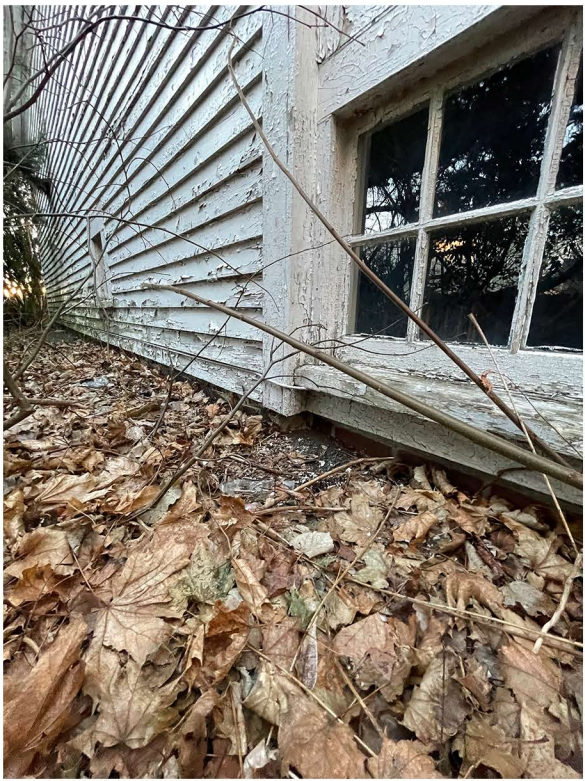
NEW WINDOW REPAIR

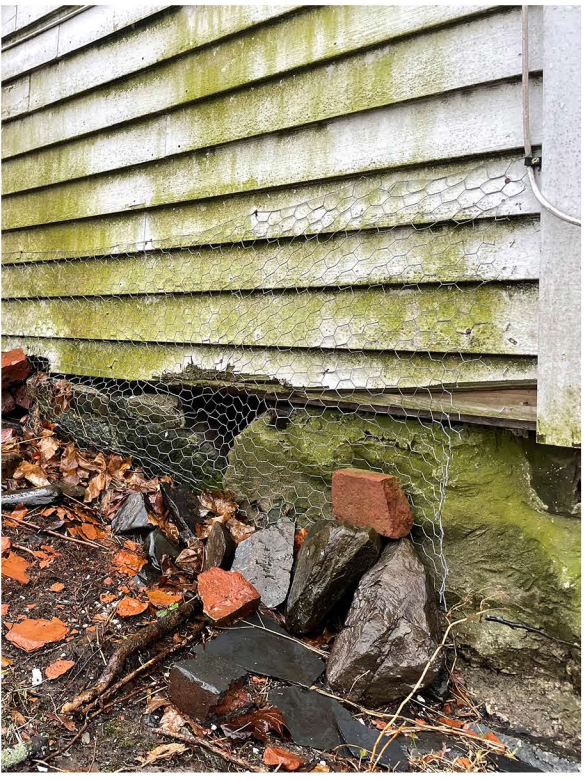
STONE RUBBLE FOUNDATION AND NEW SIDING REPAIR

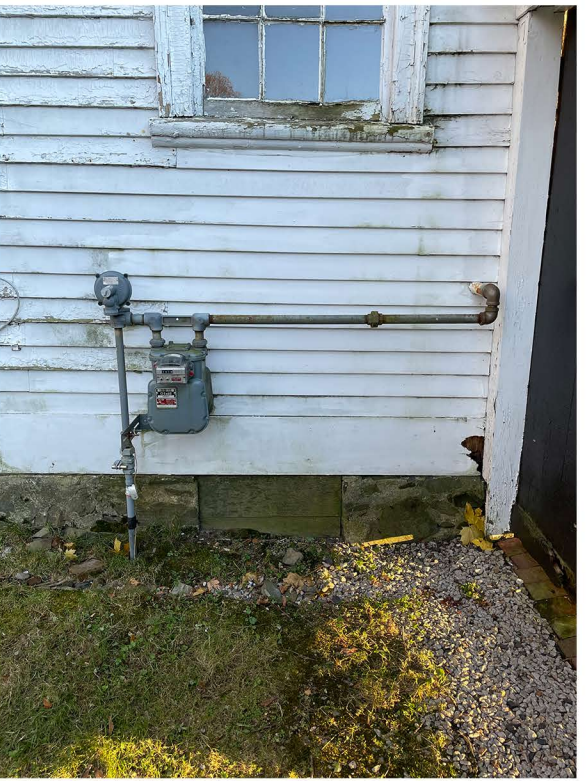
NEW SIDING REPAIR

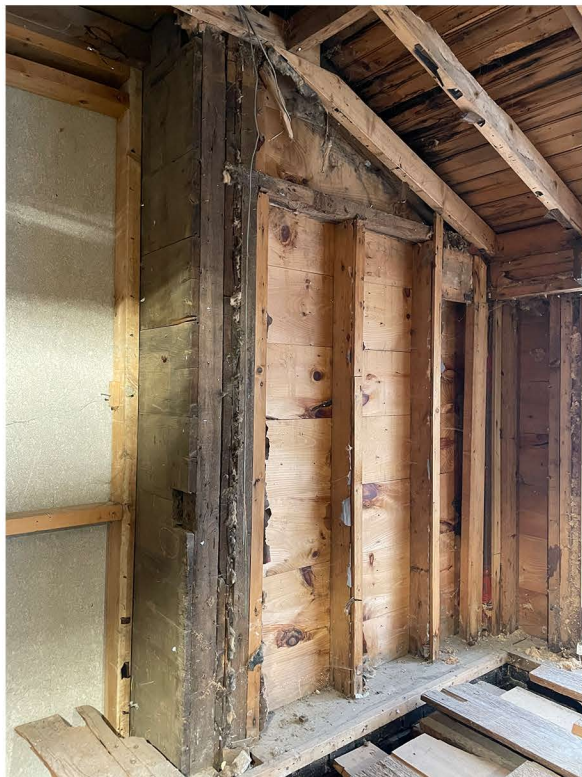
TYPICAL NEW FRAMING

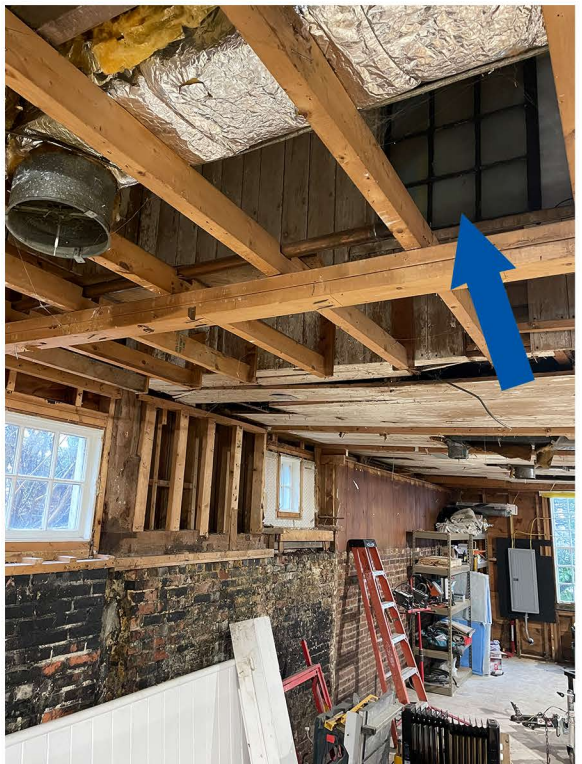
EXISTING WINDOW LOCATED AT REAR OF ORIGINAL CARRIAGE HOUSE BLOCK

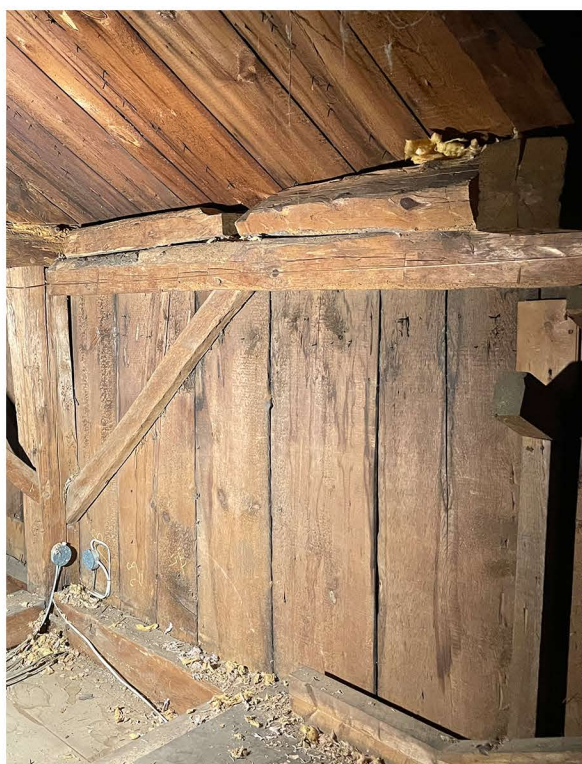
OLDER FRAMING MEMBERS HAVE BEEN MODIFIED, REMOVED, OR RELOCATED. (SECOND FLOOR OF CARRIAGE HOUSE)
