179 PLEASANT STREET
PORTSMOUTH, NEW HAMPSHIRE

HDC APPLICATION TO AMEND PREVIOUS APPROVAL: SEPTEMBER 7, 2022

Structural Condition Assessment
Connector, Barn and Carriage House
Captain Thomas Thompson House
179 Pleasant Street
Portsmouth, New Hampshire

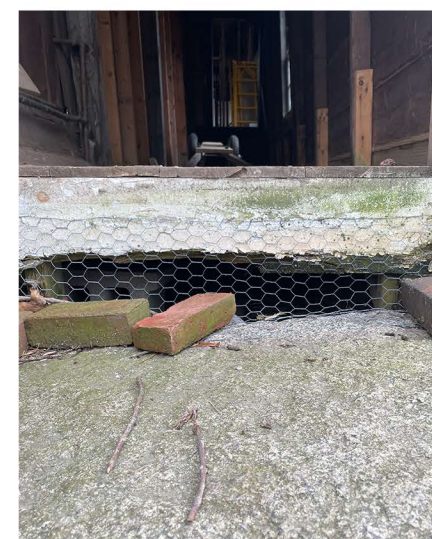
FOUNDATION SLAB

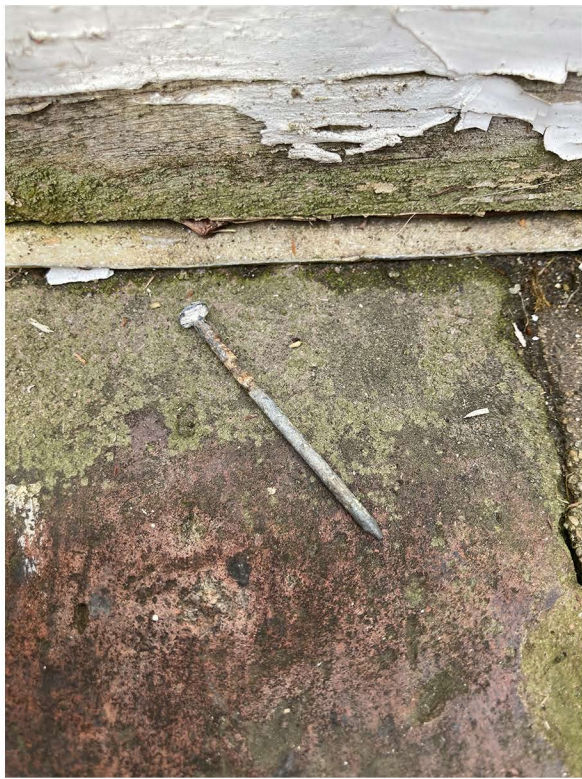
TYPICAL SIDING NAIL

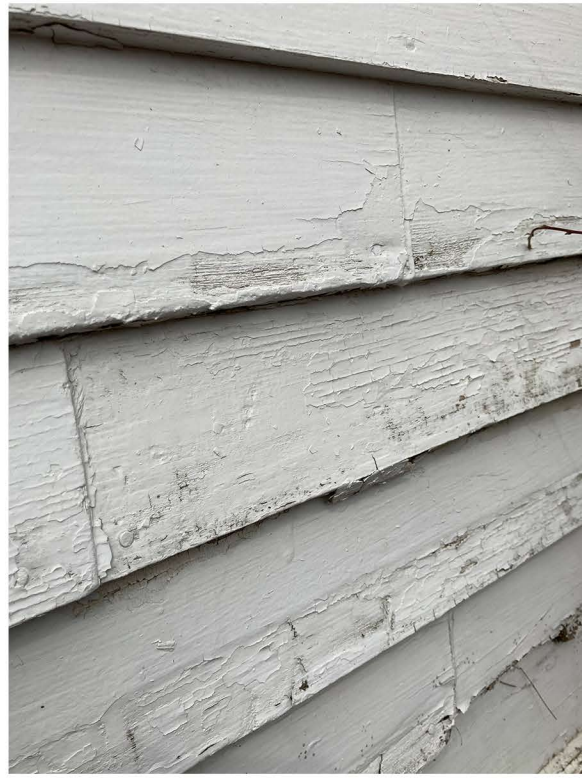
TYPICAL SIDING BUTT JOINT

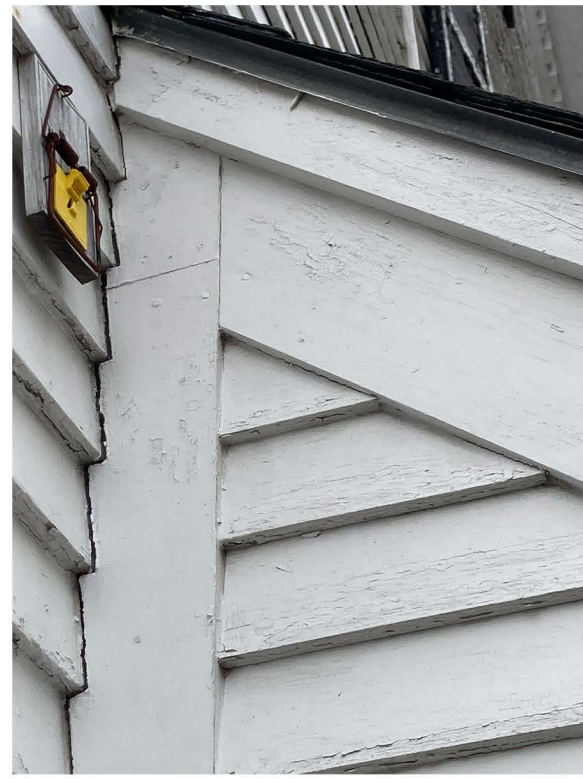
CORNER BOARD NOTCHED AGAINST ANNEX SIDING

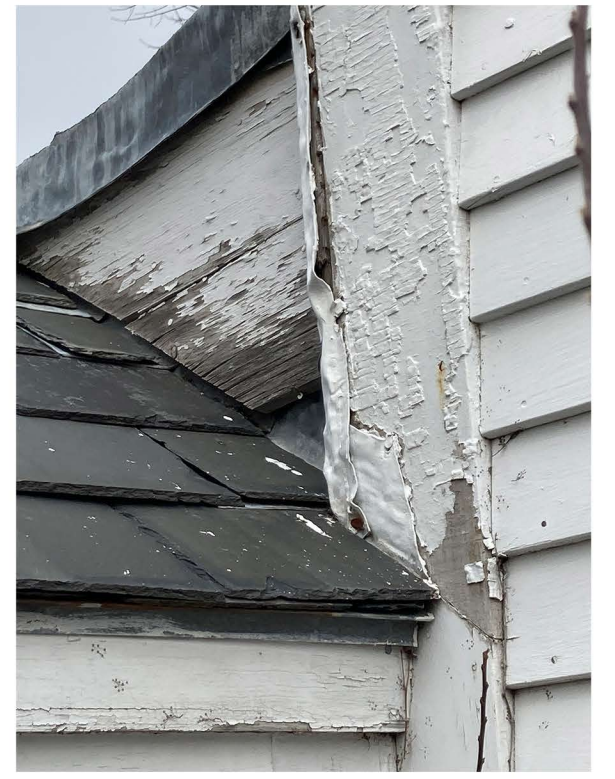
INTERSECTION WITH CONNECTOR AT ROOF

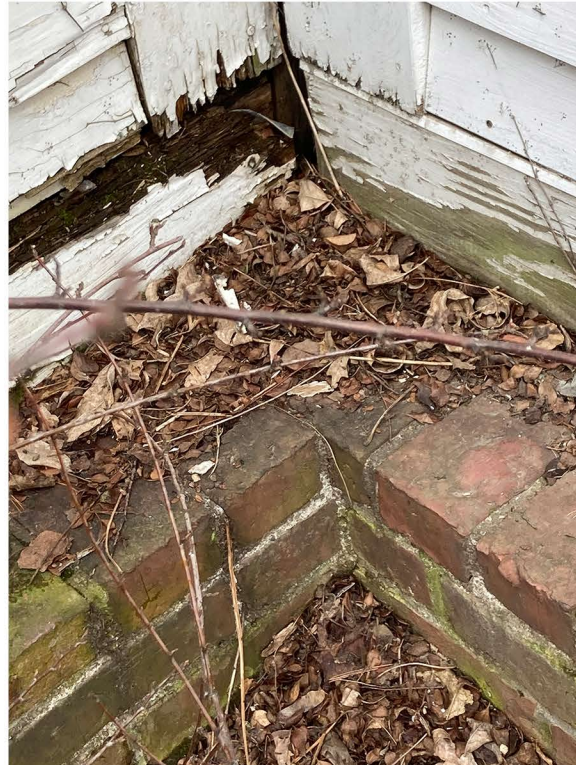
INTERSECTION WITH CONNECTOR AT FOUNDATION

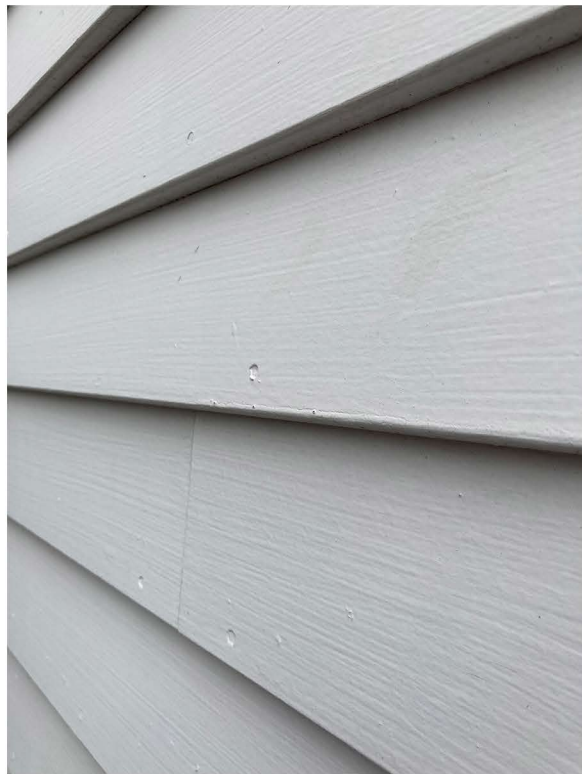
NEW SIDING

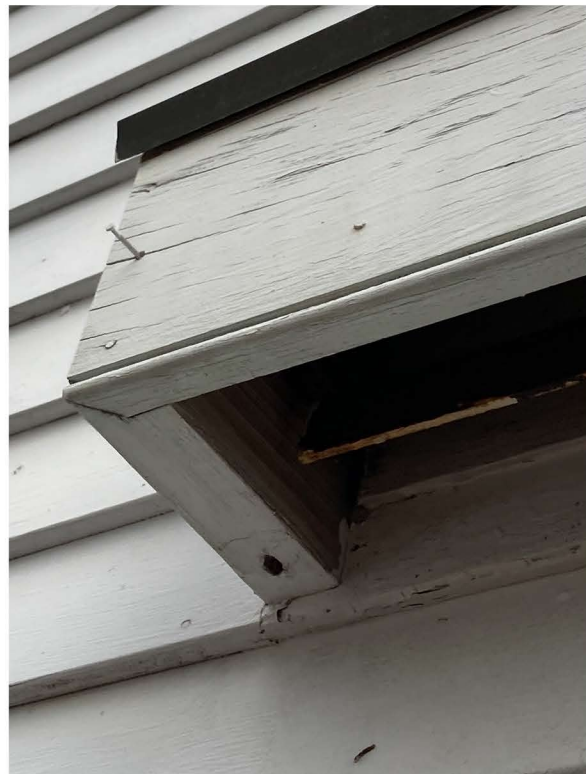
NEW BARN DOOR TRIM COVER

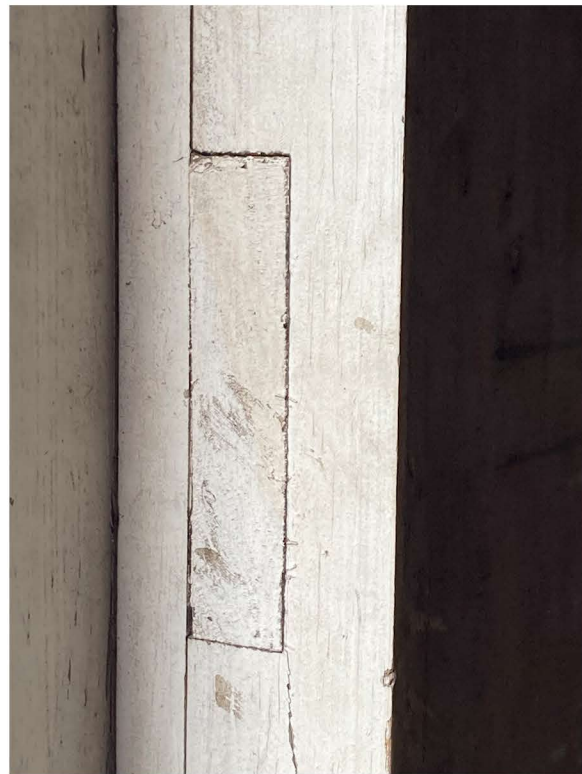
BARN DOOR MORTISE AND TENON

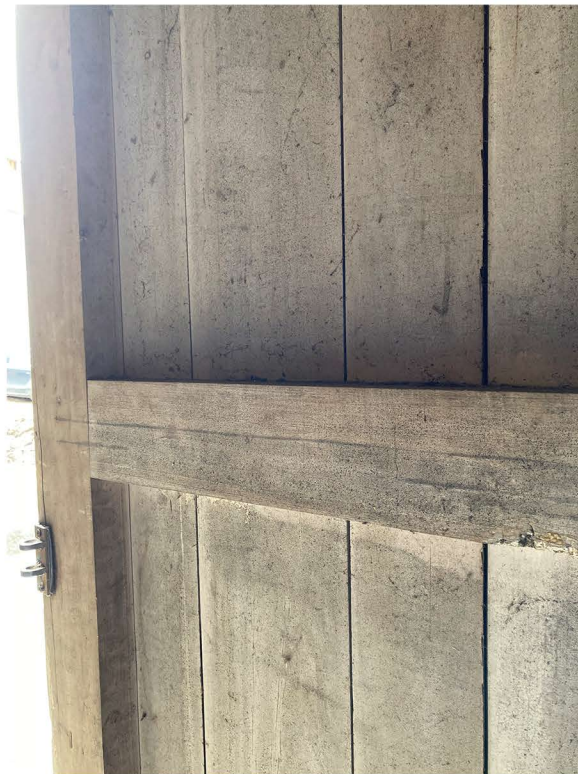
NEW BARN DOOR FRAMING

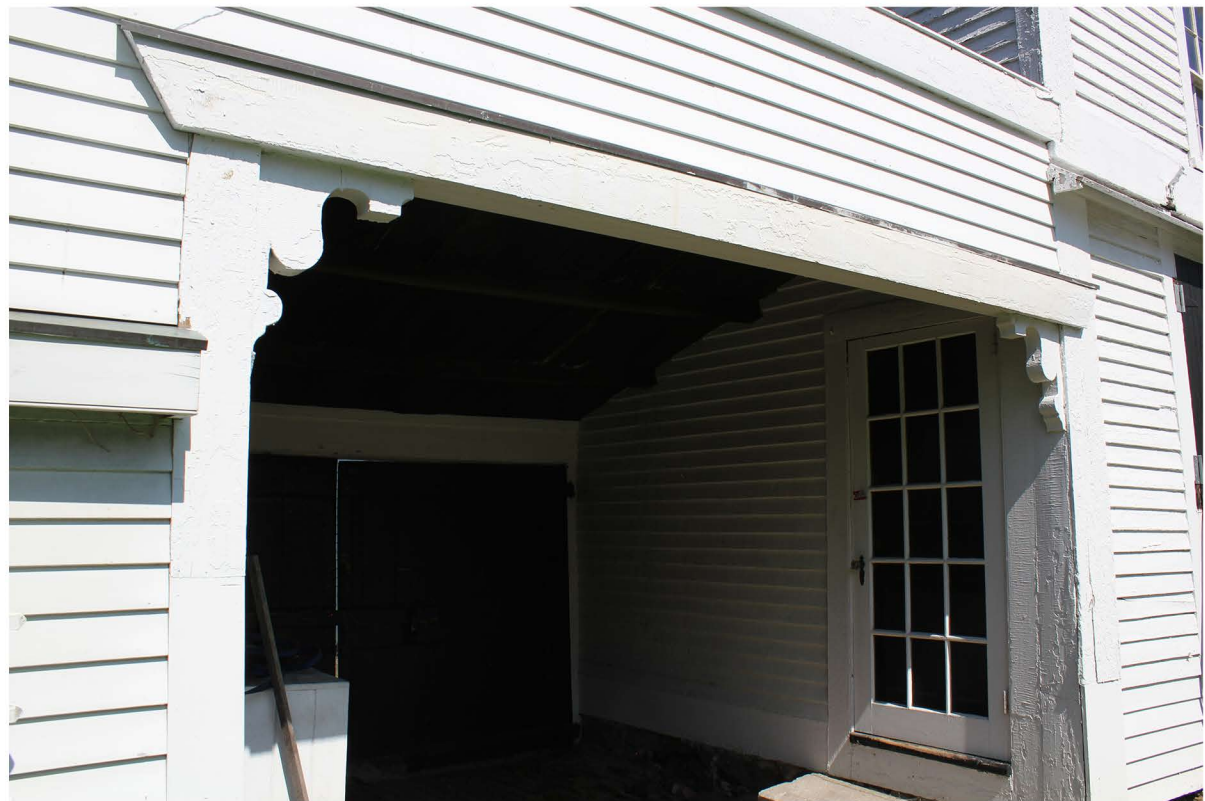
POSSIBLE HISTORIC CORBEL

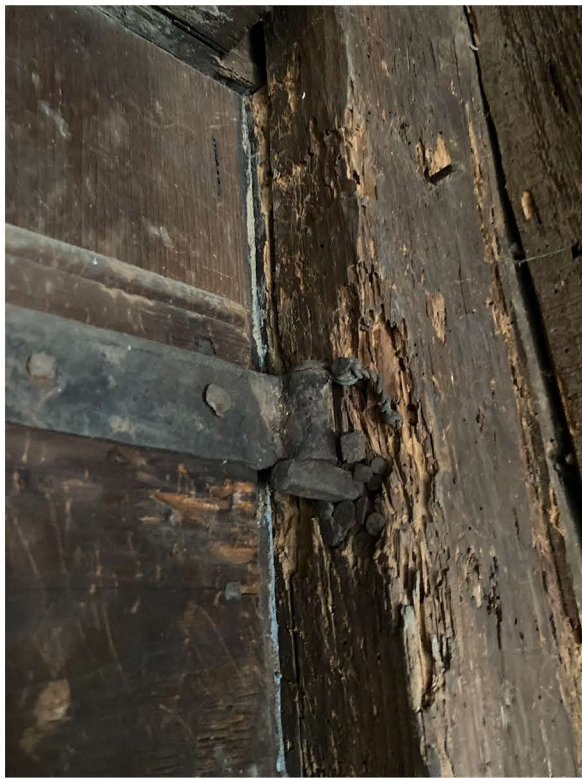
ORIGINAL HINGE (1) ON SMALL DOOR OF CONNECTOR

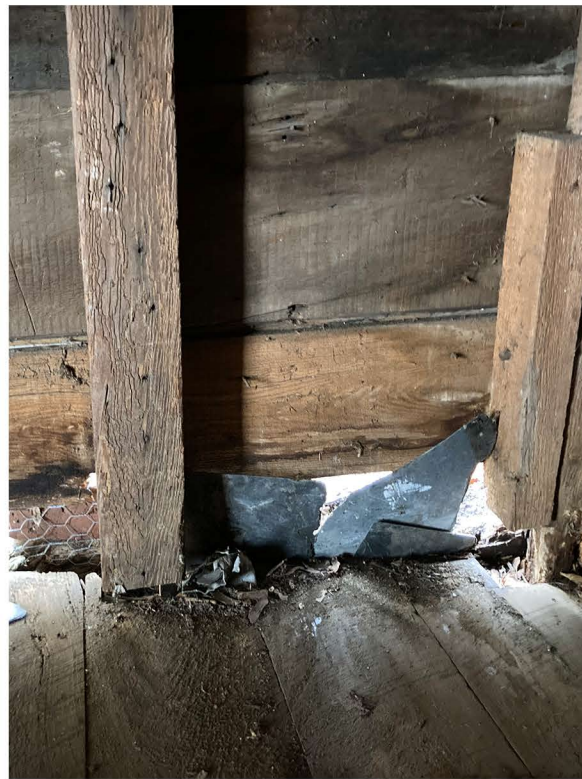
COMPROMISED STRUCTURE AT BASE

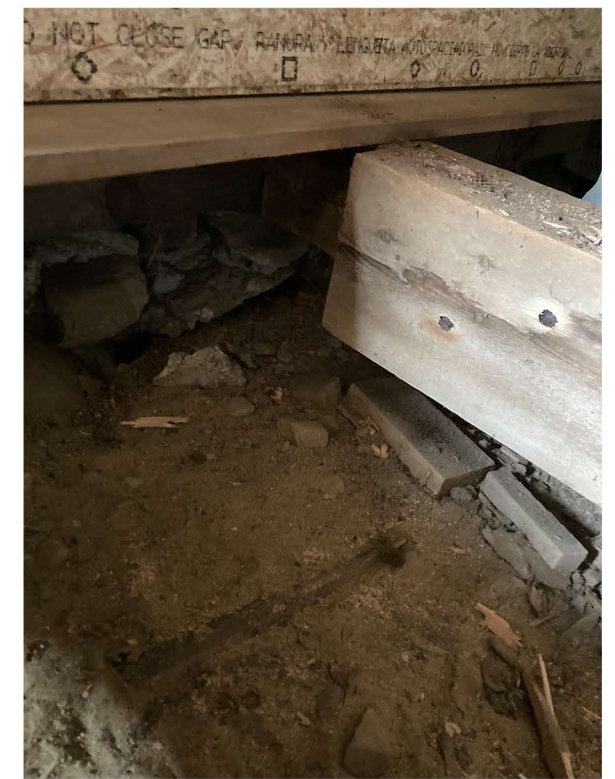
TYPICAL FLOOR FRAMING MADE UP OF REPURPOSED BEAMS

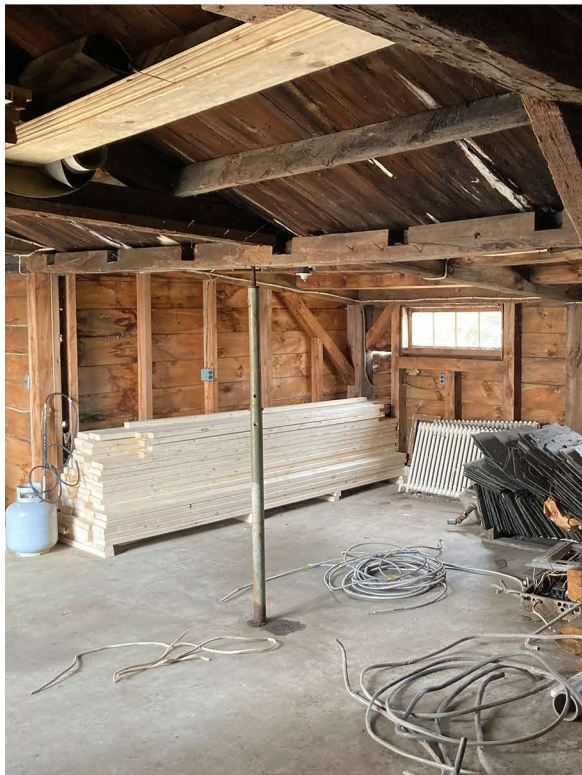
NEW FRAMING AT 1979 CARPORT

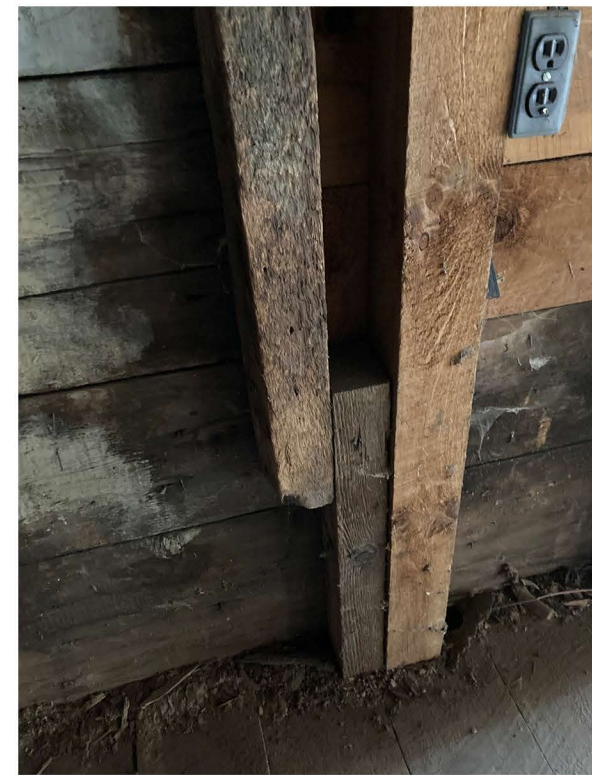
TYPICAL FRAMING AT FRONT WALL

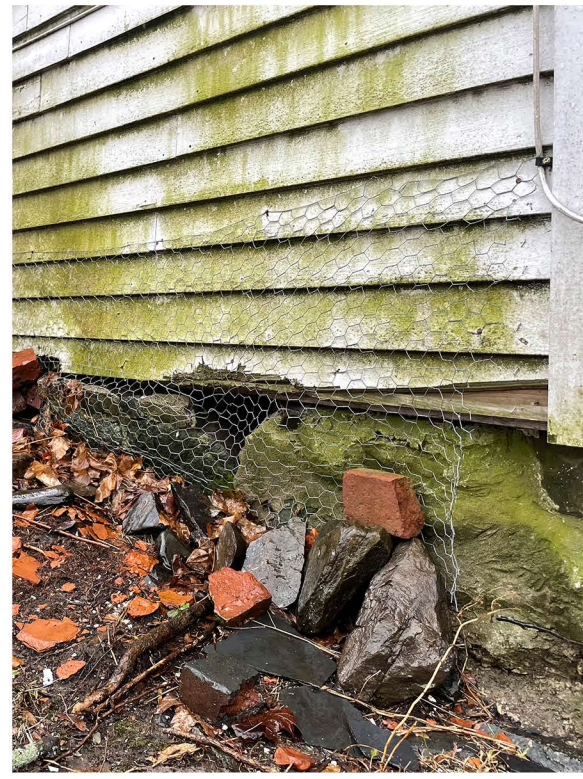
STONE RUBBLE FOUNDATION AND NEW SIDING REPAIR

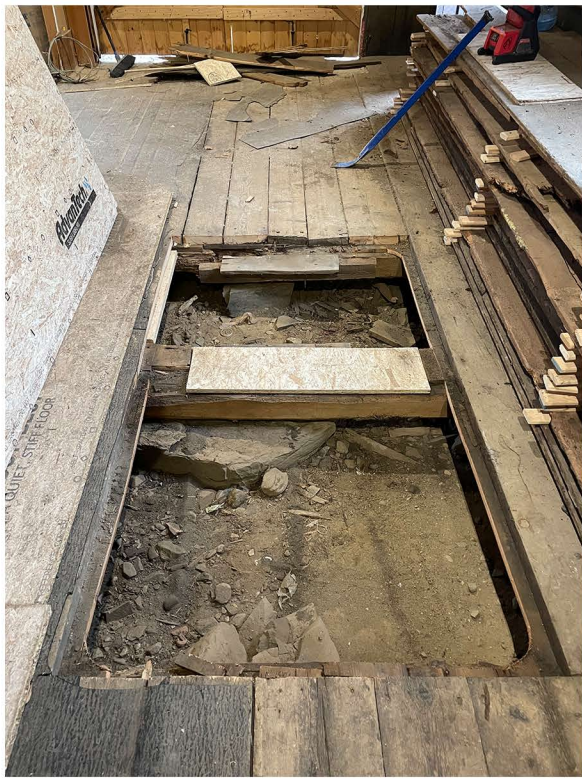
TYPICAL BEAMS IN DIRECT CONTACT WITH GROUND

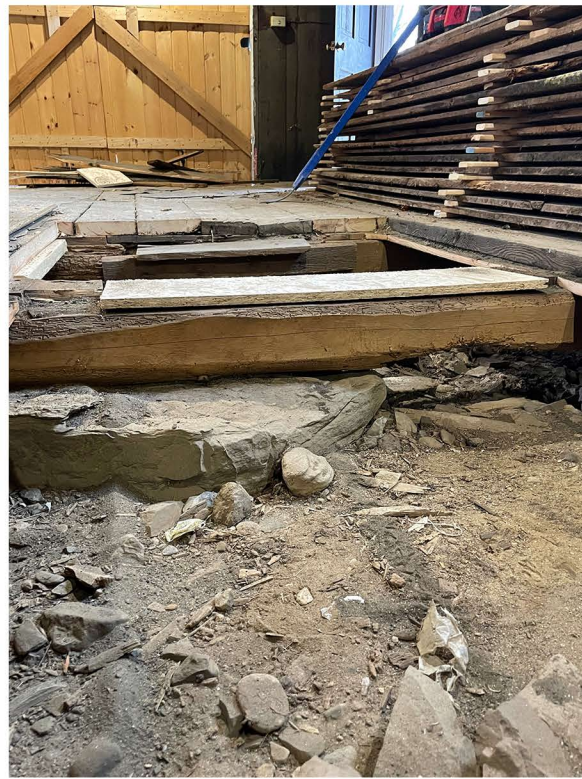
TYPICAL BEAMS IN DIRECT CONTACT WITH GROUND

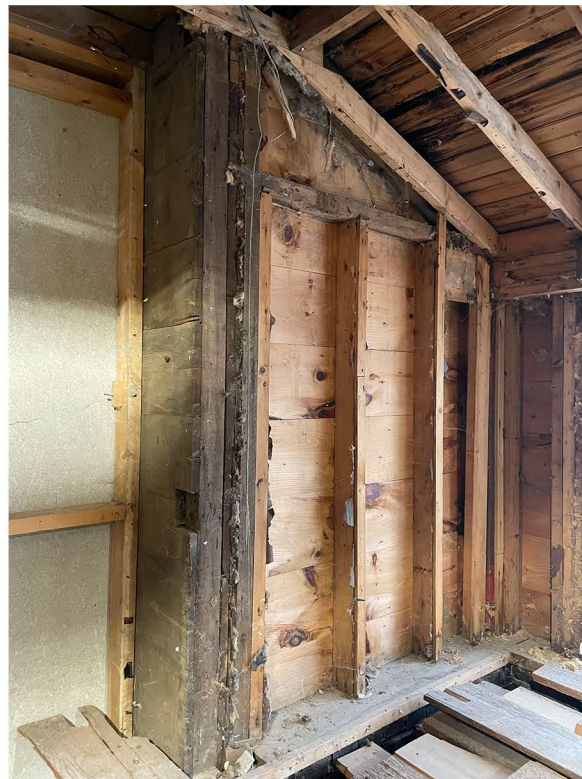
TYPICAL NEW FRAMING

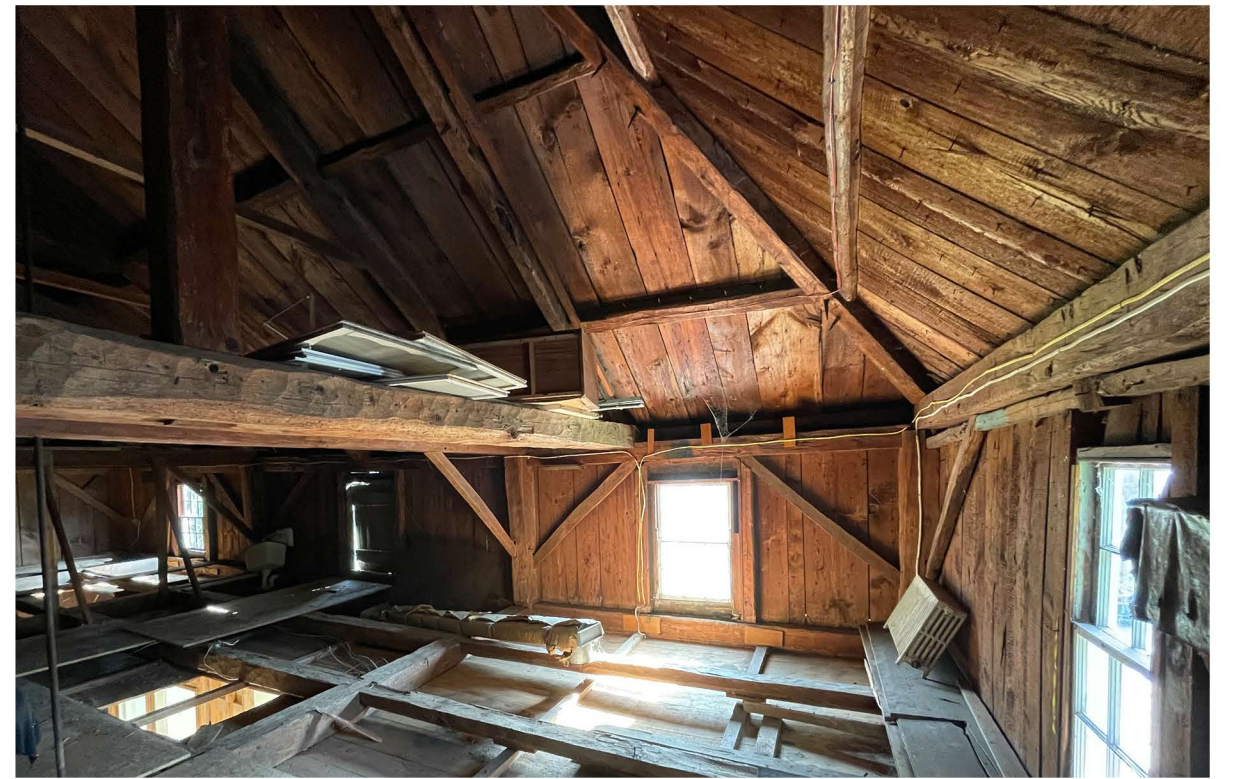
TYPICAL HISTORIC FRAMING

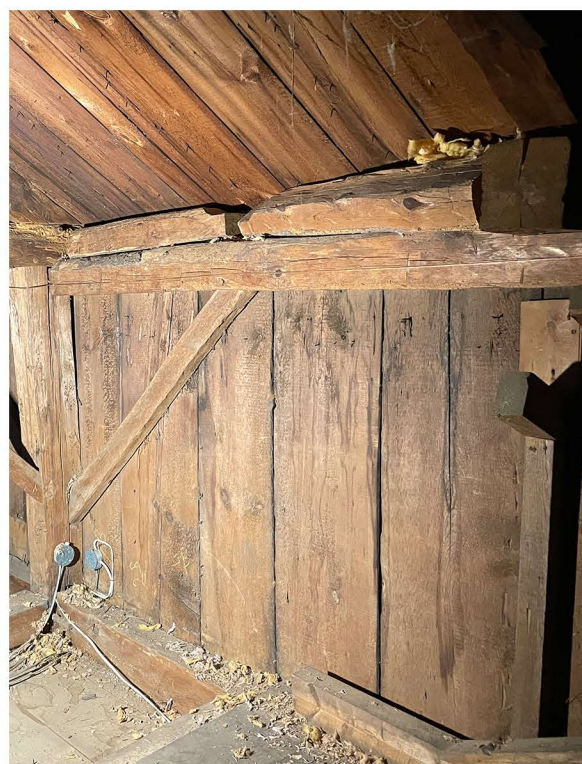
OLDER FRAMING MEMBERS HAVE BEEN MODIFIED, REMOVED, OR RELOCATED. (SECOND FLOOR OF CARRIAGE HOUSE)

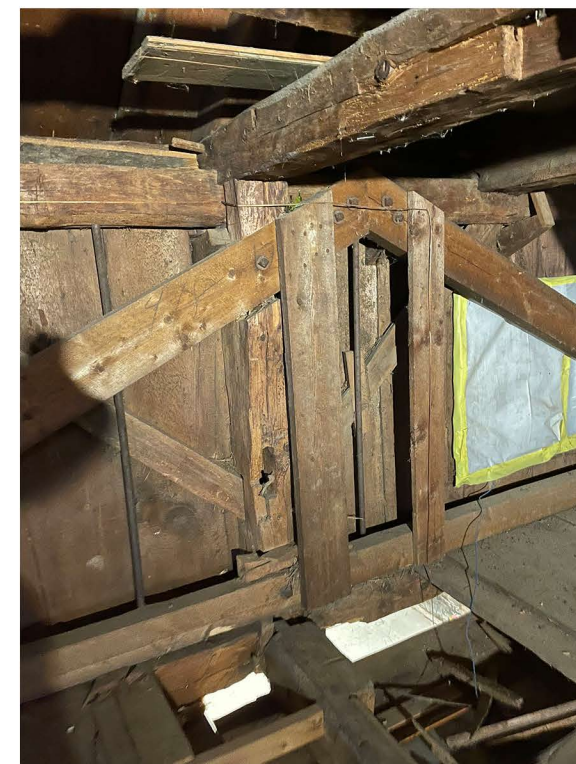
OLDER FRAMING MEMBERS HAVE BEEN MODIFIED, REMOVED, OR RELOCATED. (SECOND FLOOR OF CARRIAGE HOUSE)

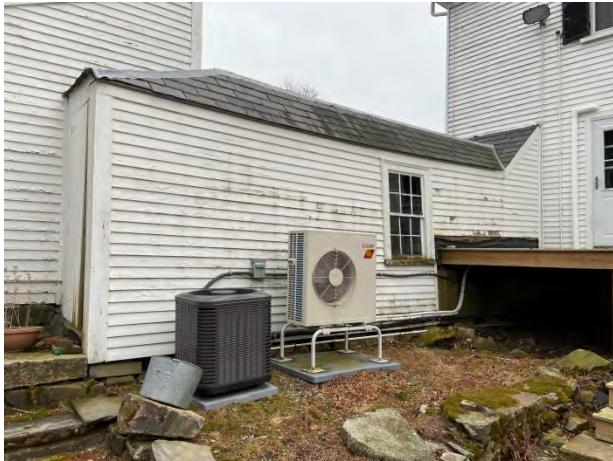
The connector foundation is made of loosely spaced stone supporting a timber plate. The exterior grade along the north side is about 1-foot below the top of the foundation wall. The exterior grade along the south side is approximately at the same elevation as the interior wood floor. Brick masonry cladding has been added along the outside face of the south wall in an attempt to provide some decay protection to the wall and timber sill. The top of this brick cladding is about 1-foot above the exterior grade and interior floor and covers decaying wall sheathing. (Images 1 – 5)

1-Connector north elevation

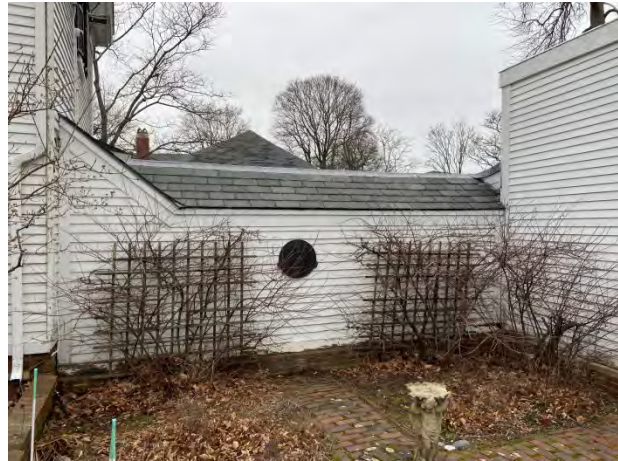
2-Connector south elevation

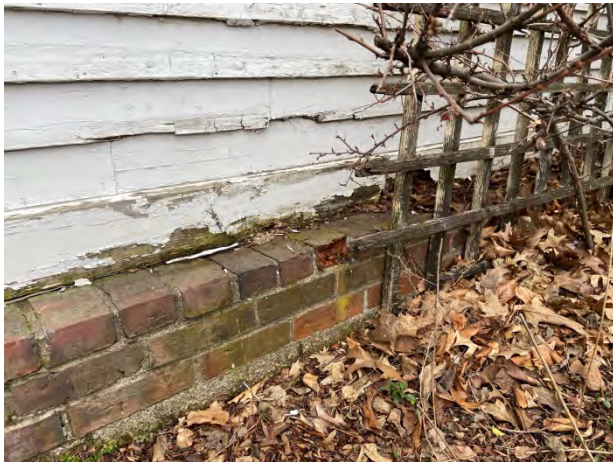
The connector construction is haphazard, with a sloping floor, walls out of plumb, and techniques that would be considered unconventional for any time period. The brick masonry cladding wall does not provide sufficient or appropriate decay protection for the wood framing materials.

3-Connector brick cladding on south side

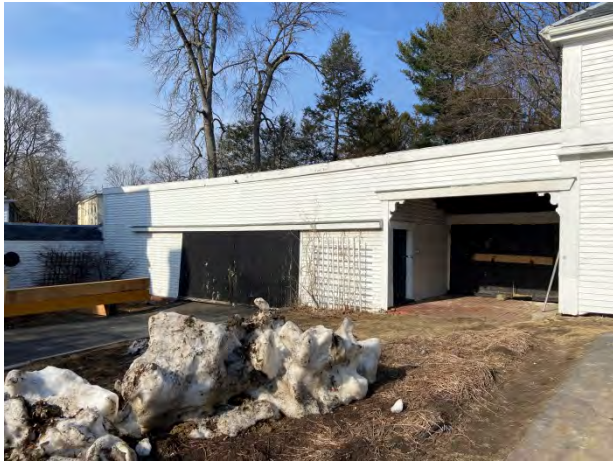
7-Barn southwest elevation

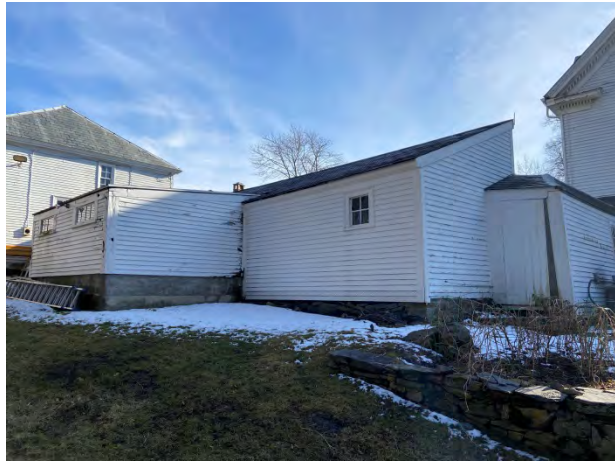
8-Barn north elevation

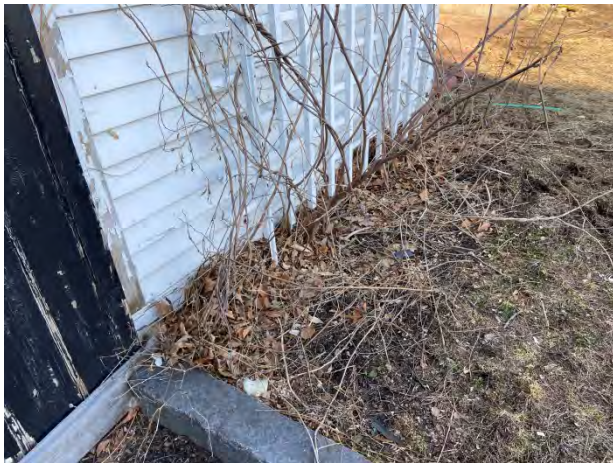
9-Siding extending below grade

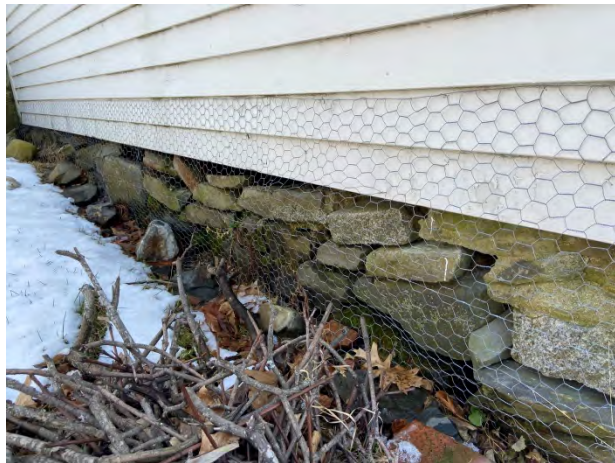
10-Stone foundation along back of barn

The barn foundation along the front of the building is not accessible or visible. It is most likely constructed similar to the connector south wall, with brick cladding covering the base of the wood wall and the dry stacked stone foundation. At some locations along the front of the building, the soil is in contact with the wood clapboard siding and is above the interior floor elevation (Image 9). Along the back of the original building, the foundation is constructed of dry stacked stone (Image 10). At the addition, the foundation is constructed of concrete block and brick masonry.

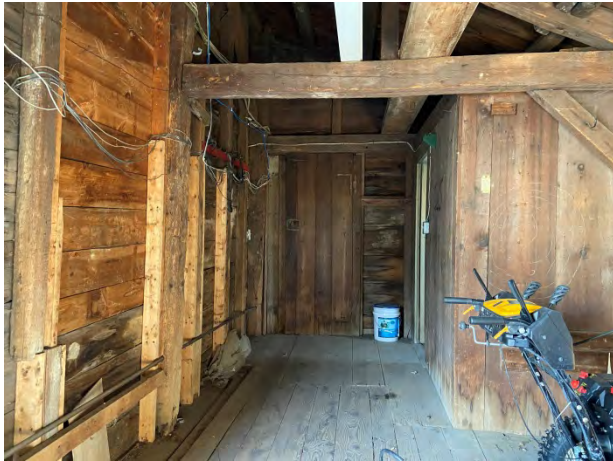
11-Inside looking north

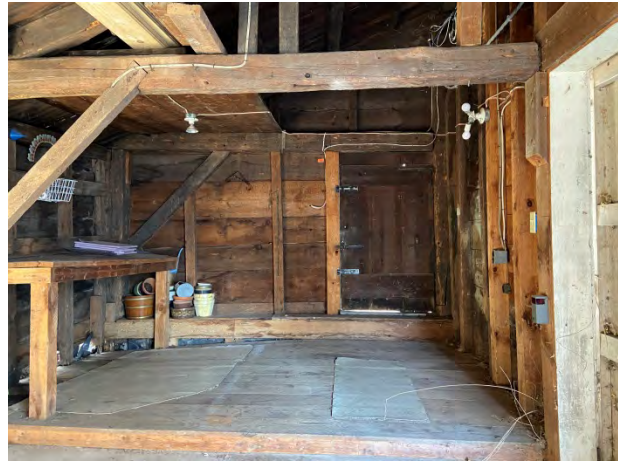
12-Inside looking south

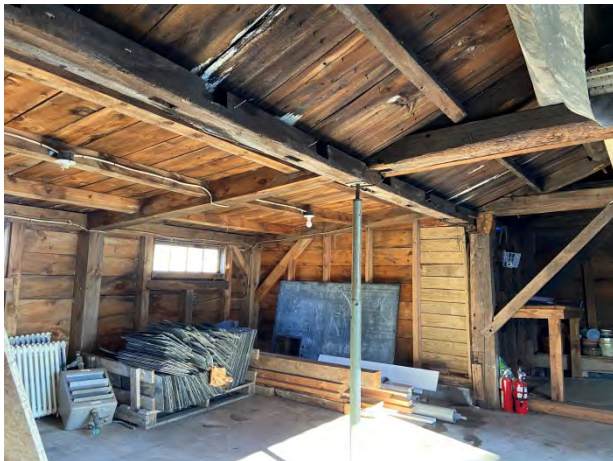
13-5x5 timber supported on screw jack

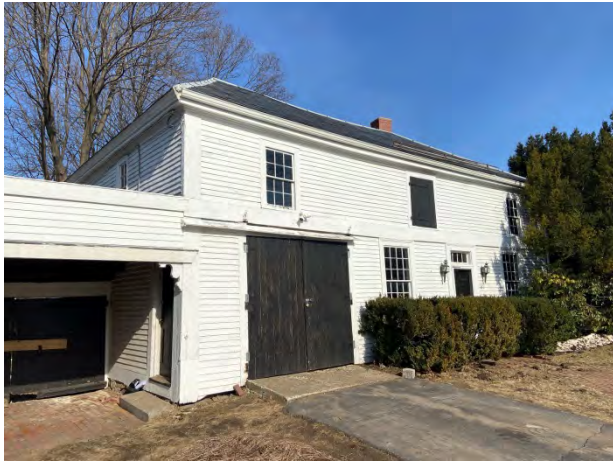
The carriage house was originally constructed as a 26'-3"x40'-6" story and a half timber frame hip-roofed structure. A subsequent renovation added a one story shed extension along the entire back of the building. (See image 17 and 18)

17-Carriage house east elevation

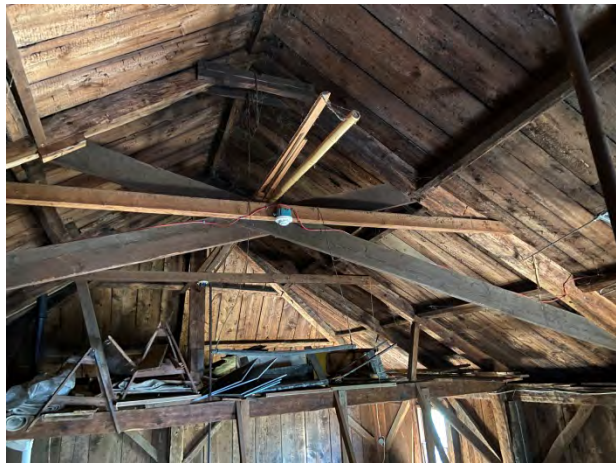
The structure has two major frames along lines 7 and 8 with steel hanger rods that extend from the second floor 8x8 carrying timber to the rafter peak. (See SK-B and SK-C) This system provides support to the second floor and relies on diagonal bracing at the second floor level and balloon posts that are continuous from the foundation to the roof truss. (See 1/SK-E) At the frame on line 7.5, the timber bottom chord was cut and removed. In an effort to compensate, 2x8 diagonal chords were installed in an attempt to create a scissor truss. (See images 21 & 22, and 2/SK-E)

22-Modified roof framing at line 7.5
