City-Wide Bridge Evaluation Portsmouth, New Hampshire

Prepared for:
City of Portsmouth, New Hampshire

Hoyle, Tanner
& Associates, Inc.
www.hoyletanner.com

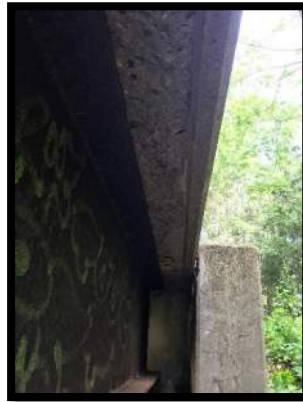
The expansion joint glands are holed, leaking, and have reached the end of their useful service life. Filler material that appears to have formed the separation between the abutments and brush curbs no longer exists. The east abutment exhibits map cracking, spalling and isolated larger cracking with horizontal movement up to 1/16". The underside of the deck is in generally satisfactory condition with delamination and spalling throughout the underside of the overhangs.

Delamination at
Deck Overhang

- Repave both approaches to correct tripping hazard.
- Touch-up the rail system with cold galvanizing compound and replace broken pickets.
- Remove spalling and loose concrete from the deck and seal to prevent further abrasion.
- Regrade the approach shoulders and embankments and add erosion stone (as necessary) to promote proper drainage and minimize erosion.
- Add filler material between abutment and brush curb.
- Clear vegetation overgrowth along west approach.

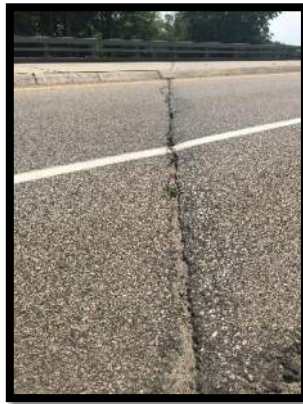
East Transition Joint

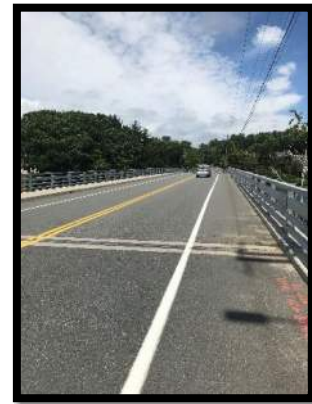
On South Approach Looking North

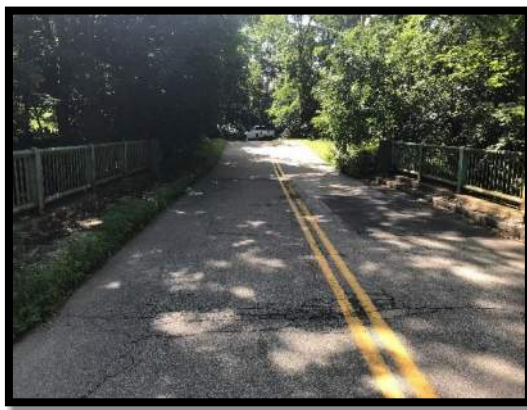
The pavement on the bridge deck and in the approaches is cracked and settled. The sidewalk and curb exhibit cracking and spalling and are covered with debris and vegetation. Nuts are missing from the anchor bolts of the steel pipe bridge rail, and the paint system is failing. The underside of the concrete deck exhibits areas of efflorescence indicating that water and chlorides are leaching through the deck. The deck concrete appears to have been poorly consolidated during construction as many patches of exposed aggregate and voids are also

Looking South from North Approach

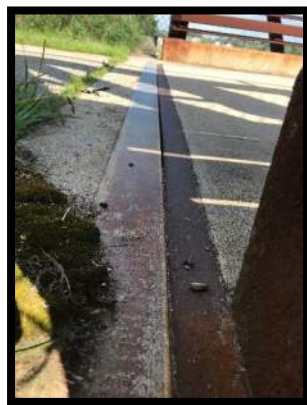
West Expansion
Joint

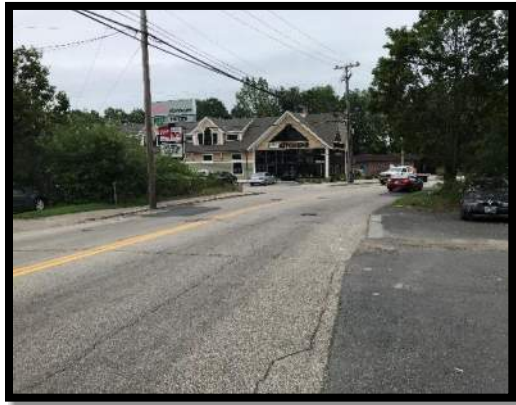
North Approach Looking South

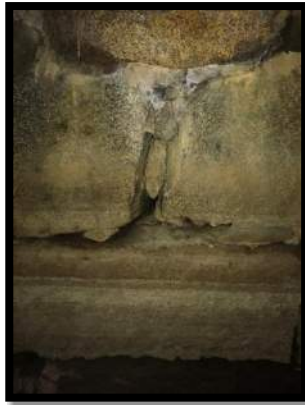
The span of the structure narrows from 11'-6" to 10'-6" at the transition between the upstream concrete box culvert to the City-owned stacked granite abutment bridge. The granite stones of the masonry abutments are cracked with voids and the mortared joints between stones are deteriorated. Large granite blocks form the bottom of the channel at the outlet. Heavy vegetation is present around the outlet of the structure and is likely a cause of the rotation that is occurring in some of the granite blocks of the east wingwalls.

Voids Between Granite
Blocks of Abutment

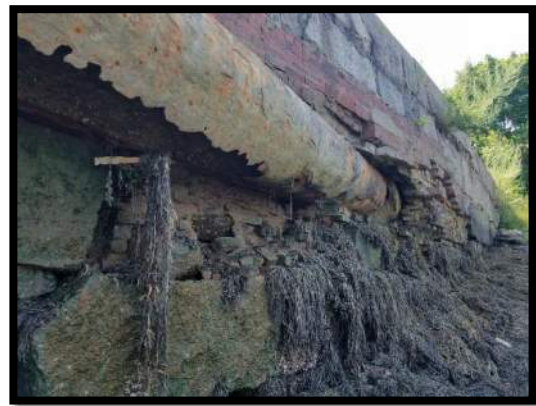
Northeast Seawall

On the east side of the bridge there is an exposed out-of-service sewer main that is severely deteriorated with extensive cracking and complete section loss along the invert. An active sewer main is located within the hydraulic opening and there is evidence that roadway backfill material is migrating through the culvert walls at the sewer main penetration. Bricks used to infill voids in the granite block headwall and seawall are missing in areas of the northwest seawall. The MPA liner exhibits heavy corrosion and several scattered holes, with 100% section loss at the bottom 6". The bolt heads along the seams in the bottom two-thirds of the MPA liner exhibit section loss. The concrete pedestals have exposed rebar, heavy deterioration, and marine growth.

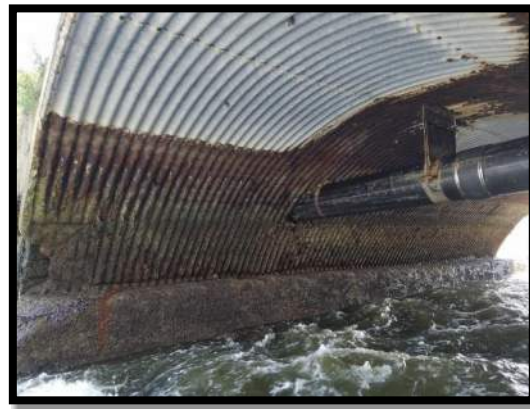
East Intrados of Arch

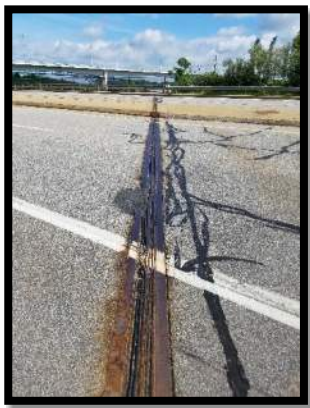
South Expansion Joint

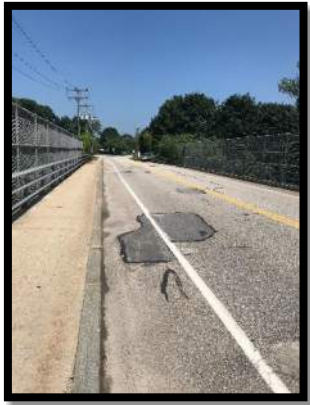
Deck Overview

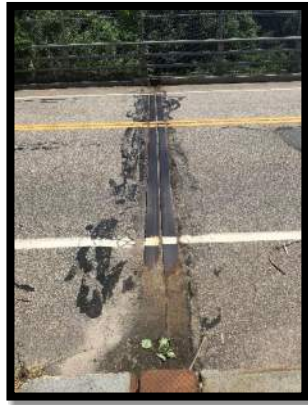
East Expansion Joint

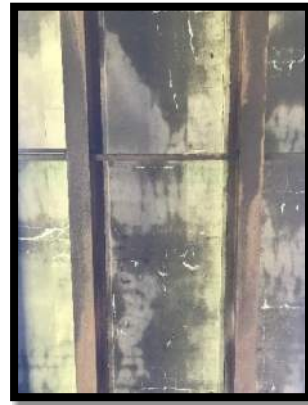
The underside of the concrete deck exhibits cracking with efflorescence and leakage, with the most severe cracking and leakage present in the three interior bays. The steel girders are in good condition. The substructure (abutments, piers and wingwalls) is in good to very good condition. Map cracking and rust stains are present in the abutments.

Underside of Deck

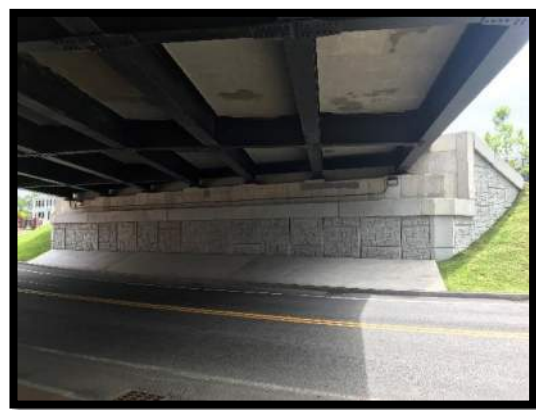
Underside of Deck

The underside of the deck exhibits cracking with efflorescence and staining within the exterior bays. It is likely water that water is penetrating between the pavement and curbing along the gutter line, migrating under the bridge deck waterproofing membrane at the curb interface, and then leaking through the cracks visible on the underside of the concrete deck. Graffiti on the underside of the deck has previously been covered. The precast concrete coping at the southwest wingwall is rotating; however, the coping is an aesthetic feature and does not contribute to the structural capacity of the wingwall.

- Within the next two years, seal along the curb lines with hot-poured crack sealant to minimize water intrusion through the pavement. This maintenance fix would be completed as an interim-repair with a more substantial repair completed in the long-term and would only be effective as long as the pavement remains in good condition.

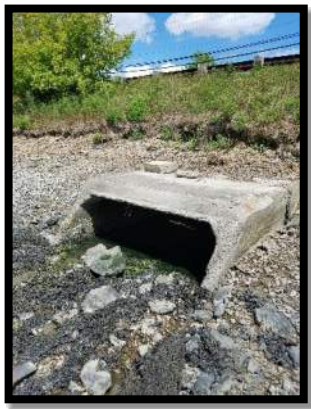
Junkins Ave over South
Mill Pond (South End)

- The existing box culvert span is 5'. However, the bankfull width of the stream conveyed appears to be approximately 12'. The existing structure may be constricting flow of the brook and does not likely meet current stream crossing regulations.
- If necessary, replacement of this structure would likely meet the NHDOT classification for a bridge.

It is recommended that the culverts discussed herein be inspected to further determine their condition. Although the culverts do not currently qualify as bridges per NHDOT criteria, the condition of some culverts may warrant eventual replacement with a structure spanning greater than 10', categorizing the replacement as a bridge. A hydrologic and hydraulic analysis and evaluation of the NHDES stream crossing regulations would need to be performed to determine the required span length. If the results of the analysis and evaluation indicate that the culvert should be replaced with a structure meeting the NHDOT definition of a bridge (span length equal to or greater than 10'), then the structures would likely qualify for funding through the NHDOT Municipally-Managed State Bridge Aid Program.

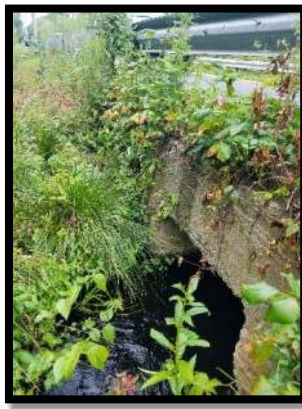
Lang Road over Branch of
Berry's Brook

- The existing structure is a 7' diameter corrugated metal pipe.
- Low flow was observed at the time of the site visit; however, a wide pond/wetland is located both up- and downstream of the crossing. It is likely that the structure is constricting the flow of the brook.

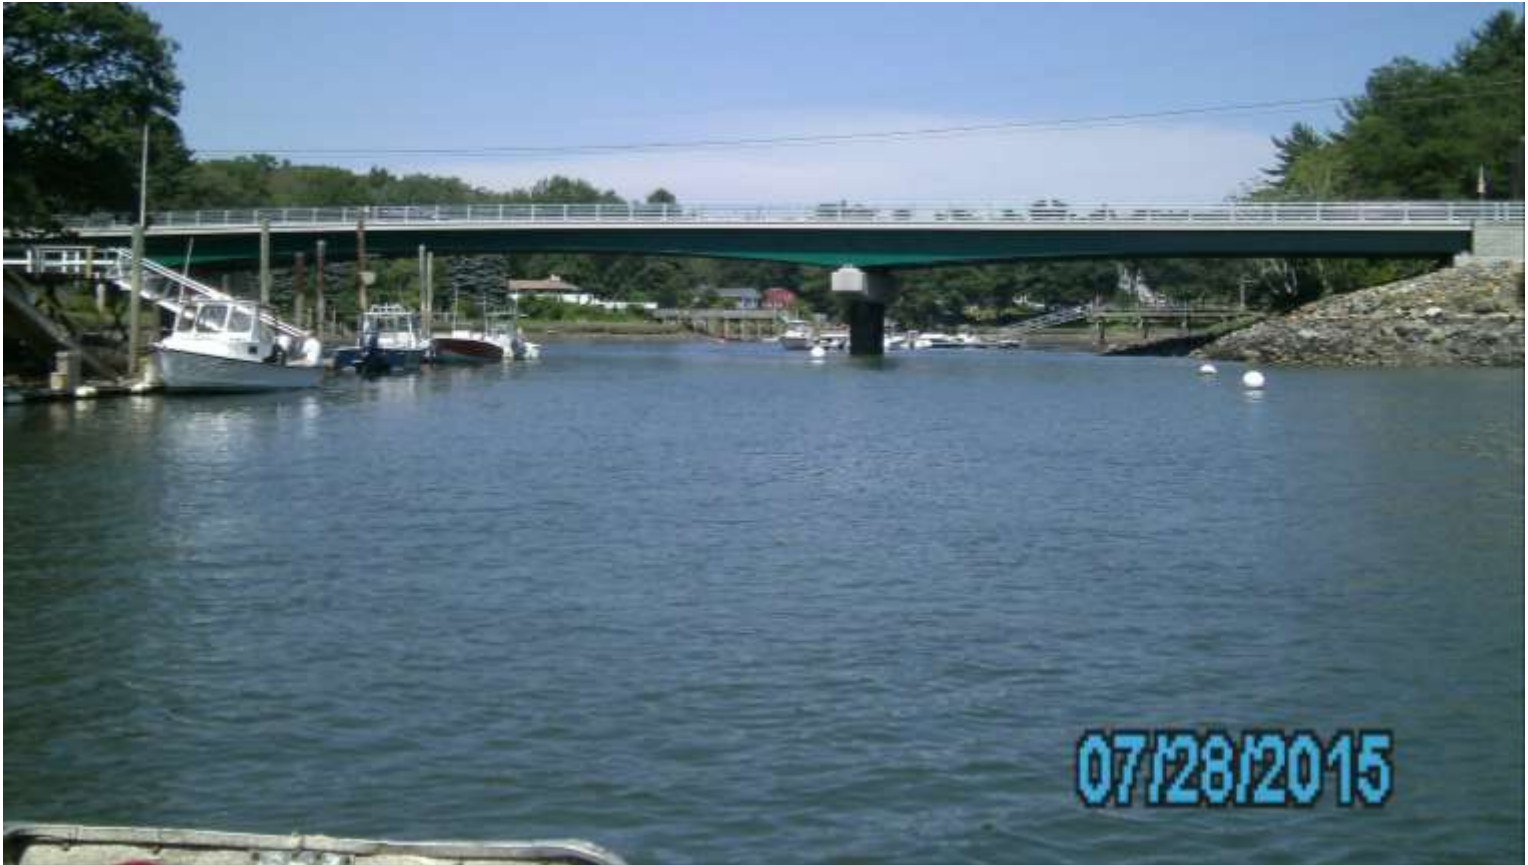
Description : Bridge structure, looking to sea

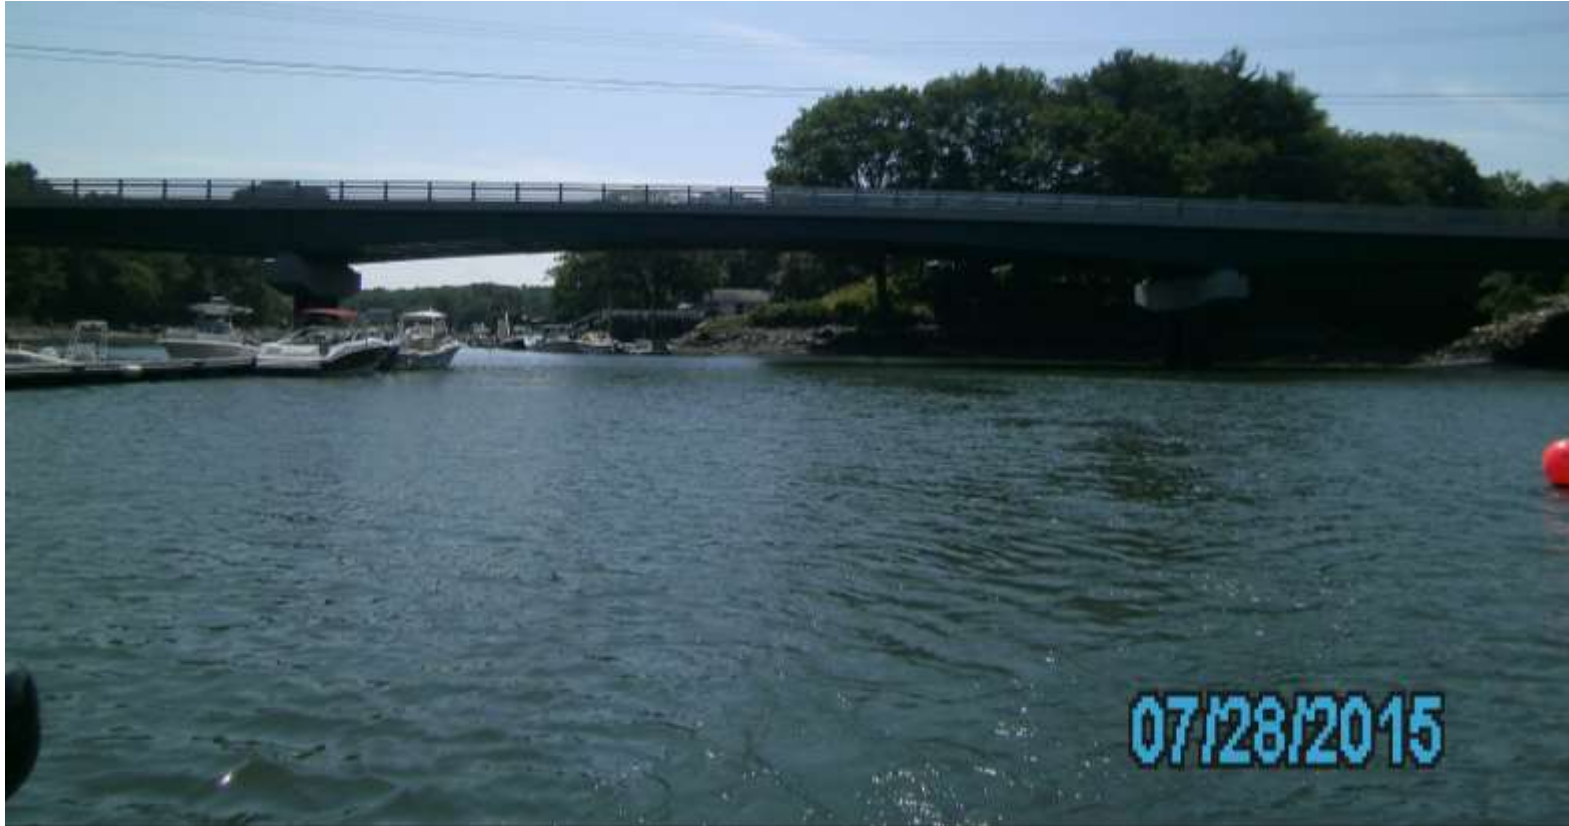
Description : Bridge structure, looking to inland

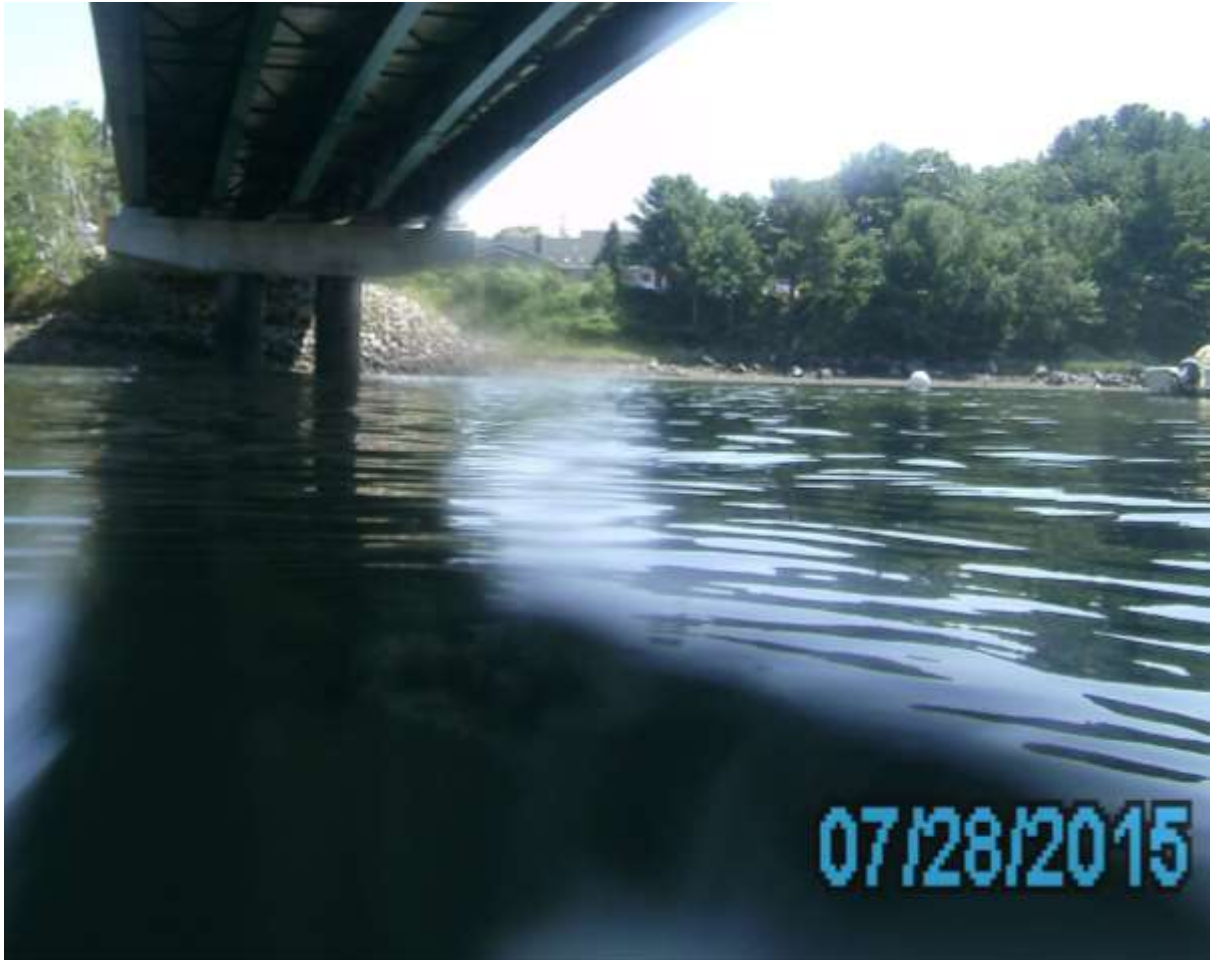
Description : **Bent 2 A & B**

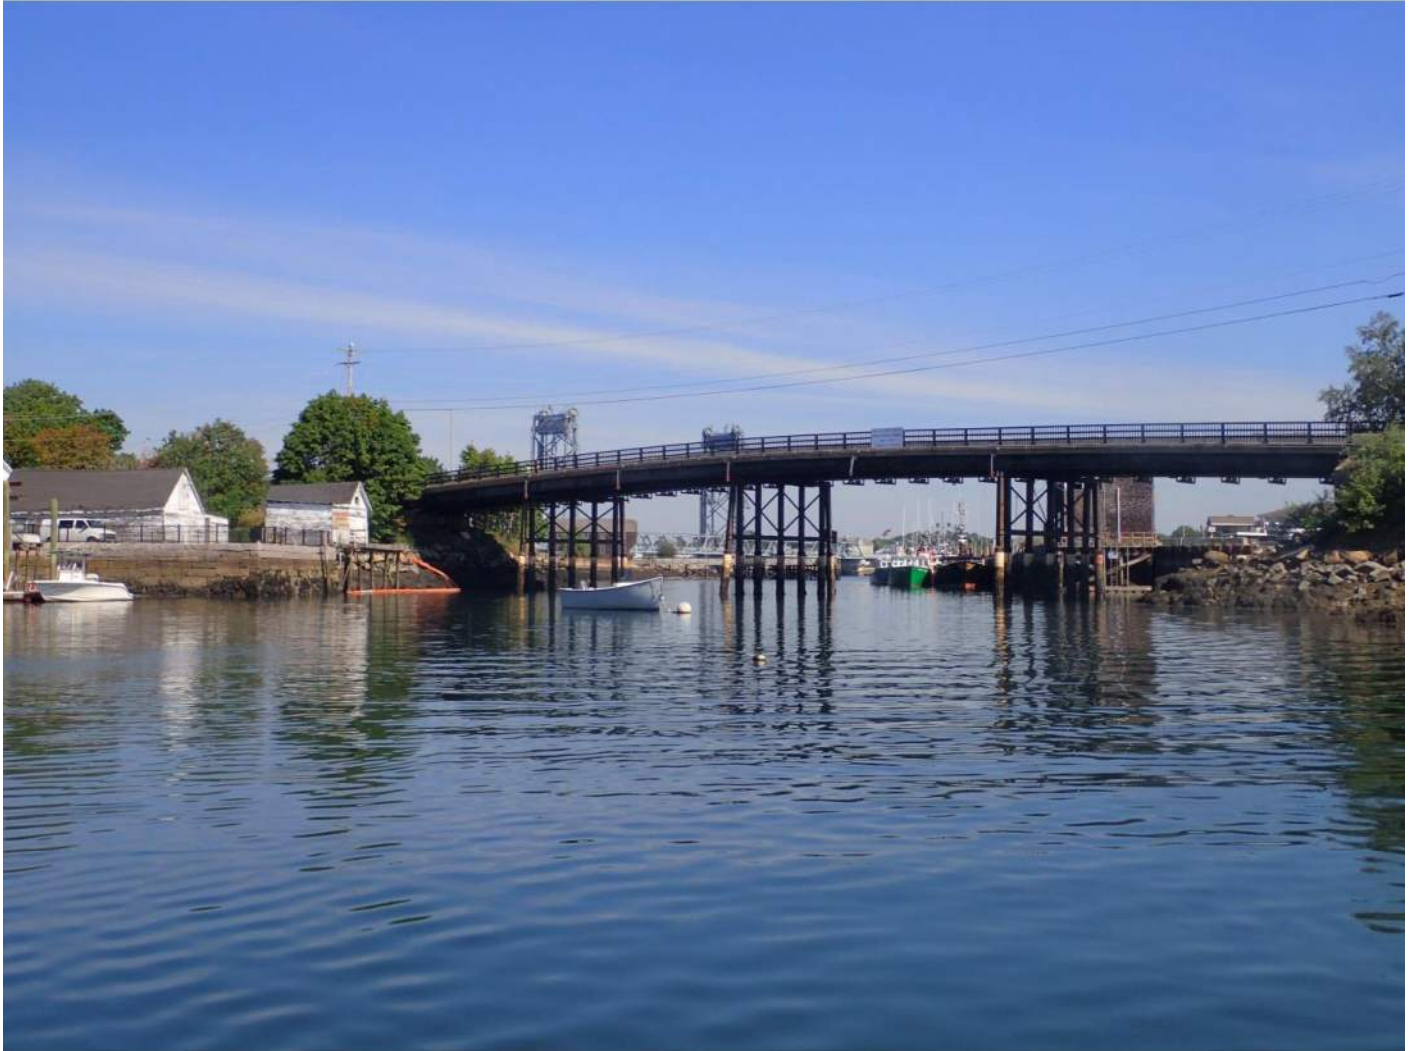
Structure ID #: 241-069, Pierces Island Road over Little Harbor Date: 08/05/2016
County: Rockingham State: New Hampshire
Description : Bridge Structure, looking ebb

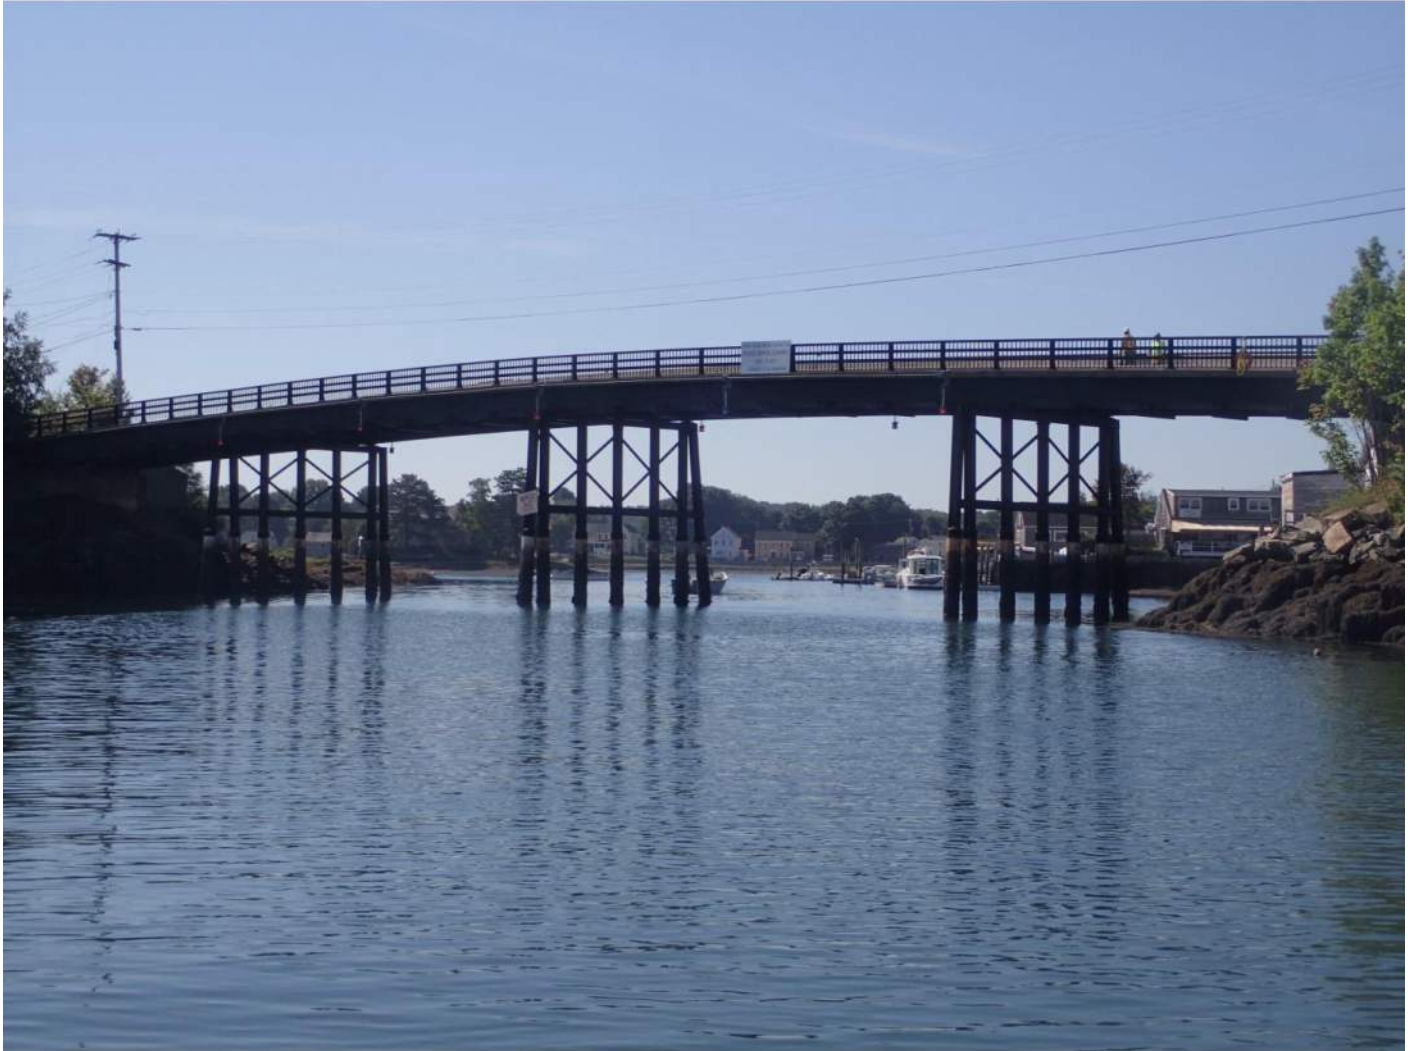
Description : Bridge Structure, looking flood

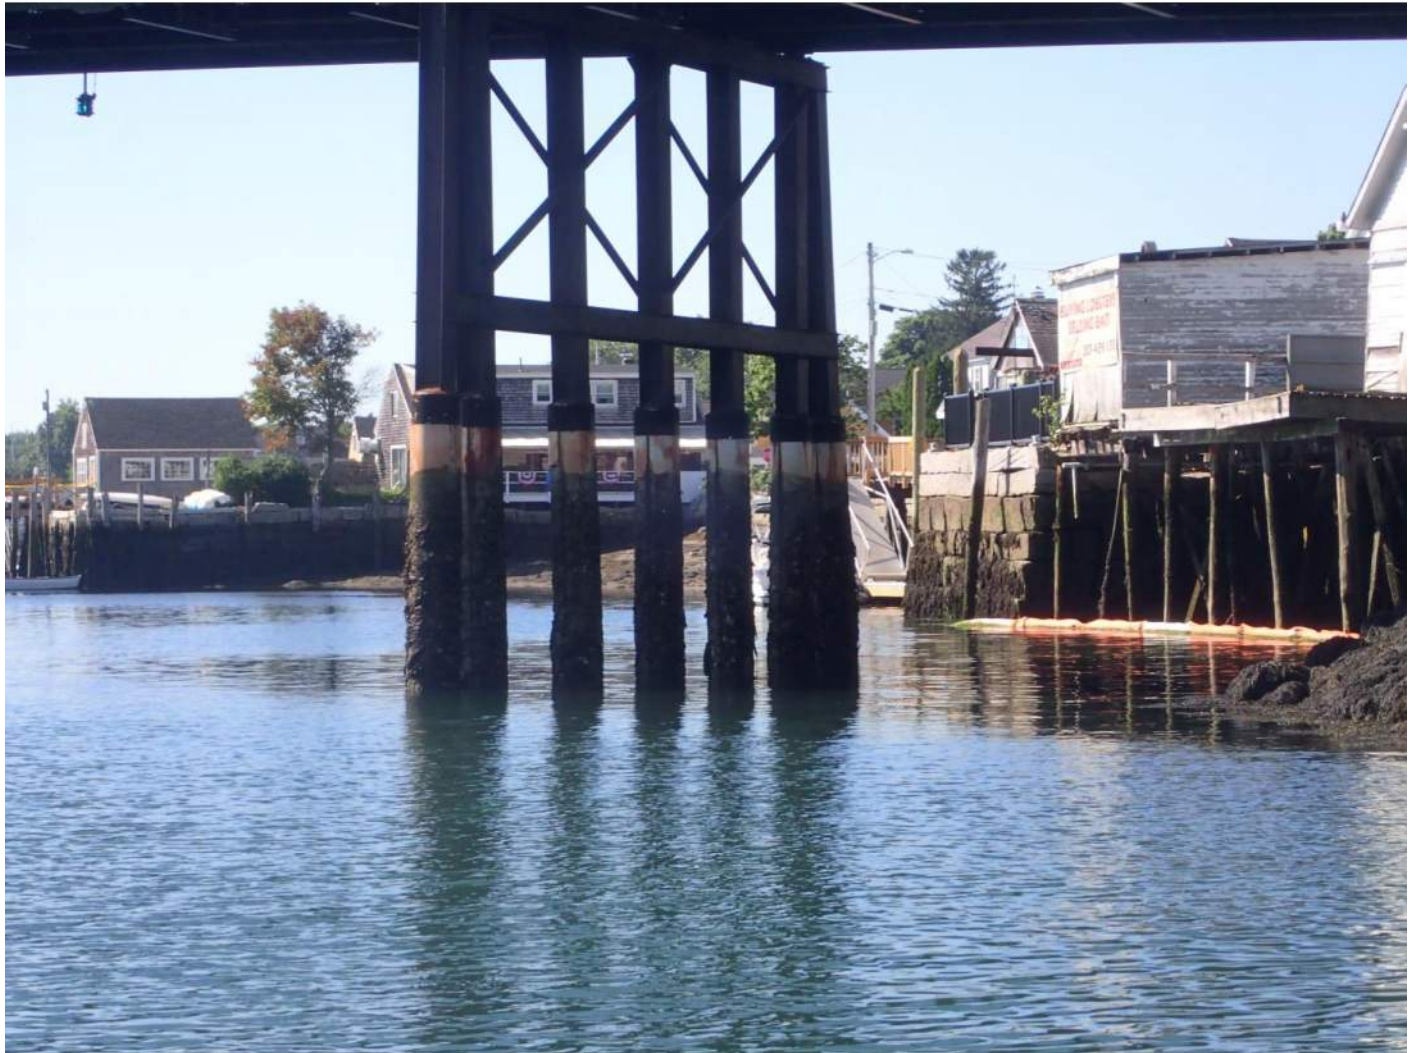
Description : **Bent 1**

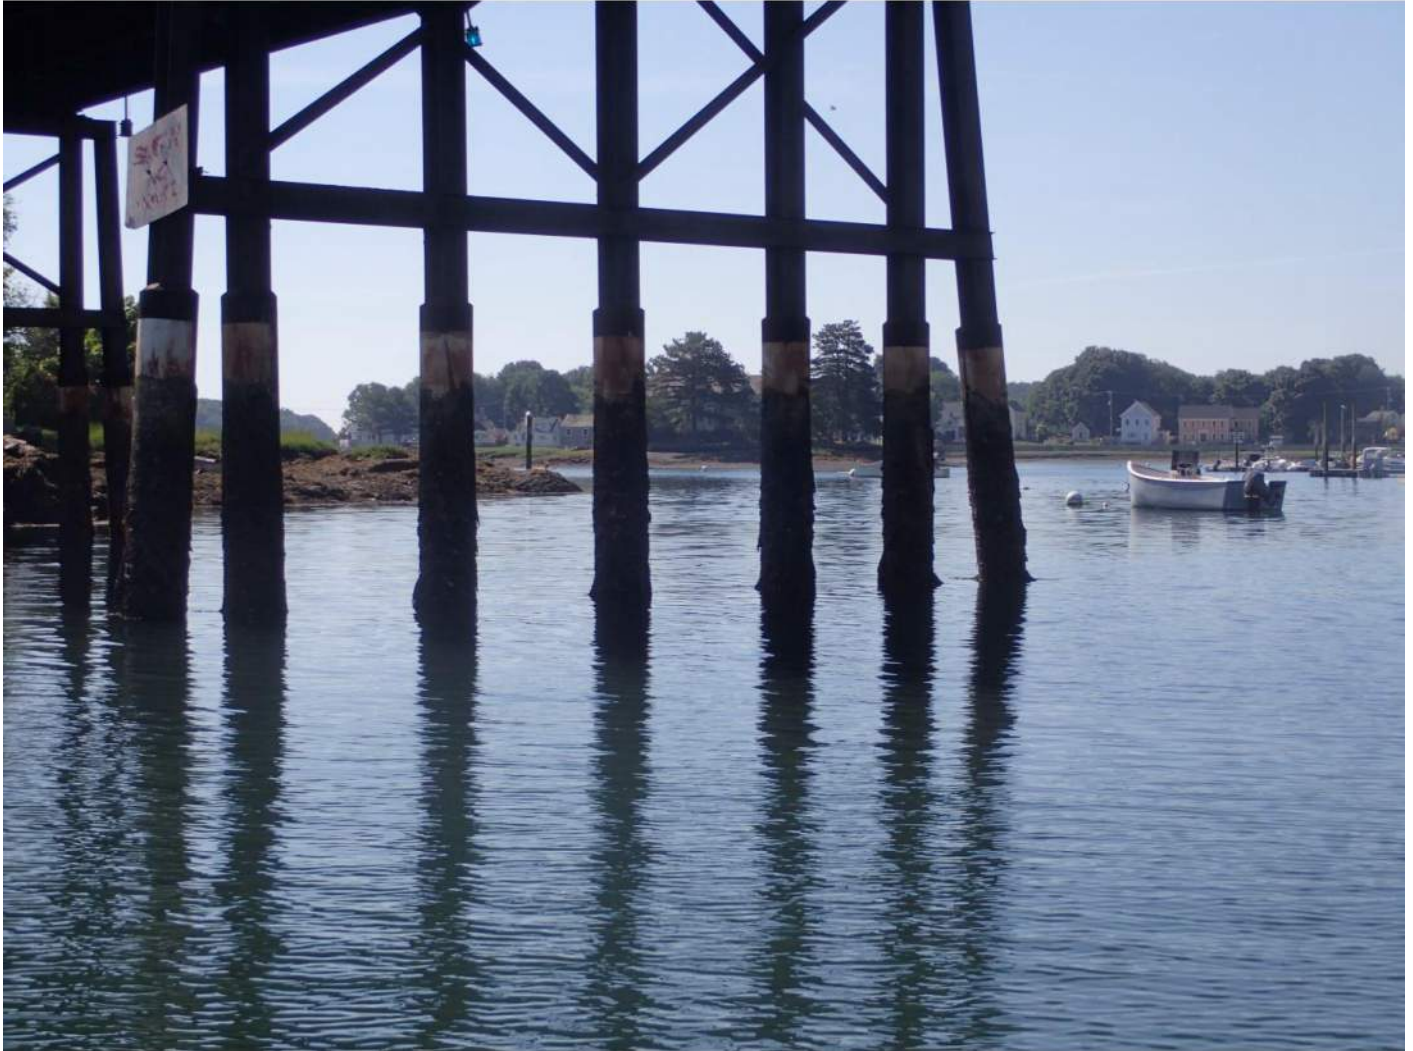
Description : Bent 2

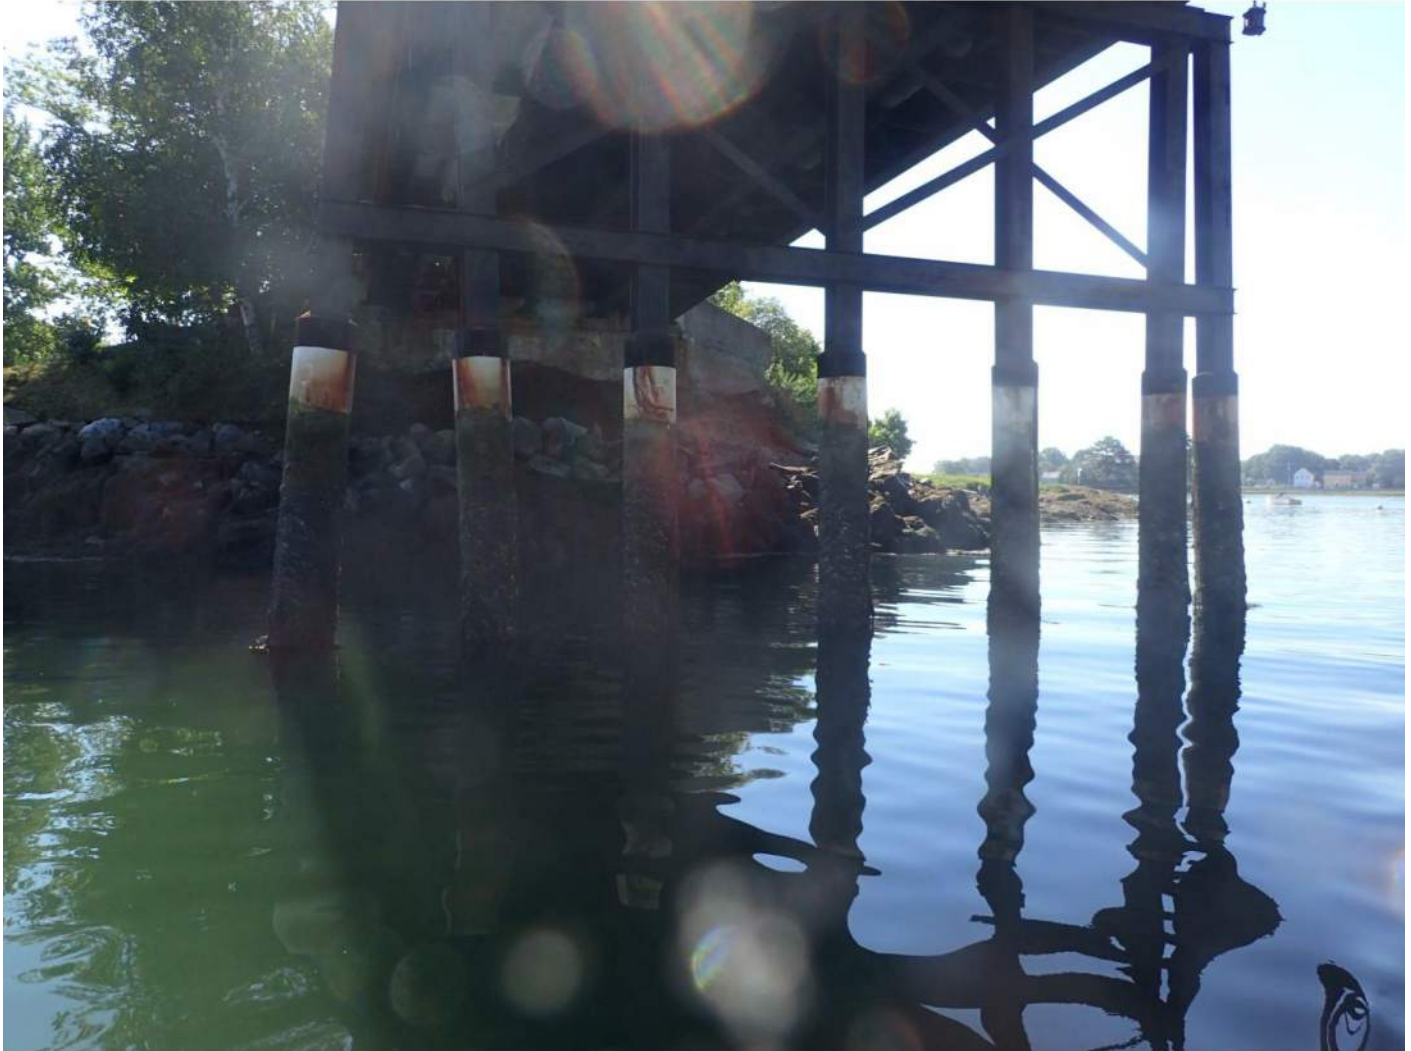
Description : Bent 3

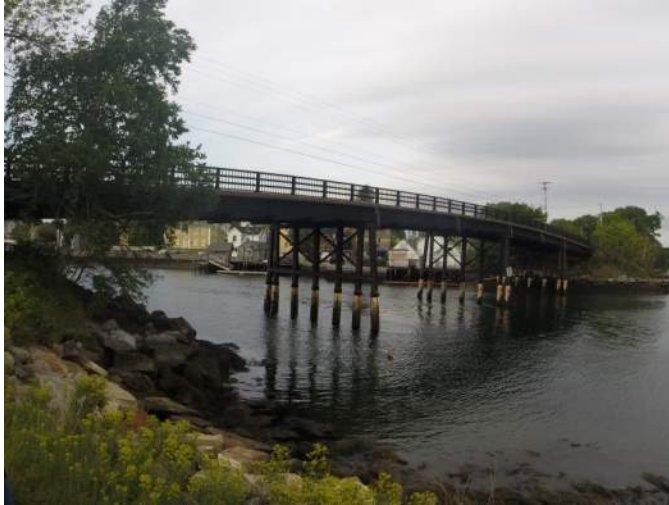
Photo 1

This letter report presents the findings from the underwater inspection of the Peirce Island Bridge over the Piscataqua River in Portsmouth, NH (Photo 1). Engineer divers from Appledore Marine Engineering, LLC (AME) conducted the field inspection on June 8th 2015. The inspection was completed to assess the general condition of the pile bents below mean high water based on a 100% Level 1 visual/tactile and a 10% Level II and Level III detailed inspection. The Level II inspection consisted of cleaning the piles in order to detect and identify damaged areas which may have been hidden by surface biofouling. Level III inspection involved sounding the fiberglass pile jackets to detect unsound grout material. The inspection procedures were completed in accordance with the National Bridge Inspection System (NBIS).

Overall view of the Peirce Island Bridge
(Looking West)

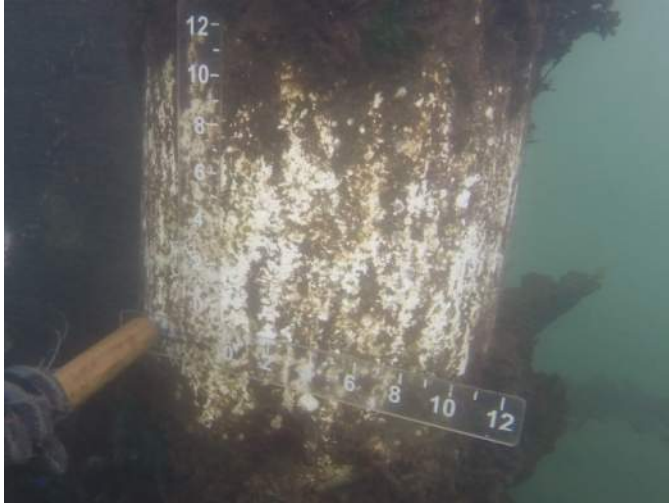
Photo 4

The piles are in good condition. The steel w-shaped piles have protective fiberglass jackets that, based on limited excavation, extend at least one foot below the riverbed (Photo 2). Marine growth covered the piles from low water to river bottom (Photo 3). Tactile inspection and select cleaning of the pile jackets

revealed no noticeable defects (broken seems or voids) that would compromise the embedded steel piles (Photo 4).

Typical cleaned pile jacket with no observed defects
